Manhole Inspection Report

Date:	05/14/2018	Weather:		Coding:	RZMACP
MH#:	M-504-041	Owner:	NA	Len. Surveyed:	9.4
P.O.#:		Surveyor:	Jen Costello	Rim to Invert:	9.7
Customer:		Cert. #:	U-907-5518	Wall Material:	Brick

Street:	Colorado St. 164' North of Home Av	Project:	Hobart, IN
City:	Hobart, IN	GPS Northing:	41.53868484
Location:		GPS Easting:	-87.27423096
Drain Area:	West	GPS Accuracy:	Nearest Meter
Cover Shape:	Circular	Evidence of Surcharge:	No
Cover Size:	22.5	Potential for Runoff:	None
Comments:

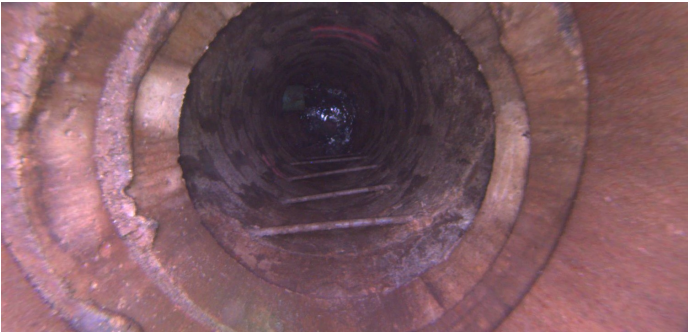
MGP

General Photo

access mh

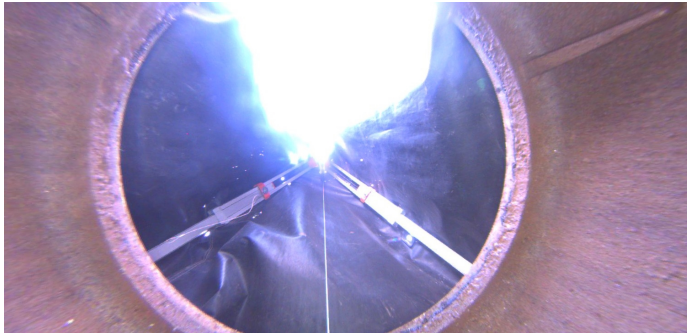
Code:	MGO
Description:	General Observation
Distance (ft):	1.5
Structural Grade:	0
O&M Grade:	0
Clock Start/From:	
Clock To:	
1st Value:	
2nd Value:	
Value Percent:	
Step:	NO
Remarks:	underside of frame

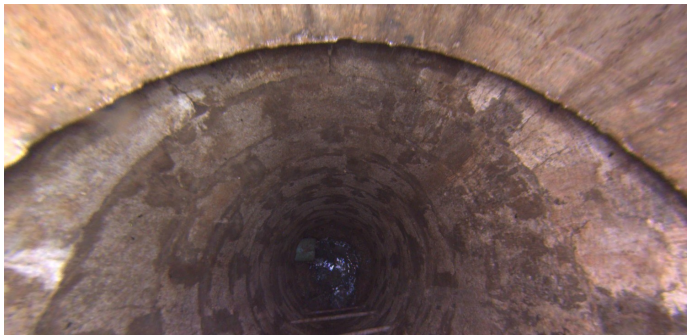
Code:	FL
Description:	Fracture Longitudinal
Distance (ft):	1.5
Structural Grade:	3
O&M Grade:	0
Clock Start/From:	10
Clock To:	
1st Value:	
2nd Value:	
Value Percent:	
Step:	NO
Remarks:

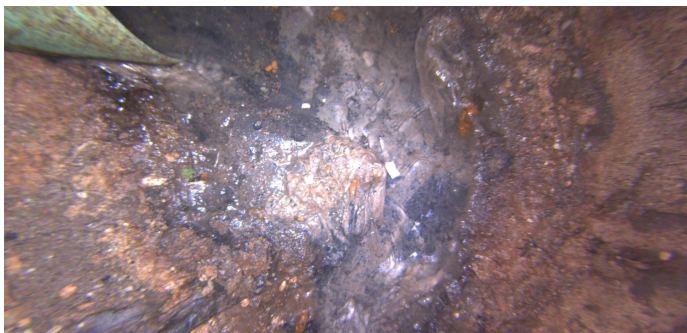
Code:	MGO
Description:	General Observation
Distance (ft):	9.4
Structural Grade:	0
O&M Grade:	0
Clock Start/From:	
Clock To:	
1st Value:	
2nd Value:	
Value Percent:	
Step:	NO
Remarks:	end survey
