Manhole Inspection Report

Date:	05/13/2018	Weather:		Coding:	RZMACP
MH#:	M-504-053	Owner:	NA	Len. Surveyed:	8.6
P.O.#:		Surveyor:	Jen Costello	Rim to Invert:	9.3
Customer:		Cert. #:	U-907-5518	Wall Material:	Concrete (reinforced)

Street:	Home Ave. 162' East Guyer St.	Project:	Hobart, IN
City:	Hobart, IN	GPS Northing:	41.53828812
Location:		GPS Easting:	-87.27646637
Drain Area:	West	GPS Accuracy:	Nearest Meter
Cover Shape:	Circular	Evidence of Surcharge:	No
Cover Size:	22.5	Potential for Runoff:	None
Comments:

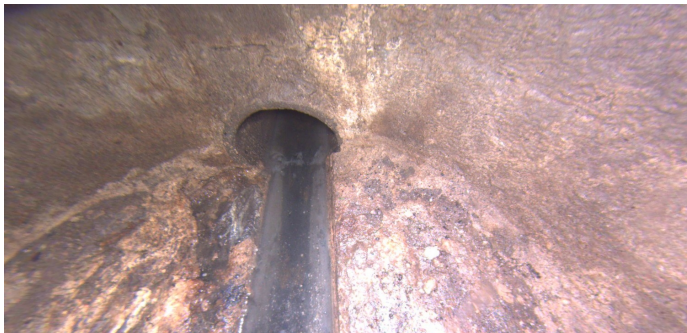
Code:	MGO
Description:	General Observation
Distance (ft):	1.8
Structural Grade:	0
O&M Grade:	0
Clock Start/From:	
Clock To:	
1st Value:	
2nd Value:	
Value Percent:	
Step:	NO
Remarks:	UNDERSIDE OF FRAME
