# Manhole Inspection Report

Date:	<b>05/14/2018</b>	Weather:		Coding:	<b>RZMACP</b>
MH#:	<b>M-504-061</b>	Owner:	<b>NA</b>	Len. Surveyed:	<b>6.1</b>
P.O.#:		Surveyor:	<b>Jen Costello</b>	Rim to Invert:	<b>6.2</b>
Customer:		Cert. #:	<b>U-907-5518</b>	Wall Material:	<b>Brick</b>

Street:	<b>Ridge Rd. 31' West of California St.</b>	Project:	<b>Hobart, IN</b>
City:	<b>Hobart, IN</b>	GPS Northing:	<b>41.54027176</b>
Location:		GPS Easting:	<b>-87.27709961</b>
Drain Area:	<b>Northwest</b>	GPS Accuracy:	<b>Nearest Meter</b>
Cover Shape:	<b>Circular</b>	Evidence of Surcharge:	<b>No</b>
Cover Size:	<b>22.5</b>	Potential for Runoff:	<b>None</b>
Comments:

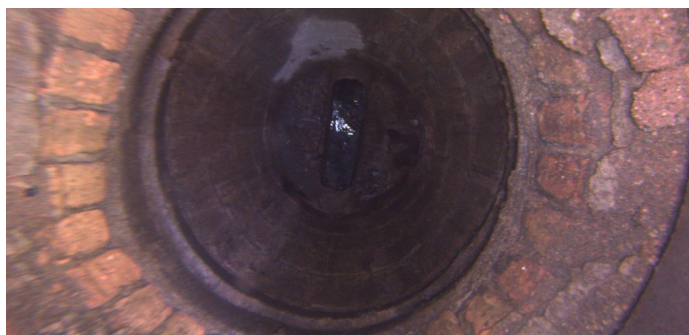
Code: **MGO**  
Description: **General Observation**

Distance (ft): **.0**  
Structural Grade: **0**  
O&M Grade: **0**  
Clock Start/From:  
Clock To:  
1st Value:  
2nd Value:  
Value Percent:  
Step: **NO**  
Remarks: **ACCESS MH**

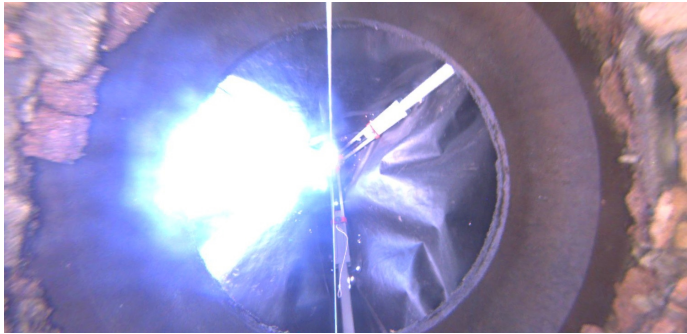
Code:	<b>MGO</b>
Description:	<b>General Observation</b>
Distance (ft):	<b>1.7</b>
Structural Grade:	<b>0</b>
O&M Grade:	<b>0</b>
Clock Start/From:	
Clock To:	
1st Value:	
2nd Value:	
Value Percent:	
Step:	<b>NO</b>
Remarks:	<b>UNDERSIDE OF FRAME</b>

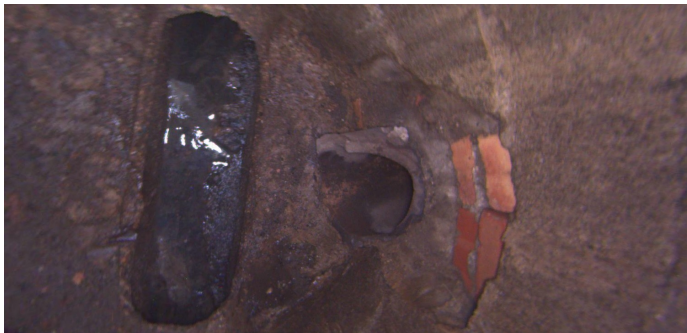
Code:	<b>RPP</b>
Description:	<b>Repair Patch</b>
Distance (ft):	<b>3.9</b>
Structural Grade:	<b>0</b>
O&M Grade:	<b>0</b>
Clock Start/From:	<b>3</b>
Clock To:	<b>4</b>
1st Value:	
2nd Value:	
Value Percent:	
Step:	<b>NO</b>
Remarks:	<b>BRICK</b>

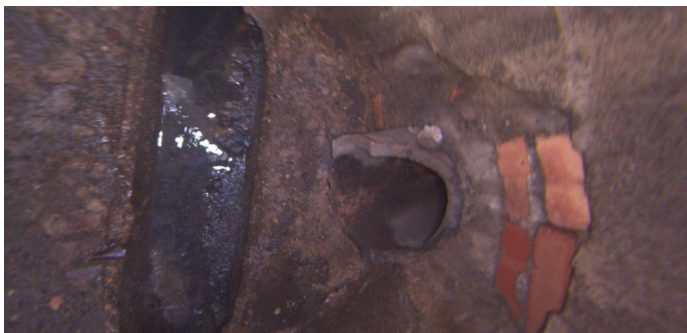
Code:	<b>FS</b>
Description:	<b>Fracture Spiral</b>
Distance (ft):	<b>4.2</b>
Structural Grade:	<b>3</b>
O&M Grade:	<b>0</b>
Clock Start/From:	<b>2</b>
Clock To:	<b>3</b>
1st Value:	
2nd Value:	
Value Percent:	
Step:	<b>NO</b>
Remarks:

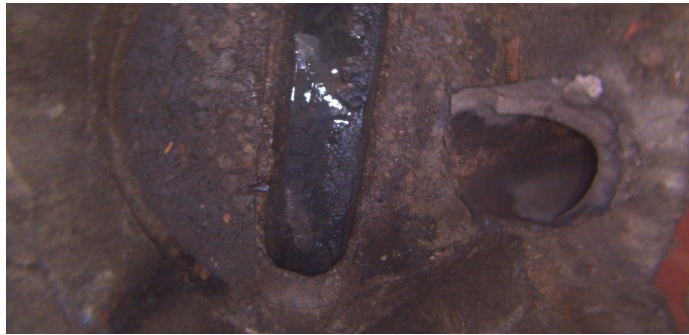
Code: **IW**  
Description: **Infil Weeper**

Distance (ft): **4.2**  
Structural Grade: **0**  
O&M Grade: **2**  
Clock Start/From: **7**  
Clock To:  
1st Value:  
2nd Value:  
Value Percent:  
Step: **NO**  
Remarks:

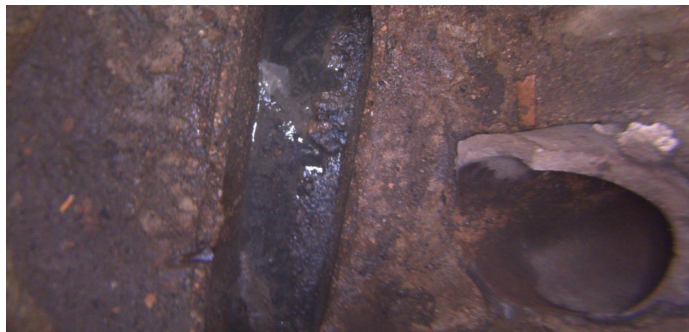
Code: **DSF**  
Description: **Deposits Settled Fine**

Distance (ft): **4.9**  
Structural Grade: **0**  
O&M Grade: **2**  
Clock Start/From: **12**  
Clock To: **12**  
1st Value:  
2nd Value:  
Value Percent: **5.000**  
Step: **NO**  
Remarks:

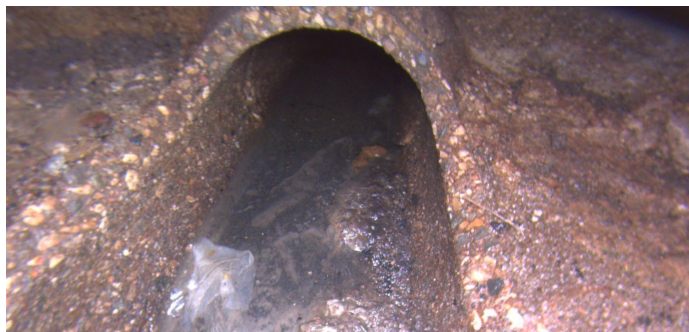
Code: **SAP**  
Description: **Surface Aggregate Projecting**

Distance (ft): **6.1**  
Structural Grade: **3**  
O&M Grade: **0**  
Clock Start/From: **2**  
Clock To: **10**  
1st Value:  
2nd Value:  
Value Percent:  
Step: **NO**  
Remarks:

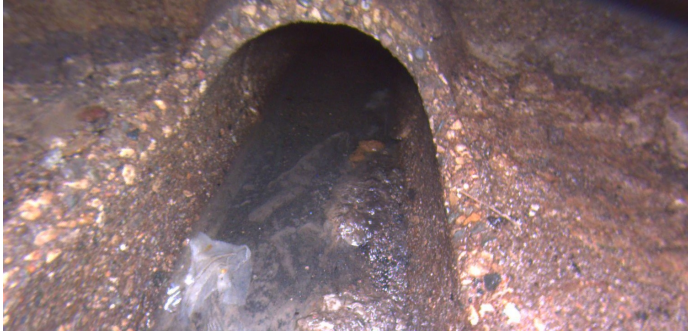
Code:	<b>MGO</b>
Description:	<b>General Observation</b>
Distance (ft):	<b>6.1</b>
Structural Grade:	<b>0</b>
O&M Grade:	<b>0</b>
Clock Start/From:	
Clock To:	
1st Value:	
2nd Value:	
Value Percent:	
Step:	<b>NO</b>
Remarks:	<b>END SURVEY</b>
