Manhole Inspection Report

Date:	05/15/2018	Weather:		Coding:	RZMACP
MH#:	M-504-074	Owner:	NA	Len. Surveyed:	13.6
P.O.#:		Surveyor:	Jen Costello	Rim to Invert:	14.2
Customer:		Cert. #:	U-907-5518	Wall Material:	Brick

Street:	218' East of Colorado St. 167' North	Project:	Hobart, IN
City:	Hobart, IN	GPS Northing:	41.54066086
Location:		GPS Easting:	-87.27391815
Drain Area:	Northwest	GPS Accuracy:	Nearest Meter
Cover Shape:	Circular	Evidence of Surcharge:	No
Cover Size:	22.5	Potential for Runoff:	None
Comments:

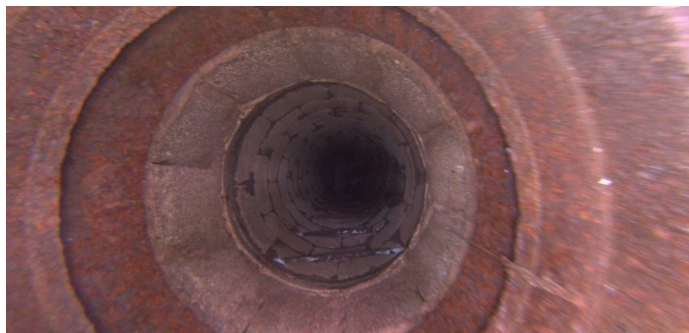
Code: **MGO**
Description: **General Observation**

Distance (ft): **.0**
Structural Grade: **0**
O&M Grade: **0**
Clock Start/From:
Clock To:
1st Value:
2nd Value:
Value Percent:
Step: **NO**
Remarks: **ACCESS MH**

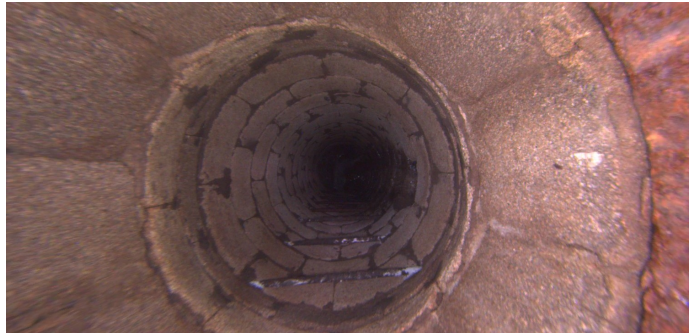
Code: **SAV**
Description: **Surface Aggregate Visible**

Distance (ft): **.9**
Structural Grade: **3**
O&M Grade: **0**
Clock Start/From: **12**
Clock To: **12**
1st Value:
2nd Value:
Value Percent:
Step: **NO**
Remarks:

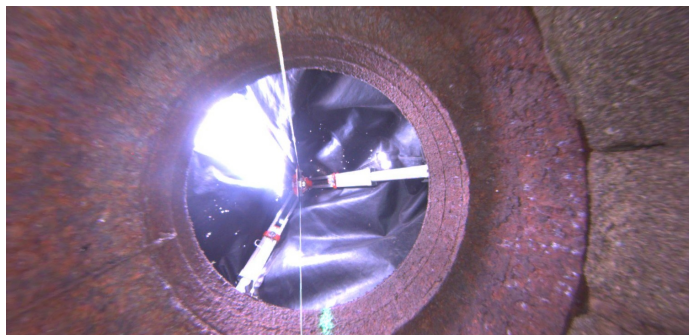
Code: **MGO**
Description: **General Observation**

Distance (ft): **2.0**
Structural Grade: **0**
O&M Grade: **0**
Clock Start/From:
Clock To:
1st Value:
2nd Value:
Value Percent:
Step: **NO**
Remarks: **UNDERSIDE OF FRAME**

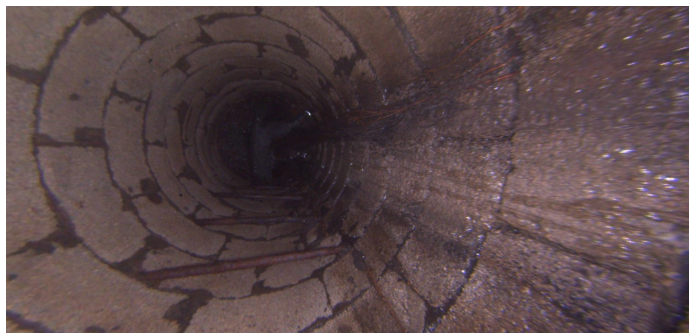
Code: **RFJ**
Description: **Roots Fine Joint**

Distance (ft): **6.7**
Structural Grade: **0**
O&M Grade: **1**
Clock Start/From: **2**
Clock To: **5**
1st Value:
2nd Value:
Value Percent:
Step: **NO**
Remarks:

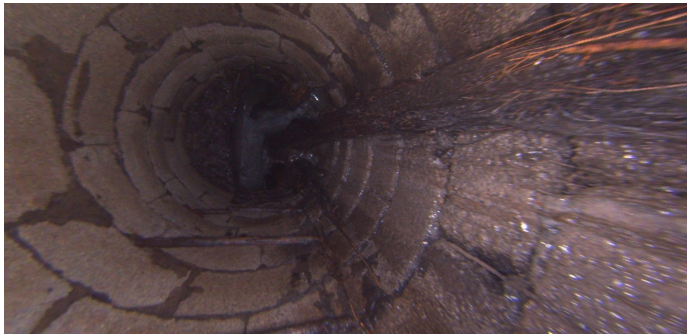
Code: **RFJ**
Description: **Roots Fine Joint**

Distance (ft): **8.9**
Structural Grade: **0**
O&M Grade: **1**
Clock Start/From: **5**
Clock To:
1st Value:
2nd Value:
Value Percent:
Step: **NO**
Remarks:

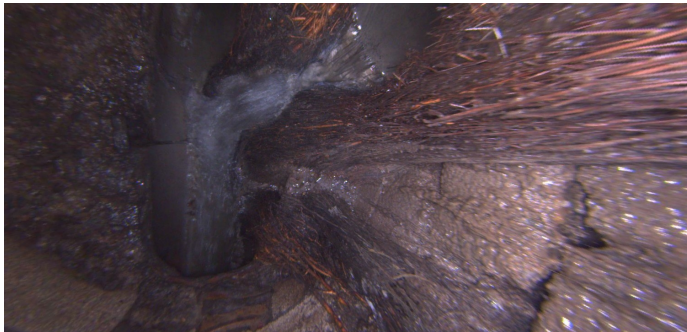
Code: **RMJ**
Description: **Roots Medium Joint**

Distance (ft): **12.7**
Structural Grade: **0**
O&M Grade: **3**
Clock Start/From: **2**
Clock To: **4**
1st Value:
2nd Value:
Value Percent: **10.000**
Step: **NO**
Remarks:

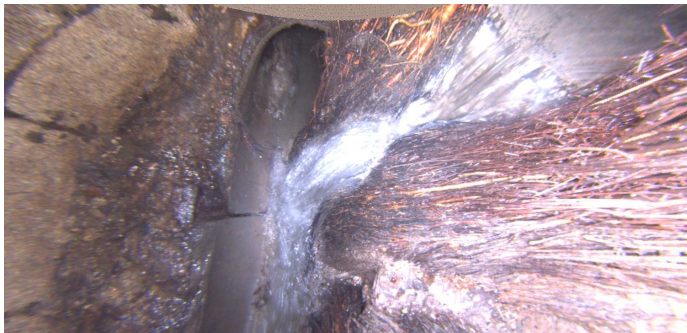
Code: **MGO**
Description: **General Observation**

Distance (ft): **13.6**
Structural Grade: **0**
O&M Grade: **0**
Clock Start/From:
Clock To:
1st Value:
2nd Value:
Value Percent:
Step: **NO**
Remarks: **ACCESS MH**

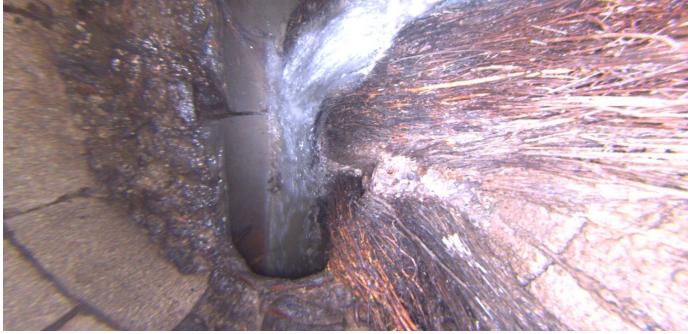
Code:	SAV
Description:	Surface Aggregate Visible
Distance (ft):	13.6
Structural Grade:	3
O&M Grade:	0
Clock Start/From:	12
Clock To:	12
1st Value:	
2nd Value:	
Value Percent:	
Step:	NO
Remarks:
