# Manhole Inspection Report

Date:	05/15/2018	Weather:		Coding:	RZMACP
MH#:	M-504-075	Owner:	NA	Len. Surveyed:	14.0
P.O.#:		Surveyor:	Jen Costello	Rim to Invert:	14.5
Customer:		Cert. #:	U-907-5518	Wall Material:	Concrete (reinforced)

Street:	Colorado St. 164' North of Ridge Rd.	Project:	Hobart, IN
City:	Hobart, IN	GPS Northing:	41.54077148
Location:		GPS Easting:	-87.27469635
Drain Area:	Northwest	GPS Accuracy:	Nearest Meter
Cover Shape:	Circular	Evidence of Surcharge:	No
Cover Size:	22.5	Potential for Runoff:	None
Comments:

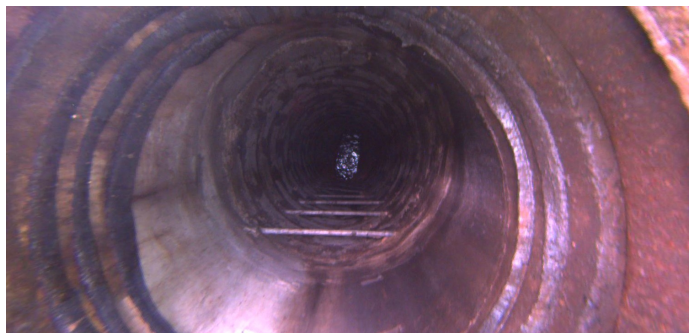
Code: **MGO**  
Description: **General Observation**

Distance (ft): **.0**  
Structural Grade: **0**  
O&M Grade: **0**  
Clock Start/From:  
Clock To:  
1st Value:  
2nd Value:  
Value Percent:  
Step: **NO**  
Remarks: **ACCESS MH**

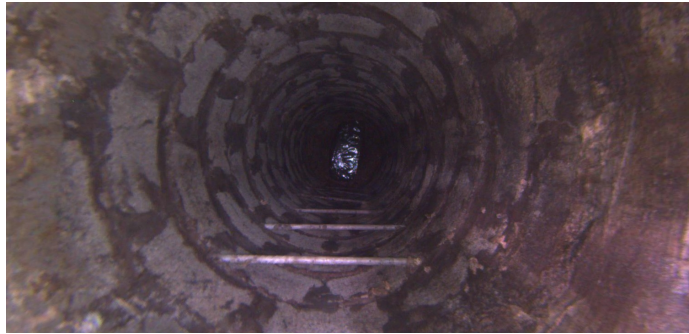
Code: **SRI**  
Description: **Surface Roughness Increased**

Distance (ft): **2.7**  
Structural Grade: **1**  
O&M Grade: **0**  
Clock Start/From: **12**  
Clock To: **12**  
1st Value:  
2nd Value:  
Value Percent:  
Step: **NO**  
Remarks:

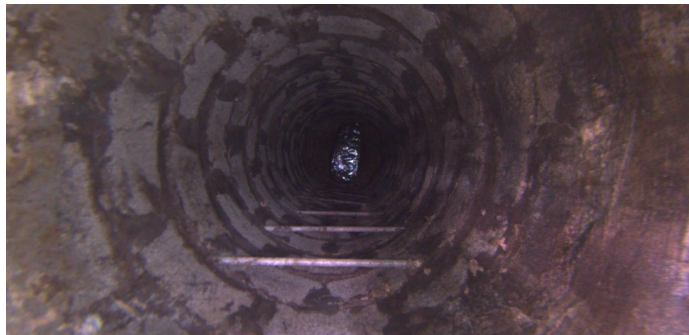
Code: **MMC**  
Description: **Material Change**

Distance (ft): **2.7**  
Structural Grade: **0**  
O&M Grade: **0**  
Clock Start/From:  
Clock To:  
1st Value:  
2nd Value:  
Value Percent:  
Step: **NO**  
Remarks: **CEMENT BLOCK**

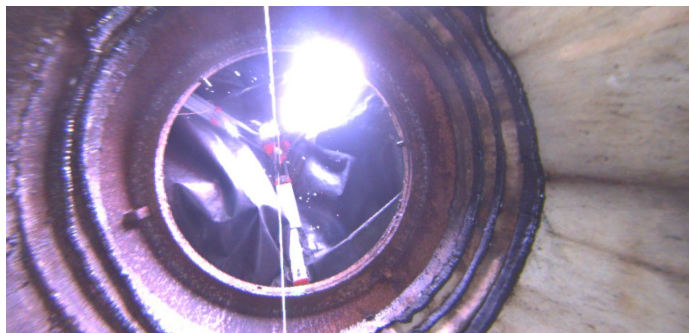
Code: **MGO**  
Description: **General Observation**

Distance (ft): **2.7**  
Structural Grade: **0**  
O&M Grade: **0**  
Clock Start/From:  
Clock To:  
1st Value:  
2nd Value:  
Value Percent:  
Step: **NO**  
Remarks: **UNDERSIDE OF FRAME**

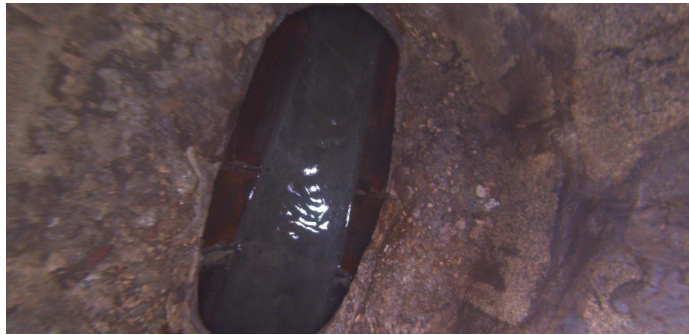
Code: **DSF**  
Description: **Deposits Settled Fine**

Distance (ft): **12.4**  
Structural Grade: **0**  
O&M Grade: **2**  
Clock Start/From: **12**  
Clock To: **12**  
1st Value:  
2nd Value:  
Value Percent: **5.000**  
Step: **NO**  
Remarks:

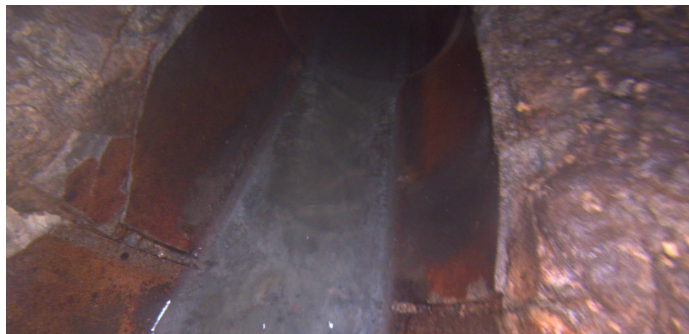
Code: **FS**  
Description: **Fracture Spiral**

Distance (ft): **14.0**  
Structural Grade: **3**  
O&M Grade: **0**  
Clock Start/From: **9**  
Clock To: **10**  
1st Value:  
2nd Value:  
Value Percent:  
Step: **NO**  
Remarks:

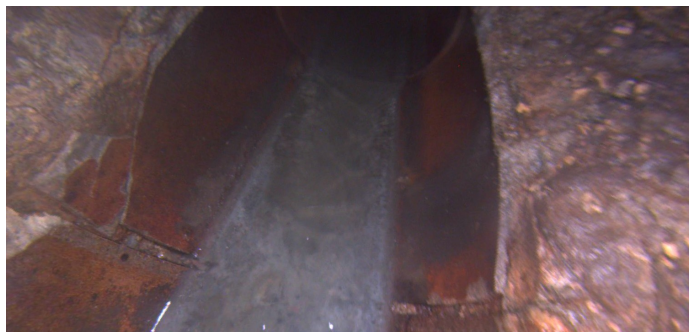
Code: **SRI**  
Description: **Surface Roughness Increased**

Distance (ft): **14.0**  
Structural Grade: **1**  
O&M Grade: **0**  
Clock Start/From: **12**  
Clock To: **12**  
1st Value:  
2nd Value:  
Value Percent:  
Step: **NO**  
Remarks:

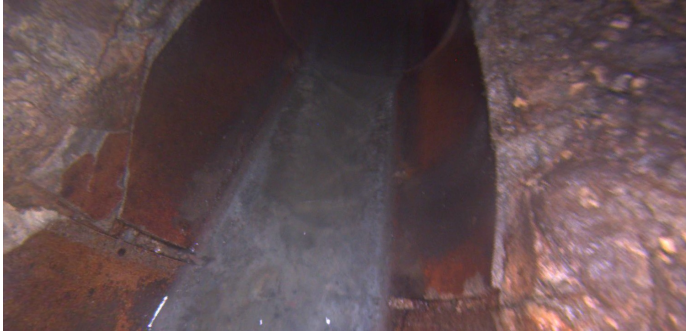
Code:	<b>MGO</b>
Description:	<b>General Observation</b>
Distance (ft):	<b>14.0</b>
Structural Grade:	<b>0</b>
O&M Grade:	<b>0</b>
Clock Start/From:	
Clock To:	
1st Value:	
2nd Value:	
Value Percent:	
Step:	<b>NO</b>
Remarks:	<b>END SURVEY</b>
