Manhole Inspection Report

| MH#: | M-504-077 | Owner: | NA | Len. Surveyed: | 11.8 |

| Street: | Cavender St. 168' North of Ridge Rd. | Project: | Hobart, IN |

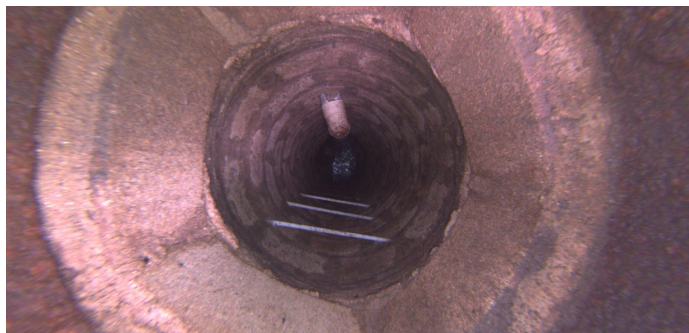
Code: **MGO**
Description: **General Observation**

Distance (ft): **.0**
Structural Grade: **0**
O&M Grade: **0**
Clock Start/From:
Clock To:
1st Value:
2nd Value:
Value Percent:
Step: **NO**
Remarks: **ACCESS MH**

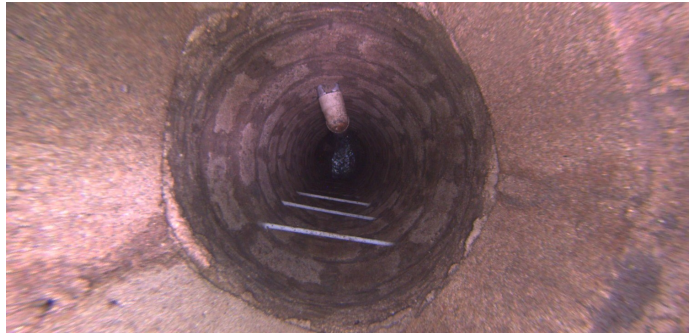
Code: **SAV**
Description: **Surface Aggregate Visible**

Distance (ft): **.3**
Structural Grade: **3**
O&M Grade: **0**
Clock Start/From: **12**
Clock To: **12**
1st Value:
2nd Value:
Value Percent:
Step: **NO**
Remarks:

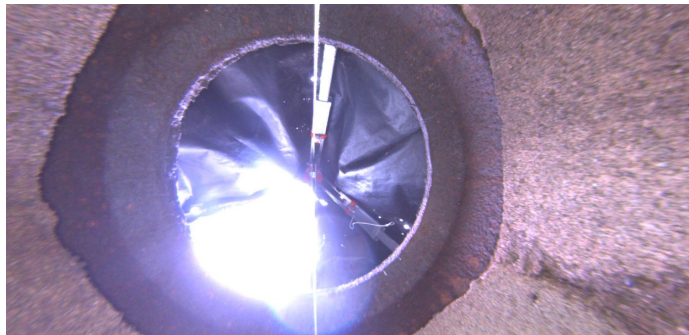
Code: **MGO**
Description: **General Observation**

Distance (ft): **1.9**
Structural Grade: **0**
O&M Grade: **0**
Clock Start/From:
Clock To:
1st Value:
2nd Value:
Value Percent:
Step: **NO**
Remarks: **UNDERSIDE OF FRAME**

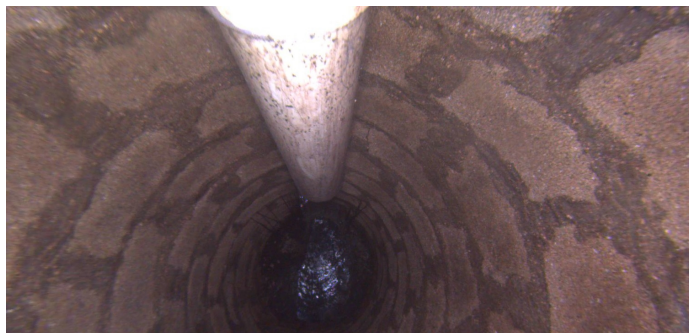
Code: **OBP**
Description: **Obstacle External Pipe or Cable**

Distance (ft): **5.4**
Structural Grade: **0**
O&M Grade: **2**
Clock Start/From: **12**
Clock To:
1st Value:
2nd Value:
Value Percent: **10.000**
Step: **NO**
Remarks:

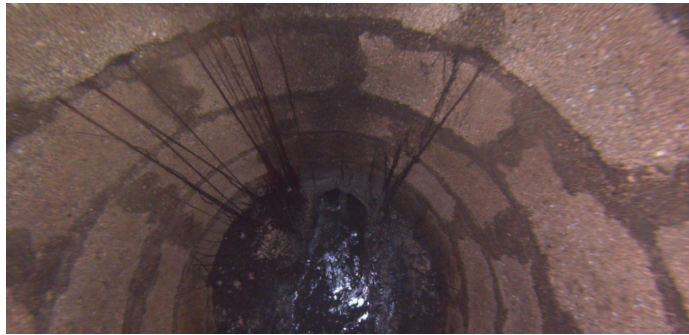
Code: **RFB**
Description: **Roots Fine Barrel**

Distance (ft): **9.6**
Structural Grade: **0**
O&M Grade: **2**
Clock Start/From: **10**
Clock To: **2**
1st Value:
2nd Value:
Value Percent:
Step: **NO**
Remarks:

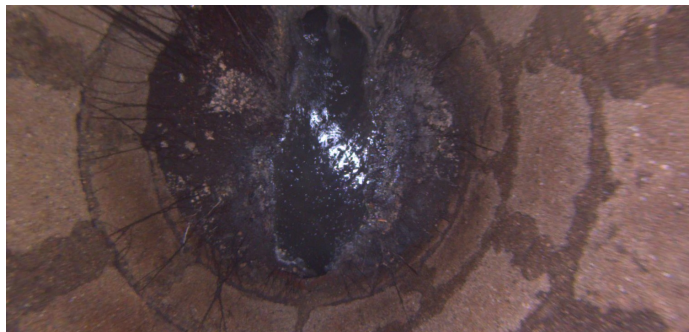
Code: **RFJ**
Description: **Roots Fine Joint**

Distance (ft): **10.8**
Structural Grade: **0**
O&M Grade: **1**
Clock Start/From: **12**
Clock To: **12**
1st Value:
2nd Value:
Value Percent:
Step: **NO**
Remarks:

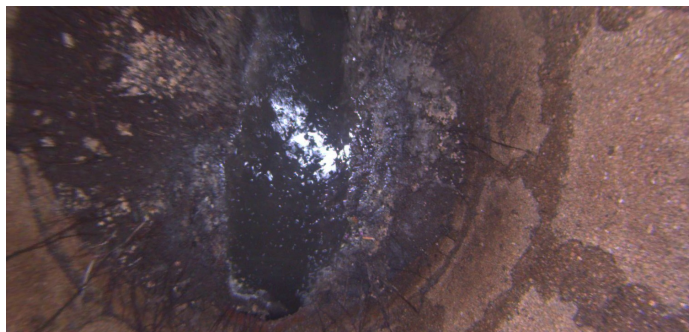
Code: **SAV**
Description: **Surface Aggregate Visible**

Distance (ft): **11.5**
Structural Grade: **3**
O&M Grade: **0**
Clock Start/From: **12**
Clock To: **12**
1st Value:
2nd Value:
Value Percent:
Step: **NO**
Remarks:

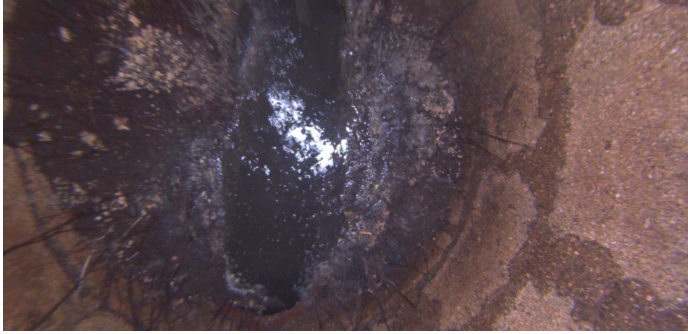
| Code: | MGO |
| Description: | General Observation |
| Distance (ft): | 11.5 |
| Remarks: | END SURVEY |
