# Manhole Inspection Report

Date:	<b>05/15/2018</b>	Weather:		Coding:	<b>RZMACP</b>
MH#:	<b>M-504-087</b>	Owner:	<b>NA</b>	Len. Surveyed:	<b>11.9</b>
P.O.#:		Surveyor:	<b>Jen Costello</b>	Rim to Invert:	<b>12.7</b>
Customer:		Cert. #:	<b>U-907-5518</b>	Wall Material:	<b>Concrete (reinforced)</b>

Street:	<b>162' West of California St. 188' Sout</b>	Project:	<b>Hobart, IN</b>
City:	<b>Hobart, IN</b>	GPS Northing:	<b>41.54074097</b>
Location:		GPS Easting:	<b>-87.27124023</b>
Drain Area:	<b>Northwest</b>	GPS Accuracy:	<b>Nearest Meter</b>
Cover Shape:	<b>Circular</b>	Evidence of Surcharge:	<b>No</b>
Cover Size:	<b>24.0</b>	Potential for Runoff:	<b>None</b>
Comments:

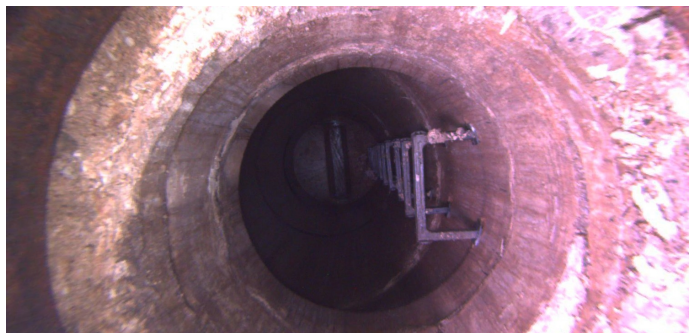
Code: **MGO**  
Description: **General Observation**

Distance (ft): **.0**  
Structural Grade: **0**  
O&M Grade: **0**  
Clock Start/From:  
Clock To:  
1st Value:  
2nd Value:  
Value Percent:  
Step: **NO**  
Remarks: **access mh**

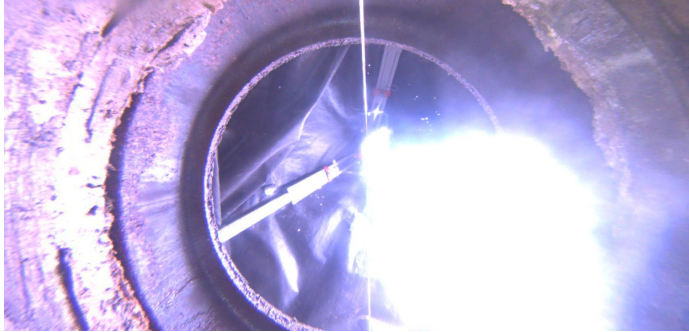
Code:	<b>MGO</b>
Description:	<b>General Observation</b>
Distance (ft):	<b>2.0</b>
Structural Grade:	<b>0</b>
O&M Grade:	<b>0</b>
Clock Start/From:	
Clock To:	
1st Value:	
2nd Value:	
Value Percent:	
Step:	<b>NO</b>
Remarks:	<b>underside of frame</b>

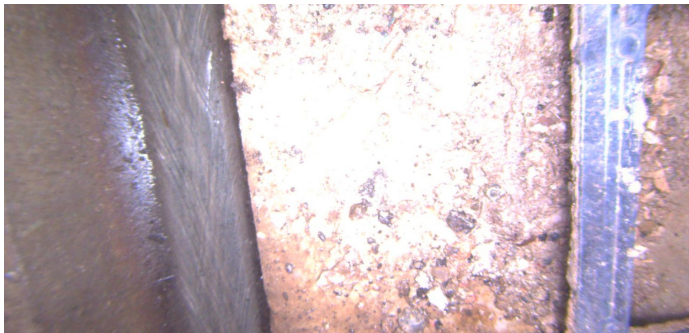
Code:	<b>DSGV</b>
Description:	<b>Deposits Settled Gravel</b>
Distance (ft):	<b>11.9</b>
Structural Grade:	<b>0</b>
O&M Grade:	<b>2</b>
Clock Start/From:	<b>12</b>
Clock To:	<b>6</b>
1st Value:	
2nd Value:	
Value Percent:	<b>5.000</b>
Step:	<b>NO</b>
Remarks:
