# Manhole Inspection Report

Date:	05/15/2018	Weather:		Coding:	RZMACP
MH#:	M-504-088	Owner:	NA	Len. Surveyed:	10.7
P.O.#:		Surveyor:	Jen Costello	Rim to Invert:	10.8
Customer:		Cert. #:	U-907-5518	Wall Material:	Concrete (reinforced)

Street:	162' East of Virginia St. 177' North o	Project:	Hobart, IN
City:	Hobart, IN	GPS Northing:	41.54225159
Location:		GPS Easting:	-87.27129364
Drain Area:	Northwest	GPS Accuracy:	Nearest Meter
Cover Shape:	Circular	Evidence of Surcharge:	No
Cover Size:	22.5	Potential for Runoff:	None
Comments:

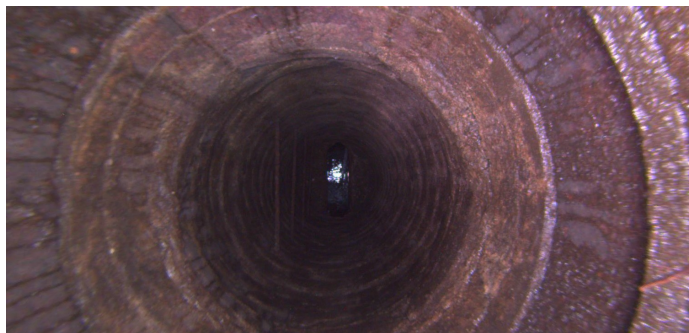
Code: **MGO**  
Description: **General Observation**

Distance (ft): **.0**  
Structural Grade: **0**  
O&M Grade: **0**  
Clock Start/From:  
Clock To:  
1st Value:  
2nd Value:  
Value Percent:  
Step: **NO**  
Remarks: **access MH**

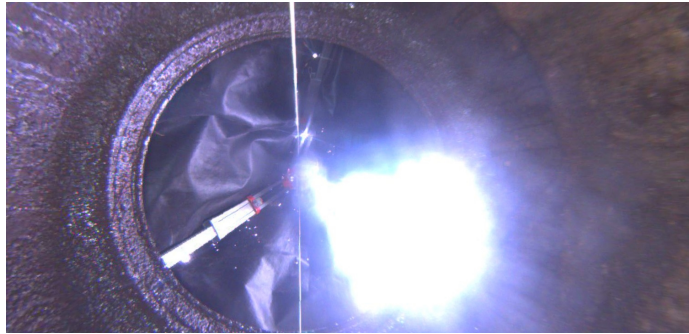
Code: **MGO**  
Description: **General Observation**

Distance (ft): **2.4**  
Structural Grade: **0**  
O&M Grade: **0**  
Clock Start/From:  
Clock To:  
1st Value:  
2nd Value:  
Value Percent:  
Step: **NO**  
Remarks: **UNDERSIDE OF FRAME**

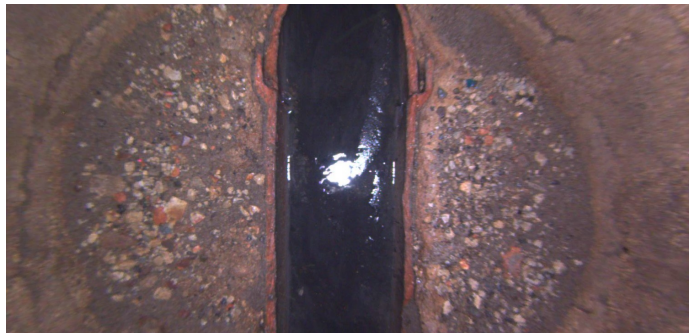
Code: **DSGV**  
Description: **Deposits Settled Gravel**

Distance (ft): **9.5**  
Structural Grade: **0**  
O&M Grade: **2**  
Clock Start/From: **12**  
Clock To: **12**  
1st Value:  
2nd Value:  
Value Percent: **5.000**  
Step: **NO**  
Remarks:

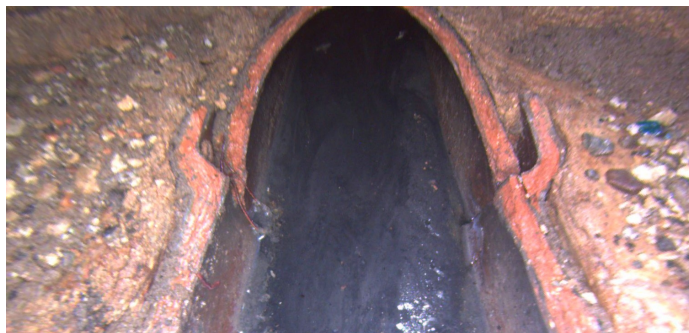
Code: **MGO**  
Description: **General Observation**

Distance (ft): **10.7**  
Structural Grade: **0**  
O&M Grade: **0**  
Clock Start/From:  
Clock To:  
1st Value:  
2nd Value:  
Value Percent:  
Step: **NO**  
Remarks: **END SURVEY**
