Manhole Inspection Report

Date:	05/15/2018	Weather:		Coding:	RZMACP
MH#:	M-504-102	Owner:	NA	Len. Surveyed:	5.6
P.O.#:		Surveyor:	Jen Costello	Rim to Invert:	5.8
Customer:		Cert. #:	U-907-5518	Wall Material:	Brick

Street:	127' East of Delaware St. 140' South	Project:	Hobart, IN
City:	Hobart, IN	GPS Northing:	41.54145813
Location:		GPS Easting:	-87.27309418
Drain Area:	Northwest	GPS Accuracy:	Nearest Meter
Cover Shape:	Circular	Evidence of Surcharge:	No
Cover Size:	22.5	Potential for Runoff:	None
Comments:

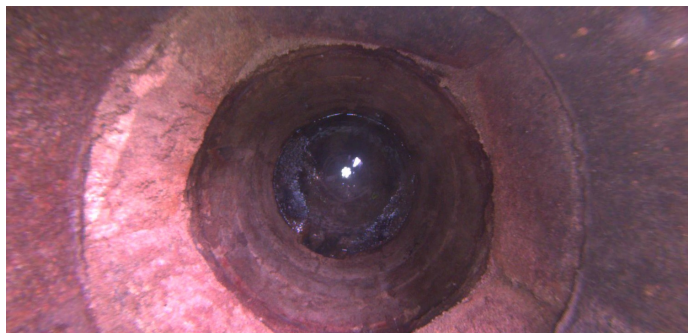
Code: **MGO**
Description: **General Observation**

Distance (ft): **.0**
Structural Grade: **0**
O&M Grade: **0**
Clock Start/From:
Clock To:
1st Value:
2nd Value:
Value Percent:
Step: **NO**
Remarks: **ACCESS MH**

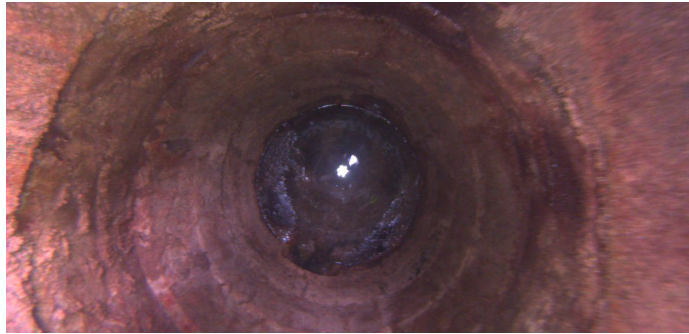
Code: **IS**
Description: **Infil Stain**

Distance (ft): **.9**
Structural Grade: **0**
O&M Grade: **0**
Clock Start/From: **12**
Clock To: **3**
1st Value:
2nd Value:
Value Percent:
Step: **NO**
Remarks:

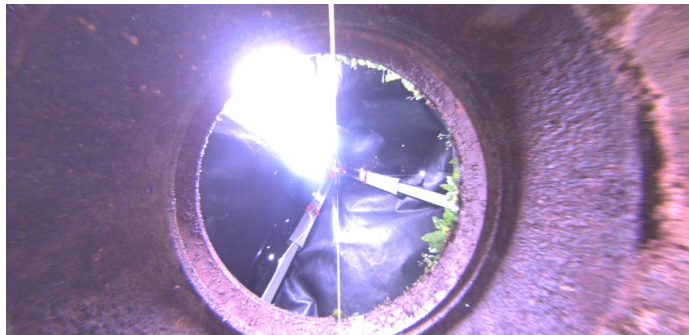
Code: **MGO**
Description: **General Observation**

Distance (ft): **1.8**
Structural Grade: **0**
O&M Grade: **0**
Clock Start/From:
Clock To:
1st Value:
2nd Value:
Value Percent:
Step: **NO**
Remarks: **UNDERSIDE OF FRAME**

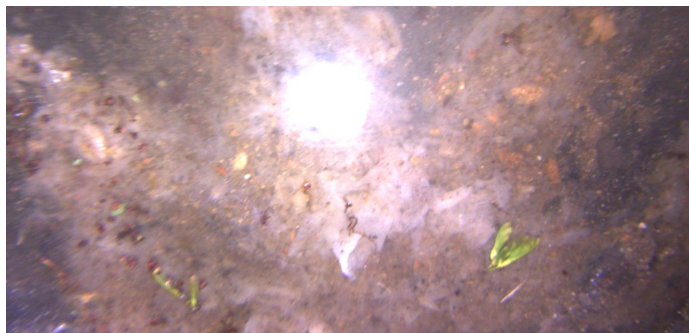
Code: **MGO**
Description: **General Observation**

Distance (ft): **5.6**
Structural Grade: **0**
O&M Grade: **0**
Clock Start/From:
Clock To:
1st Value:
2nd Value:
Value Percent:
Step: **NO**
Remarks: **END SURVEY**
