Manhole Inspection Report

Date:	05/15/2018	Weather:		Coding:	RZMACP
MH#:	M-504-103	Owner:	NA	Len. Surveyed:	11.6
P.O.#:		Surveyor:	Jen Costello	Rim to Invert:	12.2
Customer:		Cert. #:	U-907-5518	Wall Material:	Concrete (reinforced)

Street:	Delaware St. and Colorado St. South	Project:	Hobart, IN
City:	Hobart, IN	GPS Northing:	41.54092789
Location:		GPS Easting:	-87.27407837
Drain Area:	Northwest	GPS Accuracy:	Nearest Meter
Cover Shape:	Circular	Evidence of Surcharge:	No
Cover Size:	22.5	Potential for Runoff:	None
Comments:

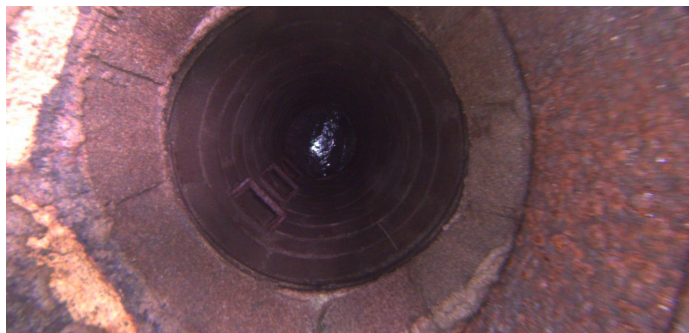
Code: **MGO**
Description: **General Observation**

Distance (ft): **.0**
Structural Grade: **0**
O&M Grade: **0**
Clock Start/From:
Clock To:
1st Value:
2nd Value:
Value Percent:
Step: **NO**
Remarks: **ACCESS MH**

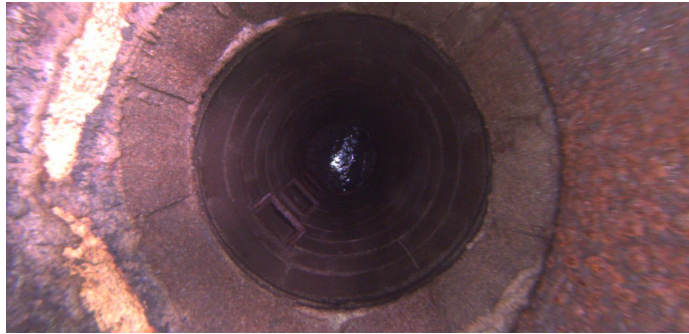
Code:	DAE
Description:	Deposits Attached Encrustation
Distance (ft):	.0
Structural Grade:	0
O&M Grade:	2
Clock Start/From:	7
Clock To:	11
1st Value:	
2nd Value:	
Value Percent:	5.000
Step:	NO
Remarks:

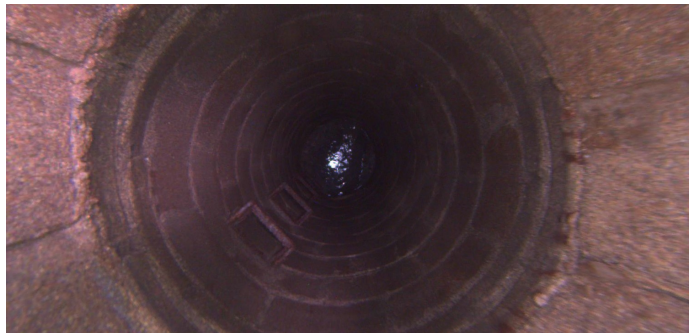
Code:	IW
Description:	Infil Weeper
Distance (ft):	.9
Structural Grade:	0
O&M Grade:	2
Clock Start/From:	2
Clock To:	5
1st Value:	
2nd Value:	
Value Percent:	
Step:	NO
Remarks:

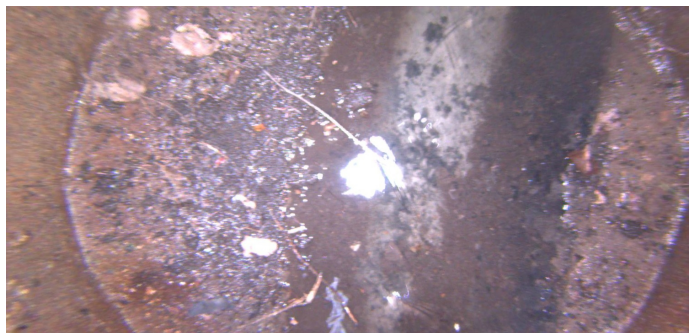
Code:	DSF
Description:	Deposits Settled Fine
Distance (ft):	11.6
Structural Grade:	0
O&M Grade:	2
Clock Start/From:	12
Clock To:	12
1st Value:	
2nd Value:	
Value Percent:	5.000
Step:	NO
Remarks:

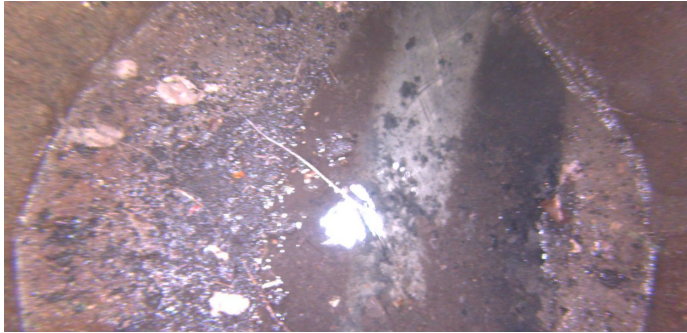
Code: **MGO**
Description: **General Observation**

Distance (ft): **11.6**

Remarks: **END SURVEY**
