# Manhole Inspection Report

Date:	<b>05/15/2018</b>	Weather:		Coding:	<b>RZMACP</b>
MH#:	<b>M-504-104</b>	Owner:	<b>NA</b>	Len. Surveyed:	<b>10.6</b>
P.O.#:		Surveyor:	<b>Jen Costello</b>	Rim to Invert:	<b>11.2</b>
Customer:		Cert. #:	<b>U-907-5518</b>	Wall Material:	<b>Brick</b>

Street:	<b>159' East of Colorado St. 133' South</b>	Project:	<b>Hobart, IN</b>
City:	<b>Hobart, IN</b>	GPS Northing:	<b>41.54148865</b>
Location:		GPS Easting:	<b>-87.27415466</b>
Drain Area:	<b>Northwest</b>	GPS Accuracy:	<b>Nearest Meter</b>
Cover Shape:	<b>Circular</b>	Evidence of Surcharge:	<b>No</b>
Cover Size:	<b>22.5</b>	Potential for Runoff:	<b>None</b>
Comments:

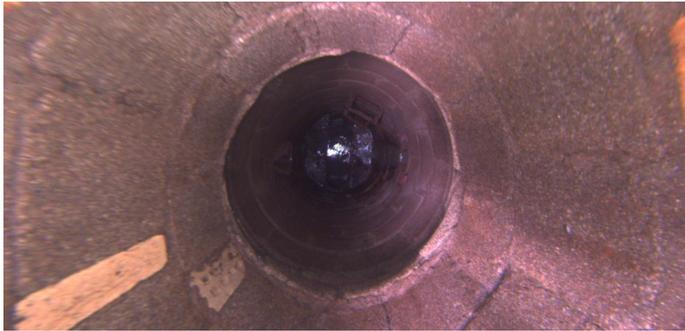
Code: **SAV**  
Description: **Surface Aggregate Visible**

Distance (ft): **.9**  
Structural Grade: **3**  
O&M Grade: **0**  
Clock Start/From: **12**  
Clock To: **12**  
1st Value:  
2nd Value:  
Value Percent:  
Step: **NO**  
Remarks:

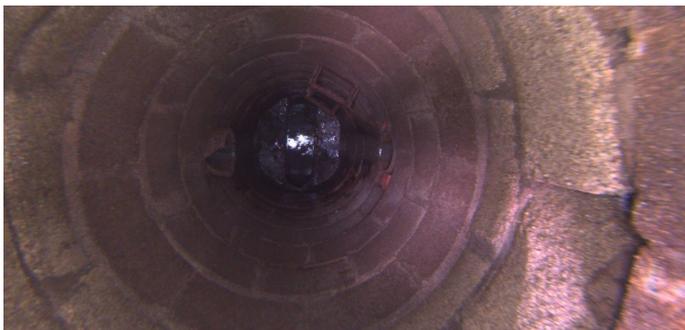
Code: **HSV**  
Description: **Hole Soil Visible**

Distance (ft): **2.4**  
Structural Grade: **5**  
O&M Grade: **0**  
Clock Start/From: **3**  
Clock To: **4**  
1st Value:  
2nd Value:  
Value Percent:  
Step: **NO**  
Remarks:

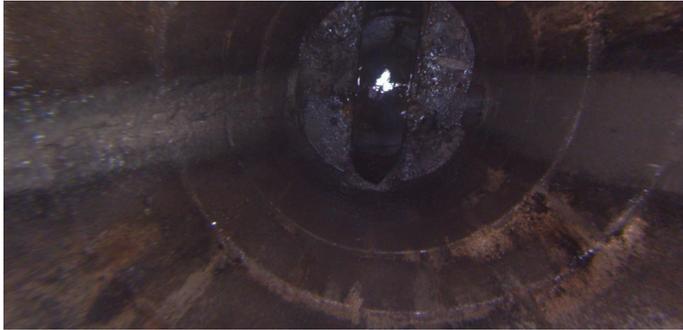
Code: **IW**  
Description: **Infil Weeper**

Distance (ft): **7.0**  
Structural Grade: **0**  
O&M Grade: **2**  
Clock Start/From: **8**  
Clock To:  
1st Value:  
2nd Value:  
Value Percent:  
Step: **NO**  
Remarks:

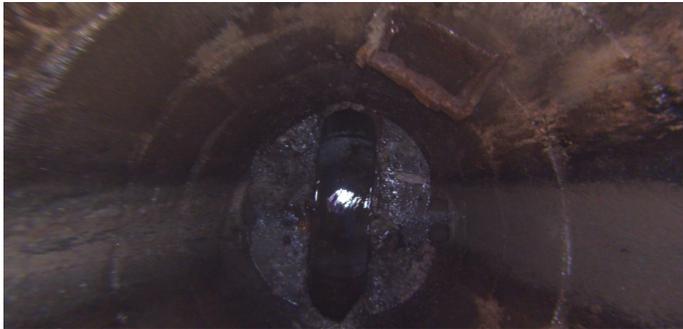
Code: **IW**  
Description: **Infil Weeper**

Distance (ft): **7.7**  
Structural Grade: **0**  
O&M Grade: **2**  
Clock Start/From: **12**  
Clock To: **12**  
1st Value:  
2nd Value:  
Value Percent:  
Step: **NO**  
Remarks:

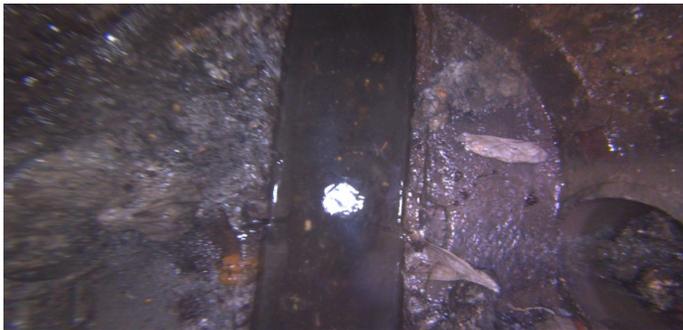
Code: **DSF**  
Description: **Deposits Settled Fine**

Distance (ft): **10.1**  
Structural Grade: **0**  
O&M Grade: **2**  
Clock Start/From: **12**  
Clock To: **12**  
1st Value:  
2nd Value:  
Value Percent: **5.000**  
Step: **NO**  
Remarks:

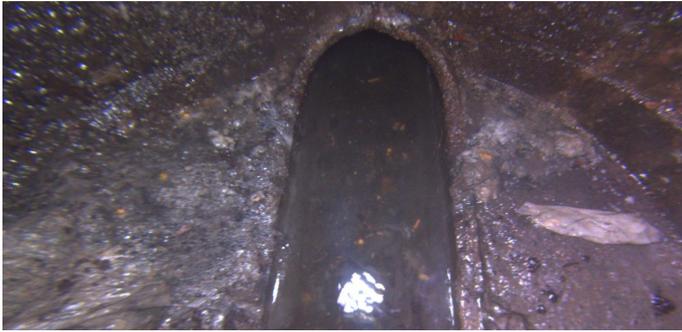
Code: **SAV**  
Description: **Surface Aggregate Visible**

Distance (ft): **10.6**  
Structural Grade: **3**  
O&M Grade: **0**  
Clock Start/From: **12**  
Clock To: **12**  
1st Value:  
2nd Value:  
Value Percent:  
Step: **NO**  
Remarks:
