Manhole Inspection Report

Date:	05/15/2018	Weather:		Coding:	RZMACP
MH#:	M-504-106	Owner:	NA	Len. Surveyed:	7.4
P.O.#:		Surveyor:	Jen Costello	Rim to Invert:	8.2
Customer:		Cert. #:	U-907-5518	Wall Material:	Brick

Street:	162' West of Virginia St. 215' South	Project:	Hobart, IN
City:	Hobart, IN	GPS Northing:	41.46604156
Location:		GPS Easting:	-87.32584381
Drain Area:	Northwest	GPS Accuracy:	Nearest Meter
Cover Shape:	Circular	Evidence of Surcharge:	No
Cover Size:	22.5	Potential for Runoff:	None
Comments:

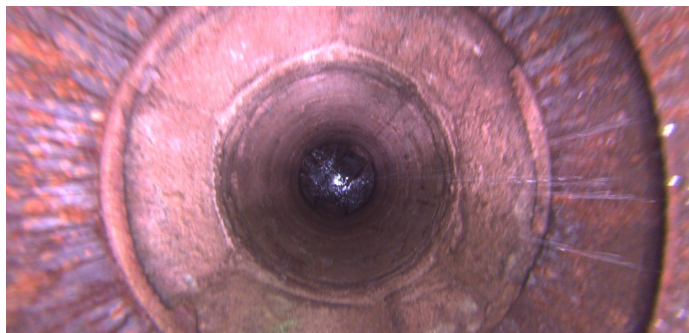
Code: **MGO**
Description: **General Observation**

Distance (ft): **.0**
Structural Grade: **0**
O&M Grade: **0**
Clock Start/From:
Clock To:
1st Value:
2nd Value:
Value Percent:
Step: **NO**
Remarks: **ACCESS MH**

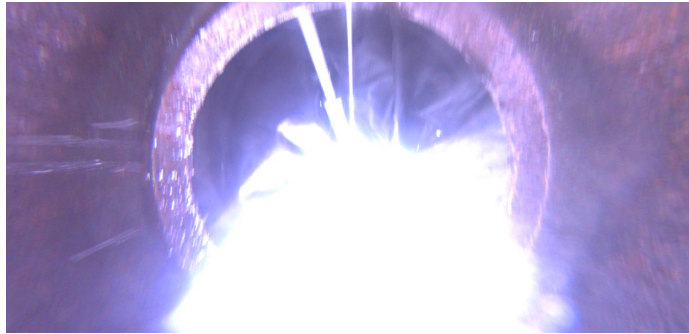
Code:	MGO
Description:	General Observation
Distance (ft):	1.3
Structural Grade:	0
O&M Grade:	0
Clock Start/From:	
Clock To:	
1st Value:	
2nd Value:	
Value Percent:	
Step:	YES
Remarks:	UNDERSIDE OF FRAME

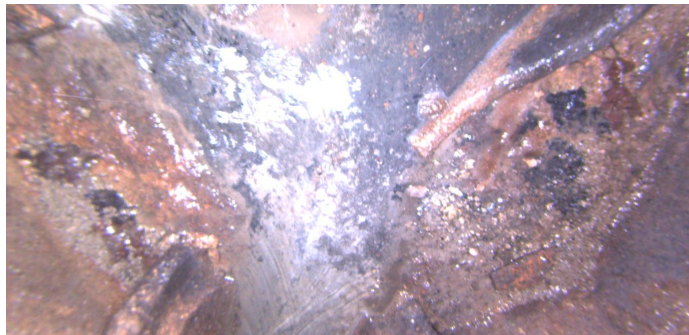
Code:	DSF
Description:	Deposits Settled Fine
Distance (ft):	7.4
Structural Grade:	0
O&M Grade:	2
Clock Start/From:	12
Clock To:	12
1st Value:	
2nd Value:	
Value Percent:	5.000
Step:	NO
Remarks:

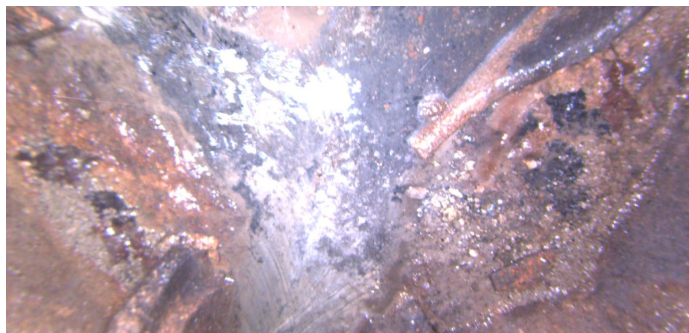
Code:	MGO
Description:	General Observation
Distance (ft):	7.4
Structural Grade:	0
O&M Grade:	0
Clock Start/From:	
Clock To:	
1st Value:	
2nd Value:	
Value Percent:	
Step:	NO
Remarks:	END SURVEY
