Manhole Inspection Report

Date:	10/09/2022	Weather:		Coding:	RZMACP
MH#:	M-504-107	Owner:	NA	Len. Surveyed:	5.4
P.O.#:		Surveyor:	Jen Costello	Rim to Invert:	6.0
Customer:		Cert. #:	U-907-5518	Wall Material:	Brick

Street:	132' North of 42nd Ave. 64' East of	Project:	Hobart, IN
City:	Hobart, IN	GPS Northing:	2292608.29
Location:	Other	GPS Easting:	2900783.82
Drain Area:	Northwest	GPS Accuracy:	Sub-Meter
Cover Shape:	Circular	Evidence of Surcharge:	No
Cover Size:	24.0	Potential for Runoff:	None
Comments:

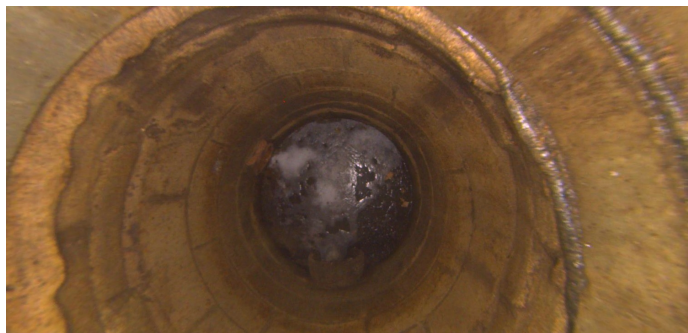
Code: **MGO**
Description: **General Observation**

Distance (ft): **.0**
Structural Grade: **0**
O&M Grade: **0**
Clock Start/From:
Clock To:
1st Value:
2nd Value:
Value Percent:
Step: **NO**
Remarks: **ACCESS MH**

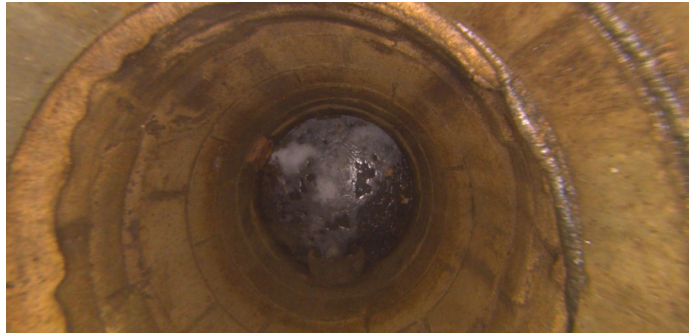
Code:	SRI
Description:	Surface Roughness Increased
Distance (ft):	.0
Structural Grade:	1
O&M Grade:	0
Clock Start/From:	12
Clock To:	12
1st Value:	
2nd Value:	
Value Percent:	
Step:	NO
Remarks:

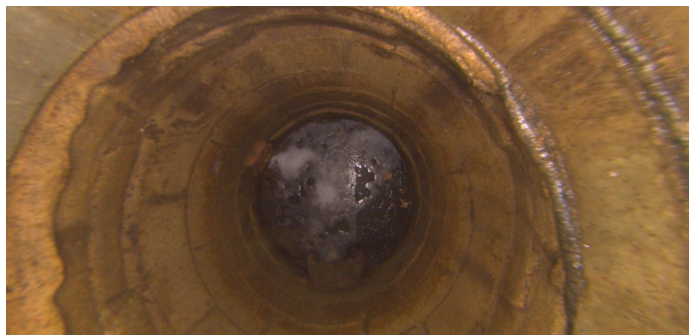
Code:	ISGT
Description:	Intruding Sealing Grout
Distance (ft):	.0
Structural Grade:	0
O&M Grade:	2
Clock Start/From:	12
Clock To:	3
1st Value:	
2nd Value:	
Value Percent:	5.000
Step:	NO
Remarks:

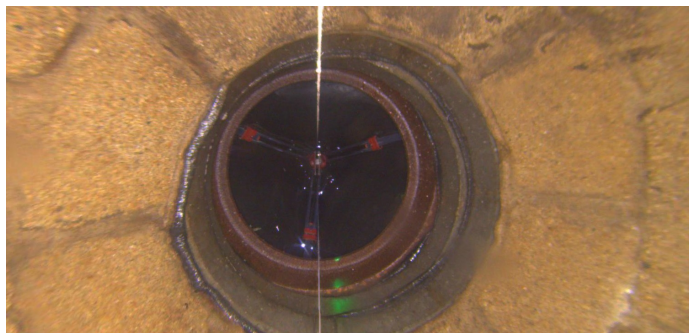
Code:	MGO
Description:	General Observation
Distance (ft):	3.0
Structural Grade:	0
O&M Grade:	0
Clock Start/From:	
Clock To:	
1st Value:	
2nd Value:	
Value Percent:	
Step:	NO
Remarks:	UNDERSIDE OF FRAME

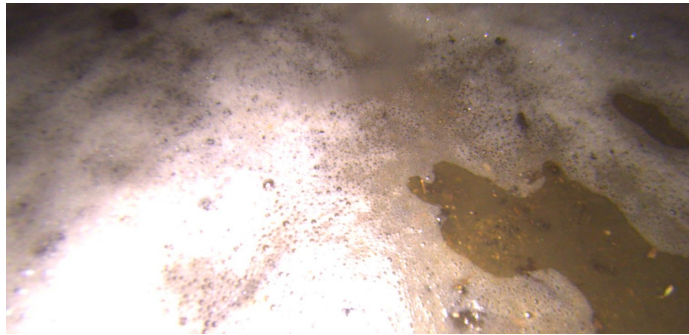
Code: **MGO**
Description: **General Observation**

Distance (ft): **5.4**
Structural Grade: **0**
O&M Grade: **0**
Clock Start/From:
Clock To:
1st Value:
2nd Value:
Value Percent:
Step: **NO**
Remarks: **END OF SURVEY**

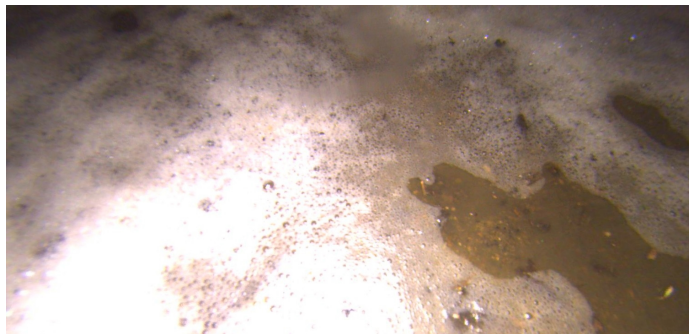
Code: **SRI**
Description: **Surface Roughness Increased**

Distance (ft): **5.4**
Structural Grade: **1**
O&M Grade: **0**
Clock Start/From: **12**
Clock To: **12**
1st Value:
2nd Value:
Value Percent:
Step: **NO**
Remarks:

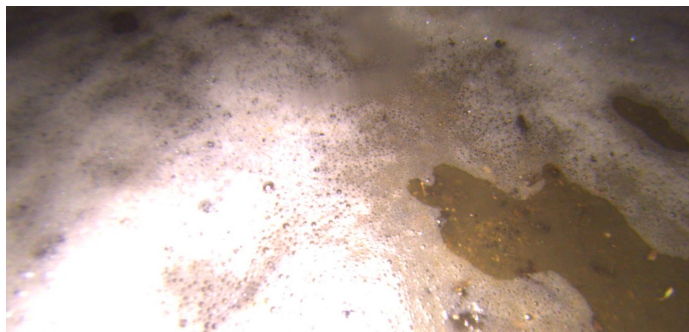
Code: **MGO**
Description: **General Observation**

Distance (ft): **5.4**
Structural Grade: **0**
O&M Grade: **0**
Clock Start/From:
Clock To:
1st Value:
2nd Value:
Value Percent:
Step: **NO**
Remarks: **BENCH IS SUBMERGED**
