Manhole Inspection Report

Date:	04/10/2018	Weather:		Coding:	RZMACP
MH#:	M-504-110	Owner:	NA	Len. Surveyed:	4.2
P.O.#:		Surveyor:	John Kuglmaier	Rim to Invert:	5.3
Customer:		Cert. #:	U-1215-07002349	Wall Material:	Concrete (reinforced)

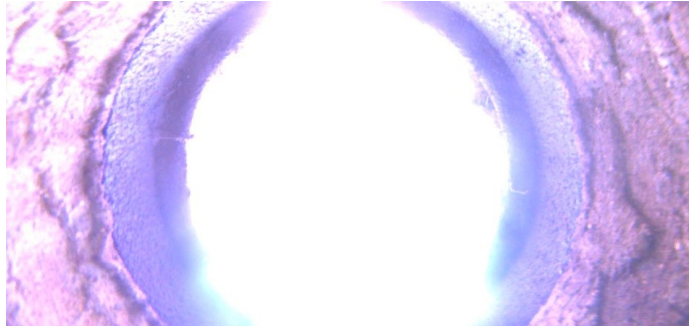
Code: **MGP**
Description: **General Photo**

Distance (ft): **2.0**
Structural Grade: **0**
O&M Grade: **0**
Clock Start/From:
Clock To:
1st Value:
2nd Value:
Value Percent:
Step: **NO**
Remarks:

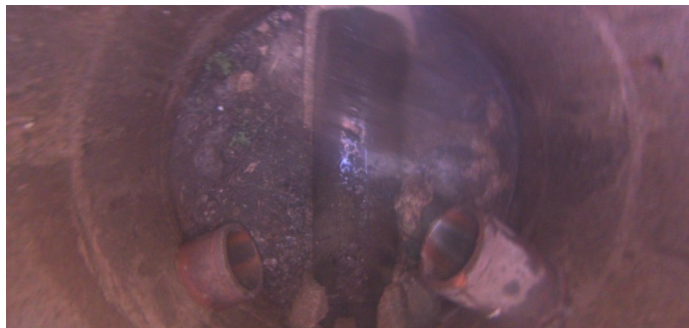
Code: **DAZ**
Description: **Deposits Attached Other**

Distance (ft): **2.4**
Structural Grade: **0**
O&M Grade: **2**
Clock Start/From: **12**
Clock To: **12**
1st Value:
2nd Value:
Value Percent: **10.000**
Step: **NO**
Remarks: **Mixed materials**

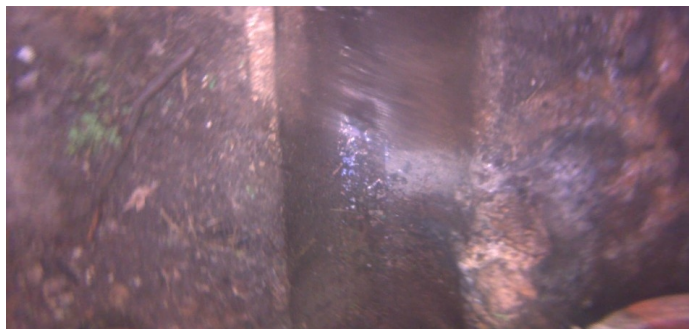
Code: **MGO**
Description: **General Observation**

Distance (ft): **3.7**
Structural Grade: **0**
O&M Grade: **0**
Clock Start/From:
Clock To:
1st Value:
2nd Value:
Value Percent:
Step: **NO**
Remarks: **Ins. Comp.**
