Manhole Inspection Report

| MH#: | M-504-112 | Owner: | NA | Len. Surveyed: | 5.2 |

| Street: | 162' East of Colorado St. 165' South | Project: | Hobart, IN |

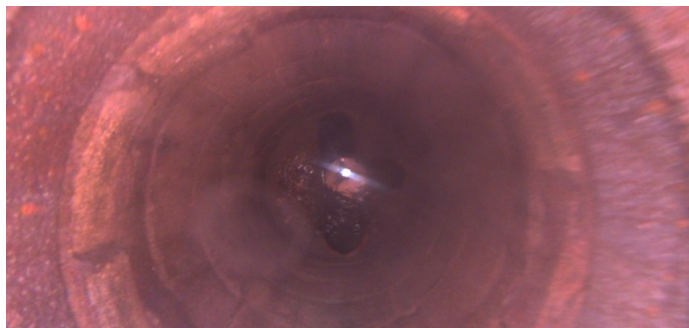
Code: **MGP**
Description: **General Photo**

Distance (ft): **.0**
Structural Grade: **0**
O&M Grade: **0**
Clock Start/From:
Clock To:
1st Value:
2nd Value:
Value Percent:
Step: **NO**
Remarks:

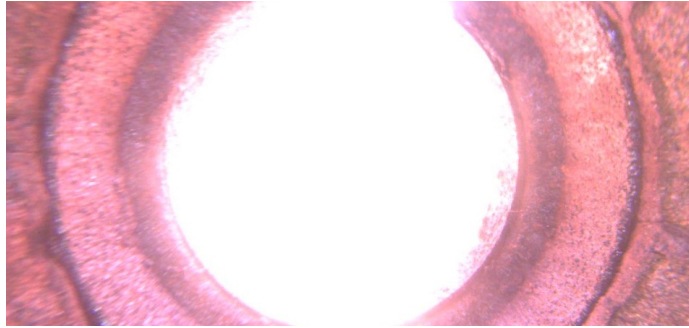
Code: **MGP**
Description: **General Photo**

Distance (ft): **2.0**
Structural Grade: **0**
O&M Grade: **0**
Clock Start/From:
Clock To:
1st Value:
2nd Value:
Value Percent:
Step: **NO**
Remarks:

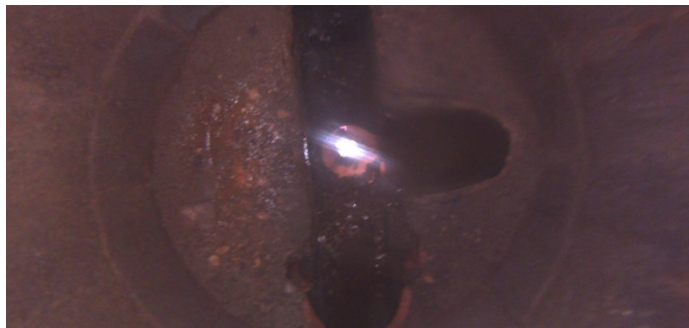
Code: **DAZ**
Description: **Deposits Attached Other**

Distance (ft): **3.3**
Structural Grade: **0**
O&M Grade: **2**
Clock Start/From: **12**
Clock To: **12**
1st Value:
2nd Value:
Value Percent: **10.000**
Step: **NO**
Remarks: **Mixed materials**

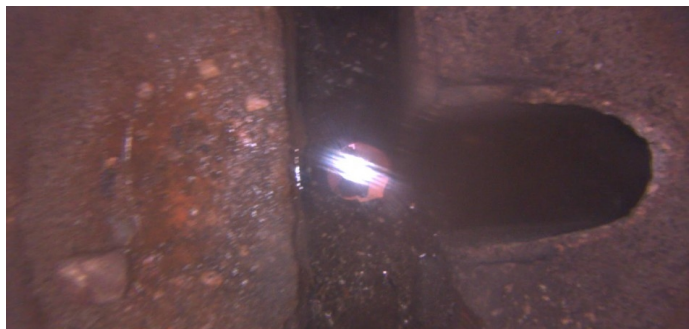
Code: **MGO**
Description: **General Observation**

Distance (ft): **4.3**
Structural Grade: **0**
O&M Grade: **0**
Clock Start/From:
Clock To:
1st Value:
2nd Value:
Value Percent:
Step: **NO**
Remarks: **Ins. Comp.**
