# Manhole Inspection Report

Date:	<b>04/10/2018</b>	Weather:		Coding:	<b>RZMACP</b>
MH#:	<b>M-504-120</b>	Owner:	<b>NA</b>	Len. Surveyed:	<b>4.7</b>
P.O.#:		Surveyor:	<b>John Kuglmaier</b>	Rim to Invert:	<b>6.3</b>
Customer:		Cert. #:	<b>U-1215-07002349</b>	Wall Material:	<b>Concrete (reinforced)</b>

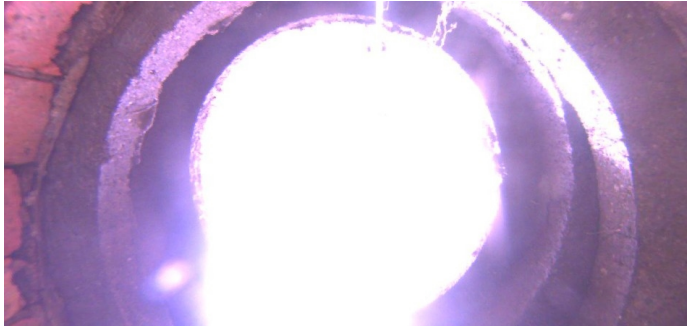
Code: **MGP**  
Description: **General Photo**

Distance (ft): **1.9**  
Structural Grade: **0**  
O&M Grade: **0**  
Clock Start/From:  
Clock To:  
1st Value:  
2nd Value:  
Value Percent:  
Step: **NO**  
Remarks:

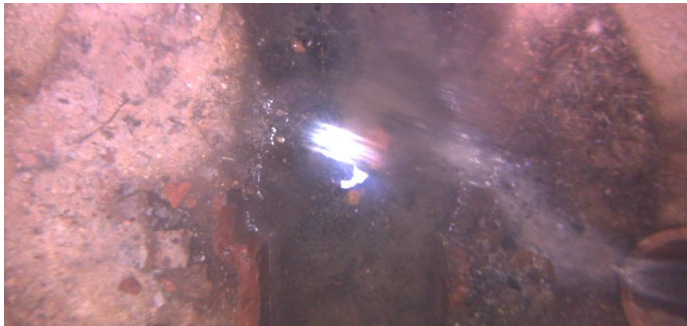
Code: **MGO**  
Description: **General Observation**

Distance (ft): **4.1**  
Structural Grade: **0**  
O&M Grade: **0**  
Clock Start/From:  
Clock To:  
1st Value:  
2nd Value:  
Value Percent:  
Step: **NO**  
Remarks: **Ins. Comp.**
