Manhole Inspection Report

| MH#: | M-504-122 | Owner: | NA | Len. Surveyed: | 9.0 |

| Street: | 113' East of Guyer St. 140' North of | Project: | Hobart, IN |

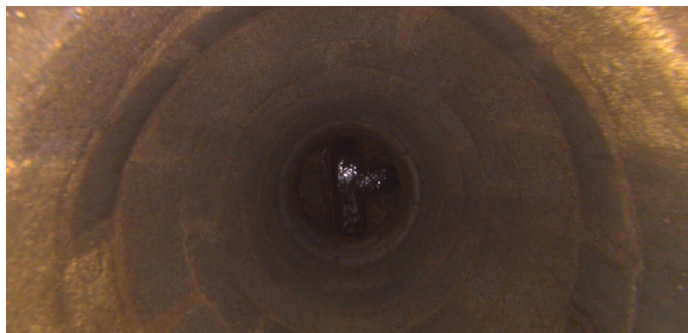
Code: **MGO**
Description: **General Observation**

Distance (ft): **.0**
Structural Grade: **0**
O&M Grade: **0**
Clock Start/From:
Clock To:
1st Value:
2nd Value:
Value Percent:
Step: **NO**
Remarks: **access mh**

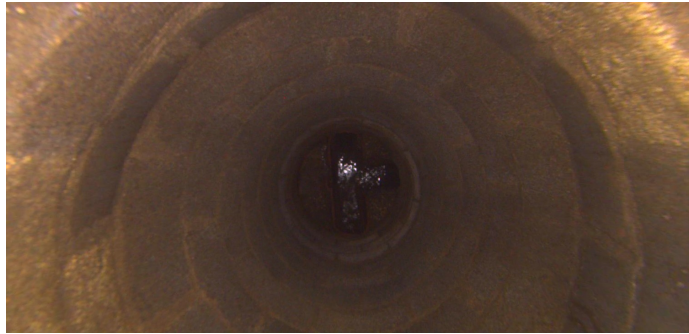
| Position | Code | Observation | Video (sec) | Grade |
|--|---|---|---|---|
| .0 | SAV | Surface Aggregate Visible | 21 | S 3 |

Code: **SAV**
Description: **Surface Aggregate Visible**

Distance (ft): **.0**
Structural Grade: **3**
O&M Grade: **0**
Clock Start/From: **12**
Clock To: **12**
1st Value:
2nd Value:
Value Percent:
Step: **NO**
Remarks:

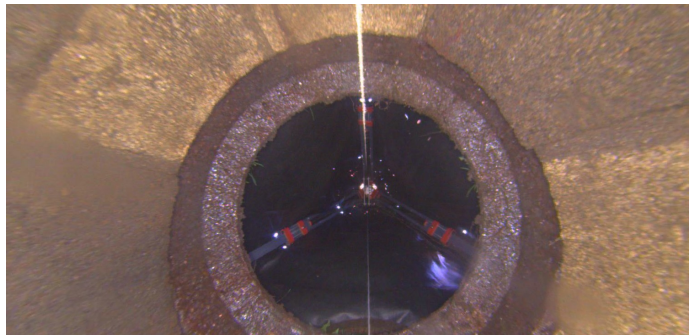
Code: **MGO**
Description: **General Observation**

Distance (ft): **2.3**
Structural Grade: **0**
O&M Grade: **0**
Clock Start/From:
Clock To:
1st Value:
2nd Value:
Value Percent:
Step: **NO**
Remarks: **underside of frame**

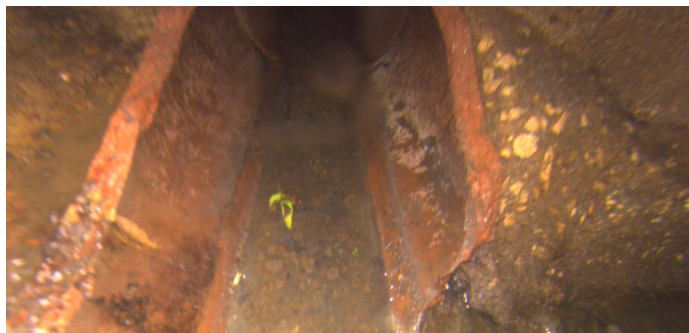
| Position | Code | Observation | Video (sec) | Grade |
|--|---|---|---|---|
| 8.3 | SAP | Surface Aggregate Projecting | 65 | S 3 |

Code: **SAP**
Description: **Surface Aggregate Projecting**

Distance (ft): **8.3**
Structural Grade: **3**
O&M Grade: **0**
Clock Start/From: **12**
Clock To: **12**
1st Value:
2nd Value:
Value Percent:
Step: **NO**
Remarks:

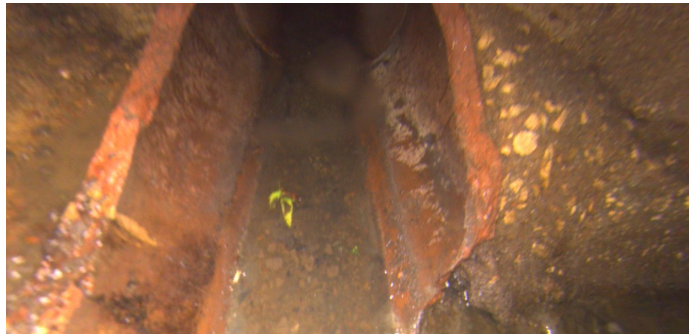
| Position | Code | Observation | Video (sec) | Grade |
|--|---|---|---|---|
| 8.3 | SAV | Surface Aggregate Visible | 77 | S 3 |

| Description: | Surface Aggregate Visible |
| Distance (ft): | 8.3 |
| Structural Grade: | 3 |

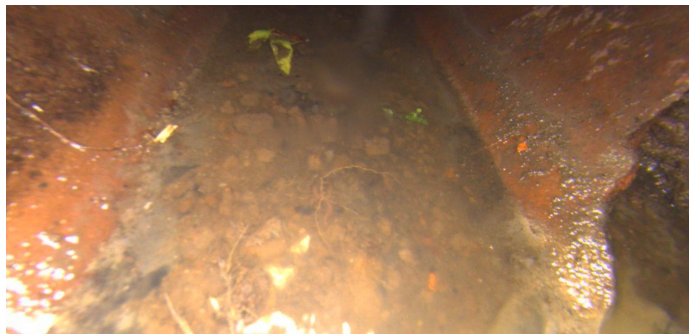
| Description: | General Observation |
| Distance (ft): | 9.0 |
| Remarks: | end of survey |
