Manhole Inspection Report

Date:	04/10/2018	Weather:		Coding:	RZMACP
MH#:	M-504-128	Owner:	NA	Len. Surveyed:	4.2
P.O.#:		Surveyor:	John Kuglmaier	Rim to Invert:	5.1
Customer:		Cert. #:	U-1215-07002349	Wall Material:	Concrete (reinforced)

Street:	41st Ave. 165' East of Wilson St.	Project:	Hobart, IN
City:	Hobart, IN	GPS Northing:	2899536.924
Location:		GPS Easting:	2899536.924
Drain Area:	Northwest	GPS Accuracy:	Sub-Meter
Cover Shape:	Circular	Evidence of Surcharge:	Yes
Cover Size:	23.0	Potential for Runoff:	None
Comments:

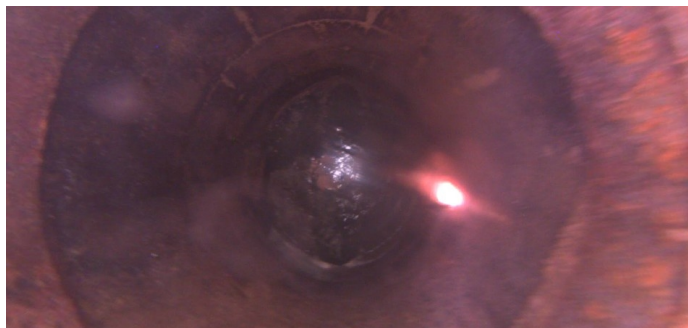
Code: **MGP**
Description: **General Photo**

Distance (ft): **.0**
Structural Grade: **0**
O&M Grade: **0**
Clock Start/From:
Clock To:
1st Value:
2nd Value:
Value Percent:
Step: **NO**
Remarks:

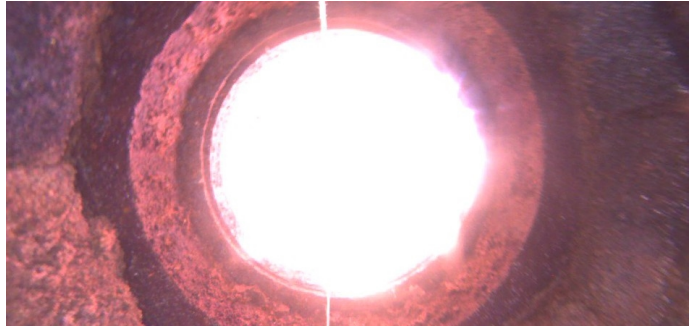
Code: **MGP**
Description: **General Photo**

Distance (ft): **2.4**
Structural Grade: **0**
O&M Grade: **0**
Clock Start/From:
Clock To:
1st Value:
2nd Value:
Value Percent:
Step: **NO**
Remarks:

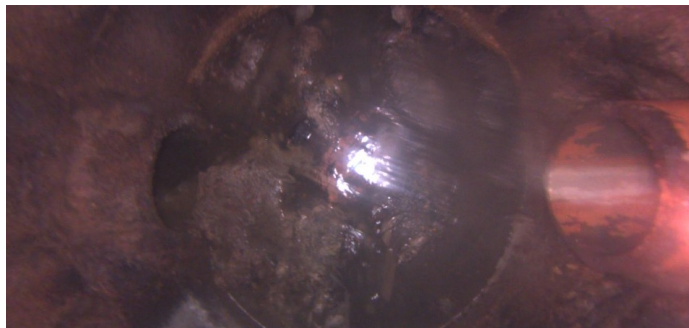
Code: **DAZ**
Description: **Deposits Attached Other**

Distance (ft): **2.7**
Structural Grade: **0**
O&M Grade: **3**
Clock Start/From: **12**
Clock To: **12**
1st Value:
2nd Value:
Value Percent: **15.000**
Step: **NO**
Remarks: **Mixed materials**

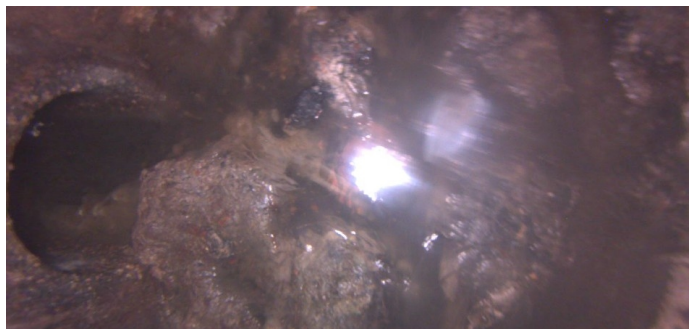
Code: **MGO**
Description: **General Observation**

Distance (ft): **3.6**
Structural Grade: **0**
O&M Grade: **0**
Clock Start/From:
Clock To:
1st Value:
2nd Value:
Value Percent:
Step: **NO**
Remarks: **Ins. Comp.**
