Manhole Inspection Report

Date:	05/14/2018	Weather:		Coding:	RZMACP
MH#:	M-504-131	Owner:	NA	Len. Surveyed:	3.6
P.O.#:		Surveyor:	Jen Costello	Rim to Invert:	3.4
Customer:		Cert. #:	U-907-5518	Wall Material:	Concrete (reinforced)

Street:	Alley Behind Wiseway. East Side. 24	Project:	Hobart, IN
City:	Hobart, IN	GPS Northing:	41.53866196
Location:		GPS Easting:	-87.39647675
Drain Area:	West	GPS Accuracy:	Nearest Meter
Cover Shape:	Circular	Evidence of Surcharge:	No
Cover Size:	22.5	Potential for Runoff:	None
Comments:

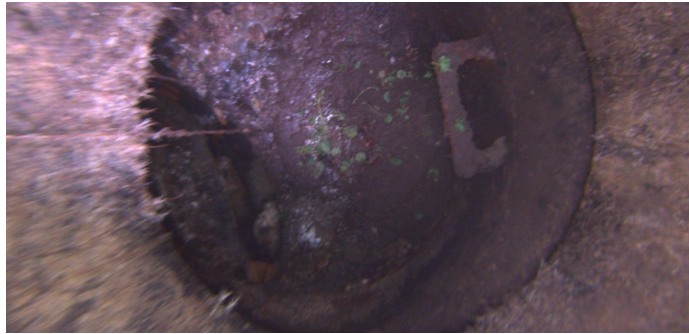
Code:	SAV
Description:	Surface Aggregate Visible
Distance (ft):	.0
Structural Grade:	3
O&M Grade:	0
Clock Start/From:	12
Clock To:	12
1st Value:	
2nd Value:	
Value Percent:	
Step:	NO
Remarks:

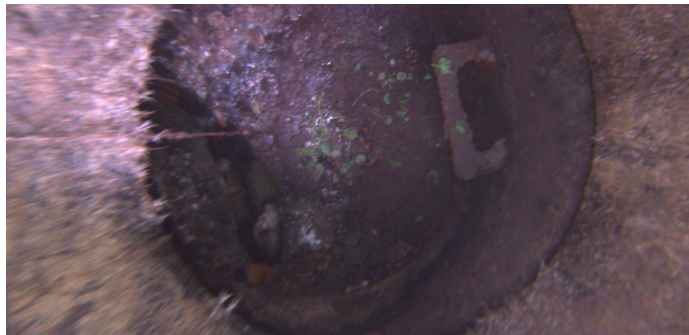
Code:	RFJ
Description:	Roots Fine Joint
Distance (ft):	.0
Structural Grade:	0
O&M Grade:	1
Clock Start/From:	12
Clock To:	12
1st Value:	
2nd Value:	
Value Percent:	
Step:	NO
Remarks:

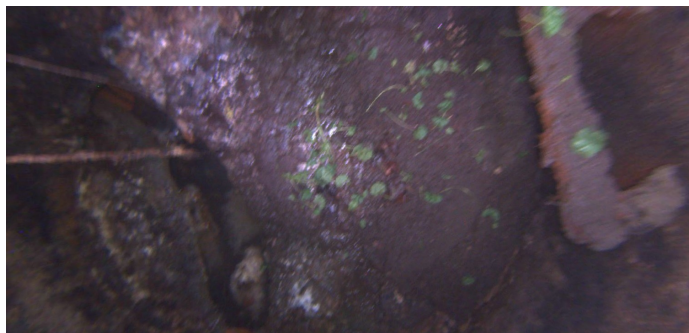
Code:	DSF
Description:	Deposits Settled Fine
Distance (ft):	1.2
Structural Grade:	0
O&M Grade:	2
Clock Start/From:	12
Clock To:	12
1st Value:	
2nd Value:	
Value Percent:	5.000
Step:	NO
Remarks:
