# Manhole Inspection Report

Date:	10/13/2022	Weather:		Coding:	RZMACP
MH#:	M-504-132	Owner:	NA	Len. Surveyed:	4.7
P.O.#:		Surveyor:	Jen Costello	Rim to Invert:	5.5
Customer:		Cert. #:	U-907-5518	Wall Material:	Concrete (cast in place)

Street:	In Alley Behind Wiseway. 319' East	Project:	Hobart, IN
City:	Hobart, IN	GPS Northing:	2291331.28
Location:	Local Rural Streets	GPS Easting:	2901143.883
Drain Area:	West	GPS Accuracy:	Sub-Meter
Cover Shape:	Circular	Evidence of Surcharge:	No
Cover Size:	24.0	Potential for Runoff:	None
Comments:

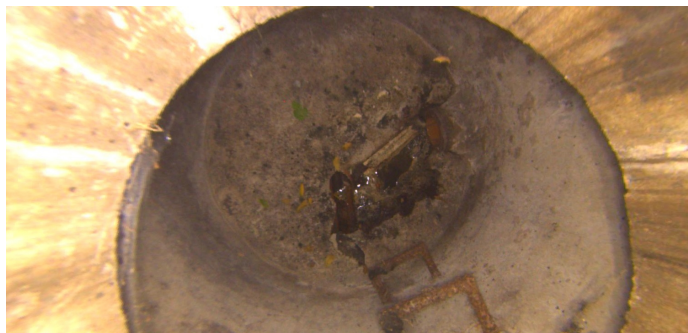
Code: **MGO**  
Description: **General Observation**

Distance (ft): **.0**  
Structural Grade: **0**  
O&M Grade: **0**  
Clock Start/From:  
Clock To:  
1st Value:  
2nd Value:  
Value Percent:  
Step: **NO**  
Remarks: **access mh**

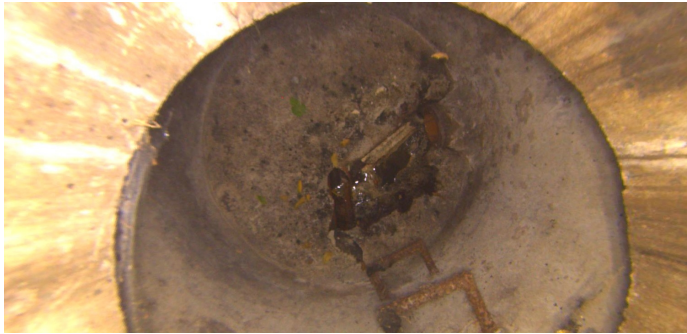
Code:	<b>SRI</b>
Description:	<b>Surface Roughness Increased</b>
Distance (ft):	<b>.0</b>
Structural Grade:	<b>1</b>
O&M Grade:	<b>0</b>
Clock Start/From:	<b>12</b>
Clock To:	<b>12</b>
1st Value:	
2nd Value:	
Value Percent:	
Step:	<b>NO</b>
Remarks:

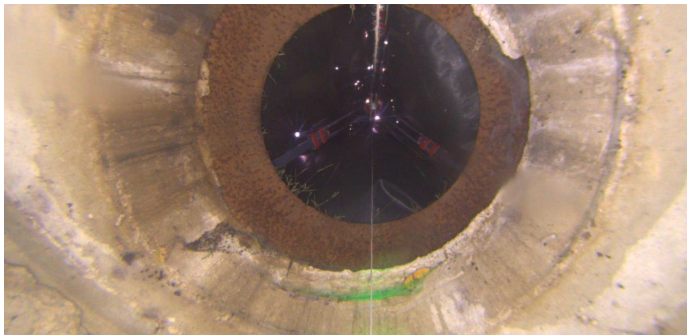
Code:	<b>MGO</b>
Description:	<b>General Observation</b>
Distance (ft):	<b>2.4</b>
Structural Grade:	<b>0</b>
O&M Grade:	<b>0</b>
Clock Start/From:	
Clock To:	
1st Value:	
2nd Value:	
Value Percent:	
Step:	<b>NO</b>
Remarks:	<b>underside of frame</b>

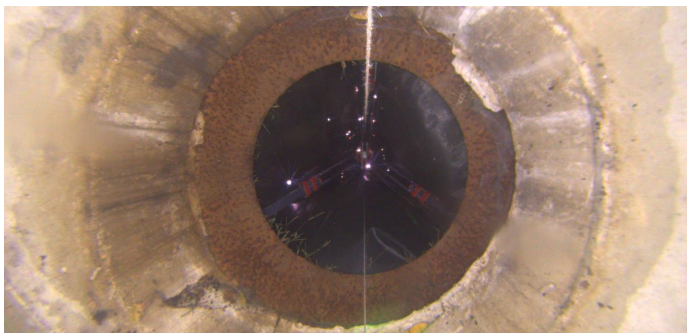
Code:	<b>RFJ</b>
Description:	<b>Roots Fine Joint</b>
Distance (ft):	<b>2.4</b>
Structural Grade:	<b>0</b>
O&M Grade:	<b>1</b>
Clock Start/From:	<b>4</b>
Clock To:	
1st Value:	
2nd Value:	
Value Percent:	
Step:	<b>NO</b>
Remarks:

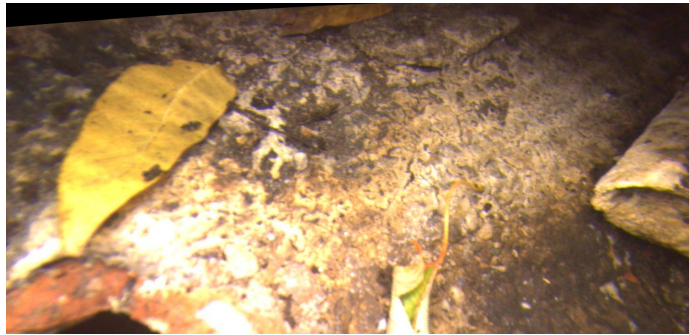
Code: **SAV**  
Description: **Surface Aggregate Visible**

Distance (ft): **4.7**  
Structural Grade: **3**  
O&M Grade: **0**  
Clock Start/From: **12**  
Clock To: **12**  
1st Value:  
2nd Value:  
Value Percent:  
Step: **NO**  
Remarks:

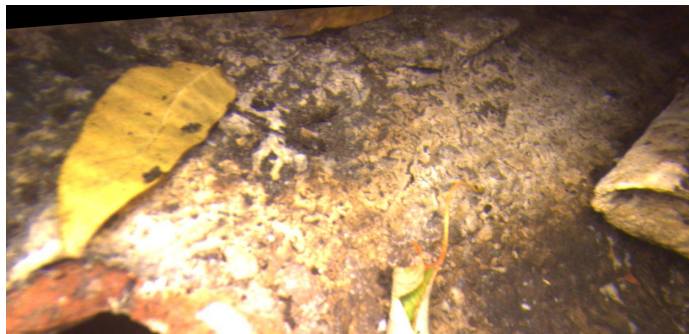
Code: **SRI**  
Description: **Surface Roughness Increased**

Distance (ft): **4.7**  
Structural Grade: **1**  
O&M Grade: **0**  
Clock Start/From: **12**  
Clock To: **12**  
1st Value:  
2nd Value:  
Value Percent:  
Step: **NO**  
Remarks:

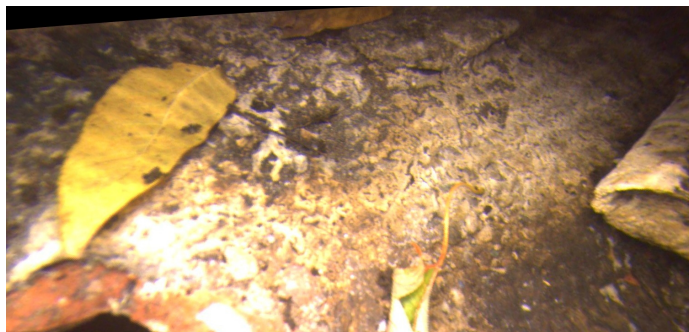
Code: **MGO**  
Description: **General Observation**

Distance (ft): **4.7**  
Structural Grade: **0**  
O&M Grade: **0**  
Clock Start/From:  
Clock To:  
1st Value:  
2nd Value:  
Value Percent:  
Step: **NO**  
Remarks: **end of survey**
