Manhole Inspection Report

Date:	05/02/2018	Weather:		Coding:	RZMACP
MH#:	M-505-002	Owner:	NA	Len. Surveyed:	10.4
P.O.#:		Surveyor:	Jen Costello	Rim to Invert:	10.4
Customer:		Cert. #:	U-907-5518	Wall Material:	Concrete (reinforced)

Street:	Intersection of Wisconsin St. and 3r	Project:	Hobart, IN
City:	Hobart, IN	GPS Northing:	41.5326767
Location:		GPS Easting:	-87.26937103
Drain Area:	West	GPS Accuracy:	Nearest Meter
Cover Shape:	Circular	Evidence of Surcharge:	No
Cover Size:	22.5	Potential for Runoff:	None
Comments:

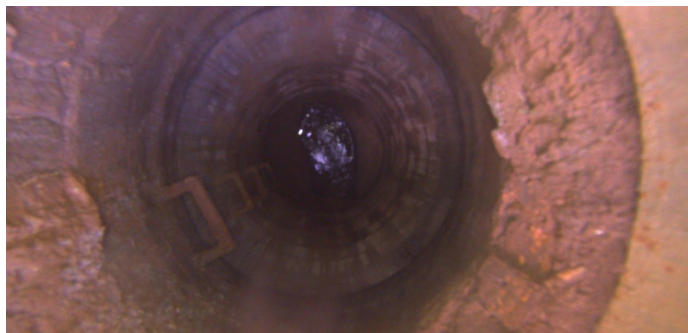
Code: **MGP**
Description: **General Photo**

Distance (ft): **.0**
Structural Grade: **0**
O&M Grade: **0**
Clock Start/From:
Clock To:
1st Value:
2nd Value:
Value Percent:
Step: **NO**
Remarks: **Access mh**

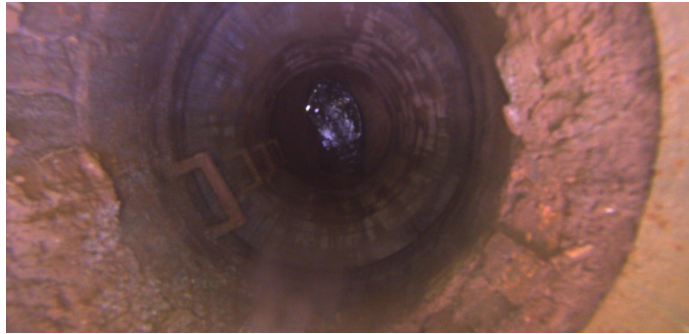
Code:	DAE
Description:	Deposits Attached Encrustation
Distance (ft):	.0
Structural Grade:	0
O&M Grade:	2
Clock Start/From:	1
Clock To:	8
1st Value:	
2nd Value:	
Value Percent:	5.000
Step:	NO
Remarks:

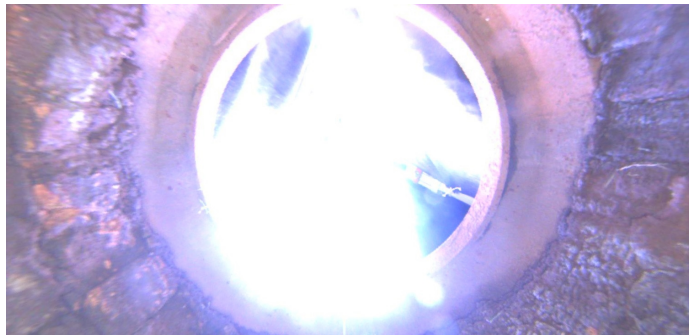
Code:	MGO
Description:	General Observation
Distance (ft):	1.9
Structural Grade:	0
O&M Grade:	0
Clock Start/From:	
Clock To:	
1st Value:	
2nd Value:	
Value Percent:	
Step:	NO
Remarks:	underside of frame

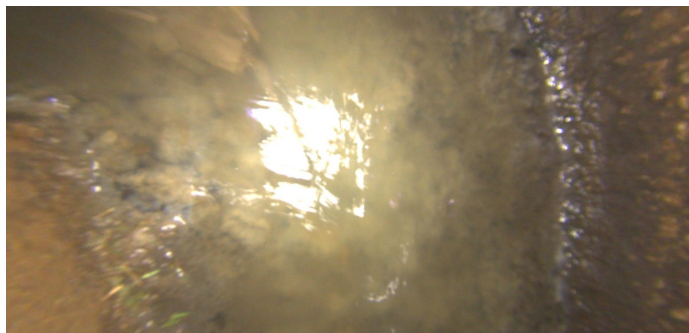
Code:	MGO
Description:	General Observation
Distance (ft):	9.9
Structural Grade:	0
O&M Grade:	0
Clock Start/From:	
Clock To:	
1st Value:	
2nd Value:	
Value Percent:	
Step:	NO
Remarks:	end survey
