Manhole Inspection Report

Date:	05/02/2018	Weather:		Coding:	RZMACP
MH#:	M-505-003	Owner:	NA	Len. Surveyed:	16.8
P.O.#:		Surveyor:	Jen Costello	Rim to Invert:	19.3
Customer:		Cert. #:	U-907-5518	Wall Material:	Brick

Street:	Wisconsin St. 195' South of 3rd St.	Project:	Hobart, IN
City:	Hobart, IN	GPS Northing:	41.53207779
Location:		GPS Easting:	-87.2693634
Drain Area:	West	GPS Accuracy:	Nearest Meter
Cover Shape:	Circular	Evidence of Surcharge:	No
Cover Size:	22.5	Potential for Runoff:	None
Comments:

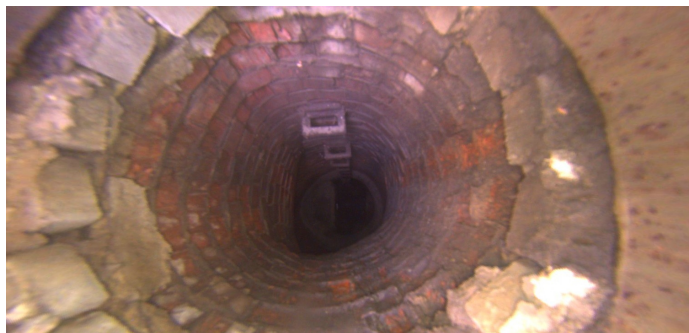
Code: **MGP**
Description: **General Photo**

Distance (ft): **.0**
Structural Grade: **0**
O&M Grade: **0**
Clock Start/From:
Clock To:
1st Value:
2nd Value:
Value Percent:
Step: **NO**
Remarks: **ACCESS MH**

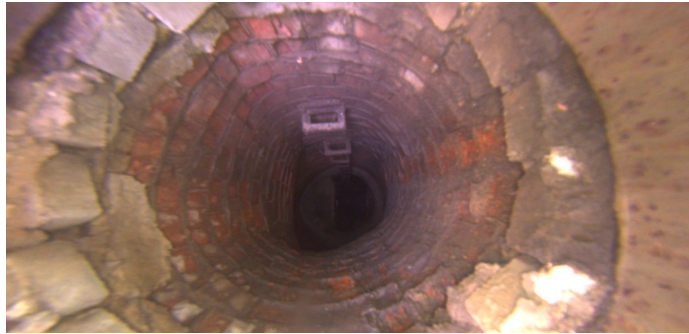
Code: **DB**
Description: **Displaced Brick**

Distance (ft): **.0**
Structural Grade: **3**
O&M Grade: **0**
Clock Start/From: **12**
Clock To: **12**
1st Value:
2nd Value:
Value Percent:
Step: **NO**
Remarks:

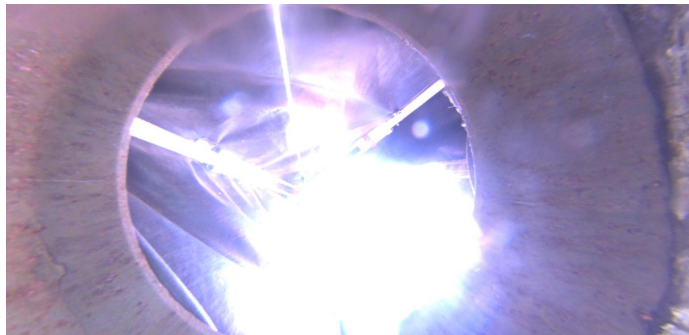
Code: **MGO**
Description: **General Observation**

Distance (ft): **1.1**
Structural Grade: **0**
O&M Grade: **0**
Clock Start/From:
Clock To:
1st Value:
2nd Value:
Value Percent:
Step: **NO**
Remarks: **UNDERSIDE OF FRAME**

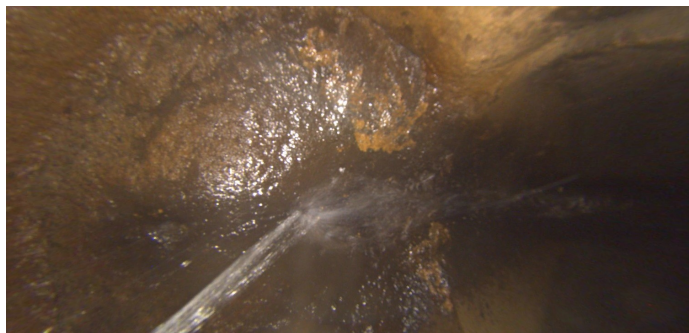
Code: **MGO**
Description: **General Observation**

Distance (ft): **16.8**
Structural Grade: **0**
O&M Grade: **0**
Clock Start/From:
Clock To:
1st Value:
2nd Value:
Value Percent:
Step: **NO**
Remarks: **END SURVEY**
