Manhole Inspection Report

Date:	04/30/2018	Weather:		Coding:	RZMACP
MH#:	M-505-005	Owner:	NA	Len. Surveyed:	4.5
P.O.#:		Surveyor:	Jen Costello	Rim to Invert:	5.0
Customer:		Cert. #:	U-907-5518	Wall Material:	Brick

Street:	California Pl. 231' South of West 3rd	Project:	Hobart, IN
City:	Hobart, IN	GPS Northing:	2901608.706
Location:		GPS Easting:	2901608.706
Drain Area:	West	GPS Accuracy:	Sub-Meter
Cover Shape:	Circular	Evidence of Surcharge:	No
Cover Size:	22.5	Potential for Runoff:	None
Comments:

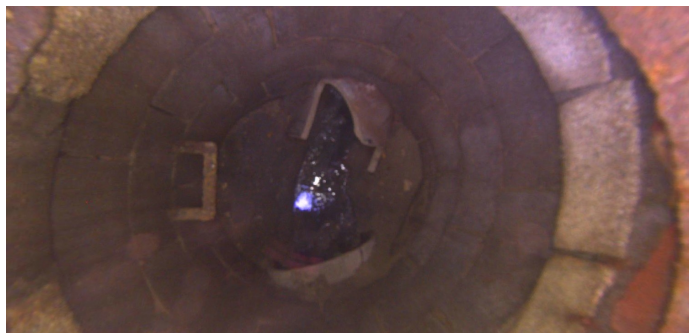
Code: **MGP**
Description: **General Photo**

Distance (ft): **.0**
Structural Grade: **0**
O&M Grade: **0**
Clock Start/From:
Clock To:
1st Value:
2nd Value:
Value Percent:
Step: **NO**
Remarks: **access mh**

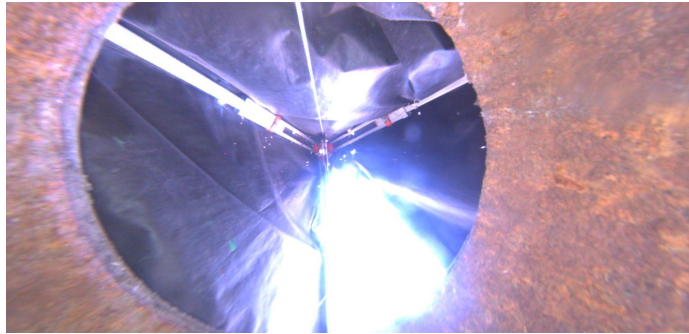
Code:	MGO
Description:	General Observation
Distance (ft):	1.2
Structural Grade:	0
O&M Grade:	0
Clock Start/From:	
Clock To:	
1st Value:	
2nd Value:	
Value Percent:	
Step:	NO
Remarks:	underside of frame

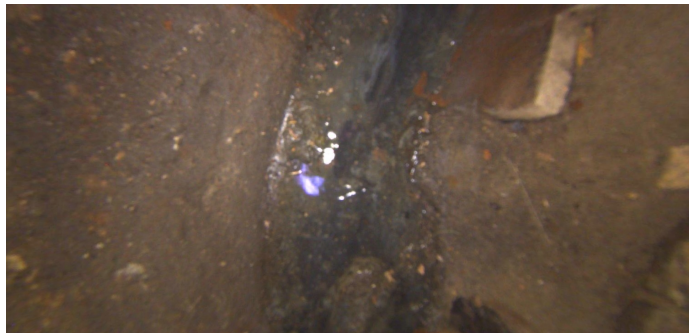
Code:	DSF
Description:	Deposits Settled Fine
Distance (ft):	3.4
Structural Grade:	0
O&M Grade:	2
Clock Start/From:	12
Clock To:	12
1st Value:	
2nd Value:	
Value Percent:	5.000
Step:	NO
Remarks:

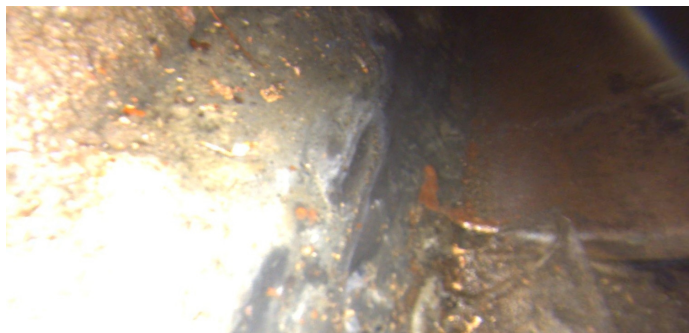
Code:	MGO
Description:	General Observation
Distance (ft):	4.5
Structural Grade:	0
O&M Grade:	0
Clock Start/From:	
Clock To:	
1st Value:	
2nd Value:	
Value Percent:	
Step:	NO
Remarks:	end survey
