Manhole Inspection Report

Date:	04/30/2018	Weather:		Coding:	RZMACP
MH#:	M-505-011	Owner:	NA	Len. Surveyed:	8.1
P.O.#:		Surveyor:	Jen Costello	Rim to Invert:	8.2
Customer:		Cert. #:	U-907-5518	Wall Material:	Brick

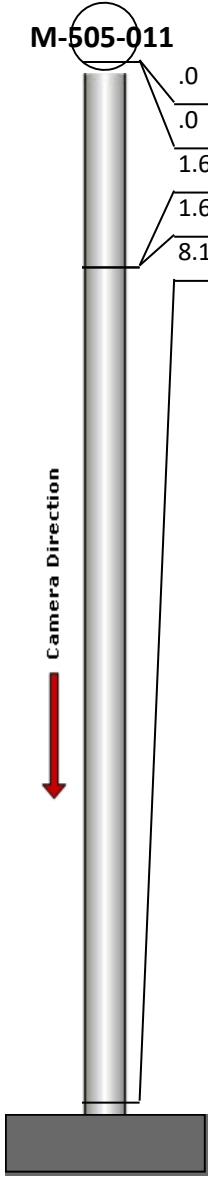
M-505-011				
	.0	MGP	General Photo	10	NA
	.0	SAP	Surface Aggregate Projecting	22	S 3
	1.6	MGO	General Observation	38	NA
	1.6	FL	Fracture Longitudinal	49	S 3
	8.1	MGO	General Observation	75	NA

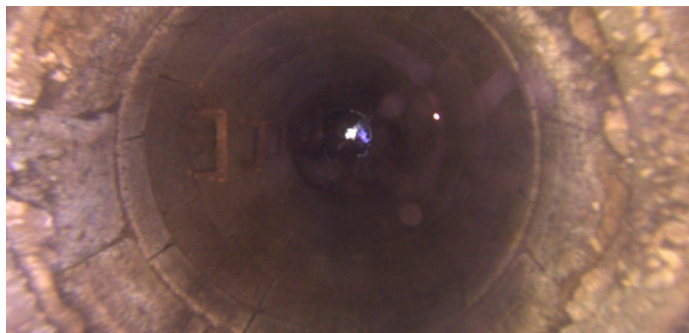
Code: **MGP**
Description: **General Photo**

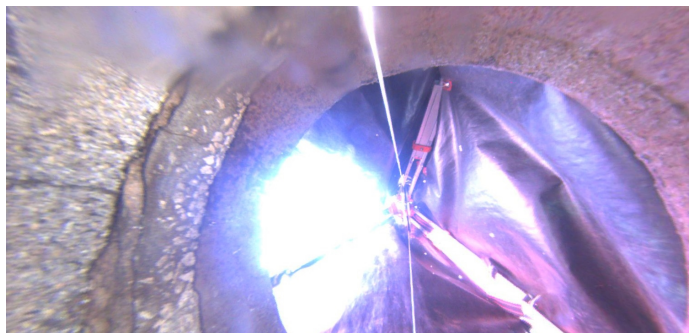
Code:	FL
Description:	Fracture Longitudinal
Distance (ft):	1.6
Structural Grade:	3
O&M Grade:	0
Clock Start/From:	2
Clock To:	
1st Value:	
2nd Value:	
Value Percent:	
Step:	NO
Remarks:

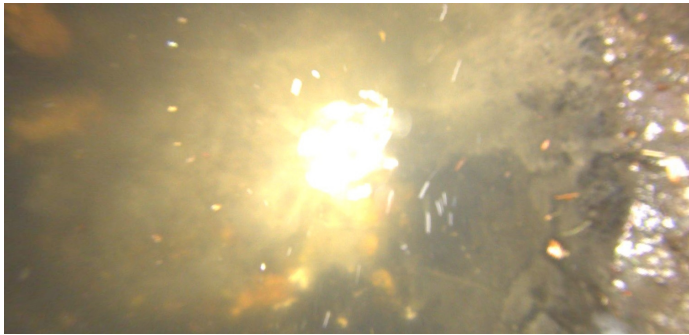
Code:	MGO
Description:	General Observation
Distance (ft):	8.1
Structural Grade:	0
O&M Grade:	0
Clock Start/From:	
Clock To:	
1st Value:	
2nd Value:	
Value Percent:	
Step:	NO
Remarks:	END SURVEY
