Manhole Inspection Report

Date:	04/30/2018	Weather:		Coding:	RZMACP
MH#:	M-505-012	Owner:	NA	Len. Surveyed:	7.7
P.O.#:		Surveyor:	Jen Costello	Rim to Invert:	7.7
Customer:		Cert. #:	U-907-5518	Wall Material:	Brick

Street:	Cherry Ln. 176' South of 3rd St.	Project:	Hobart, IN
City:	Hobart, IN	GPS Northing:	2900694.099
Location:		GPS Easting:	2900694.099
Drain Area:	West	GPS Accuracy:	Sub-Meter
Cover Shape:	Circular	Evidence of Surcharge:	No
Cover Size:	22.5	Potential for Runoff:	None
Comments:

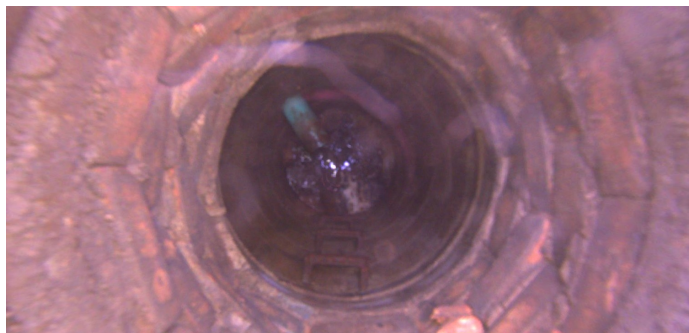
Code: **MGO**
Description: **General Observation**

Distance (ft): **.0**
Structural Grade: **0**
O&M Grade: **0**
Clock Start/From:
Clock To:
1st Value:
2nd Value:
Value Percent:
Step: **NO**
Remarks: **ACCESS MH**

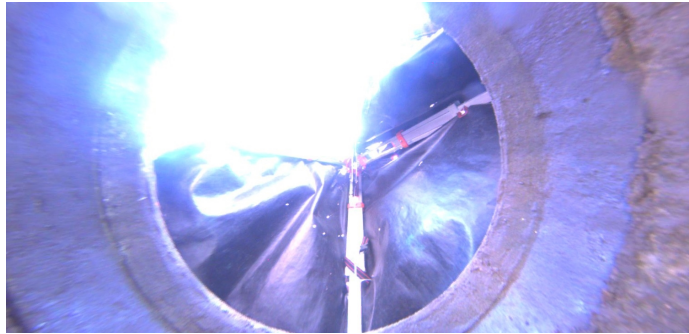
Code:	MGO
Description:	General Observation
Distance (ft):	1.6
Structural Grade:	0
O&M Grade:	0
Clock Start/From:	
Clock To:	
1st Value:	
2nd Value:	
Value Percent:	
Step:	NO
Remarks:	UNDERSIDE OF FRAME

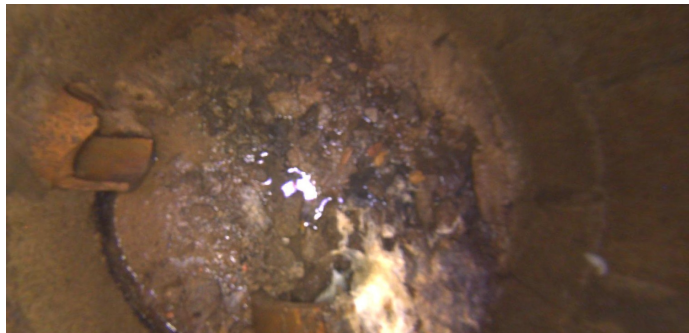
Code:	DSZ
Description:	Deposits Settled Other
Distance (ft):	5.9
Structural Grade:	0
O&M Grade:	2
Clock Start/From:	12
Clock To:	12
1st Value:	
2nd Value:	
Value Percent:	10.000
Step:	NO
Remarks:	MISC

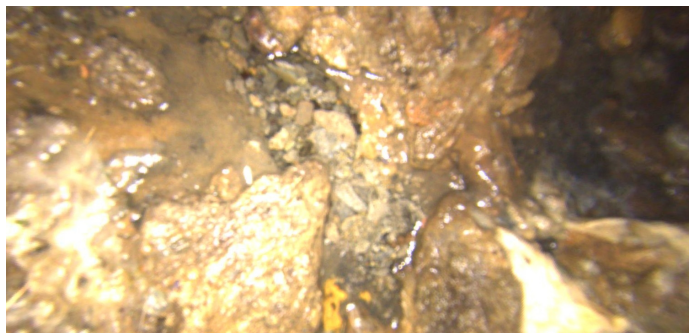
Code:	MGO
Description:	General Observation
Distance (ft):	7.7
Structural Grade:	0
O&M Grade:	0
Clock Start/From:	
Clock To:	
1st Value:	
2nd Value:	
Value Percent:	
Step:	NO
Remarks:	END SURVEY
