Manhole Inspection Report

Date:	04/30/2018	Weather:		Coding:	RZMACP
MH#:	M-505-014	Owner:	NA	Len. Surveyed:	13.2
P.O.#:		Surveyor:	Jen Costello	Rim to Invert:	14.2
Customer:		Cert. #:	U-907-5518	Wall Material:	Concrete (reinforced)

Street:	Intersection of W. 3rd Pl. and Virgini	Project:	Hobart, IN
City:	Hobart, IN	GPS Northing:	2901133.302
Location:		GPS Easting:	2901133.302
Drain Area:	West	GPS Accuracy:	Sub-Meter
Cover Shape:	Circular	Evidence of Surcharge:	No
Cover Size:	22.5	Potential for Runoff:	None
Comments:

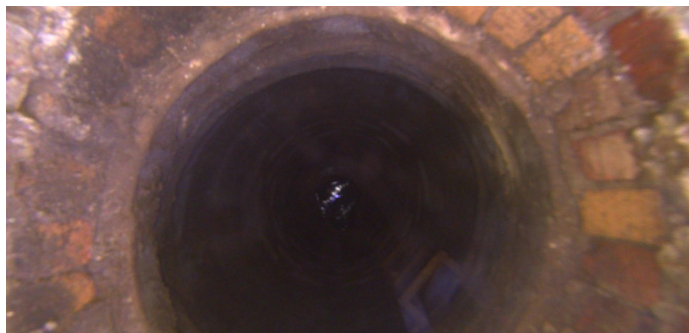
Code: **MGO**
Description: **General Observation**

Distance (ft): **.0**
Structural Grade: **0**
O&M Grade: **0**
Clock Start/From:
Clock To:
1st Value:
2nd Value:
Value Percent:
Step: **NO**
Remarks: **ACCESS MH**

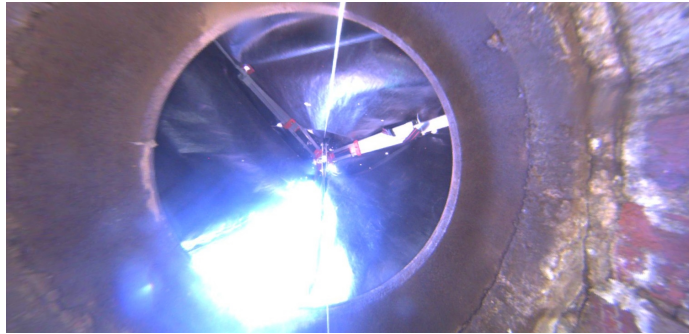
Code: **MGO**
Description: **General Observation**

Distance (ft): **1.2**
Structural Grade: **0**
O&M Grade: **0**
Clock Start/From:
Clock To:
1st Value:
2nd Value:
Value Percent:
Step: **NO**
Remarks: **UNDERSIDE OF FRAME**

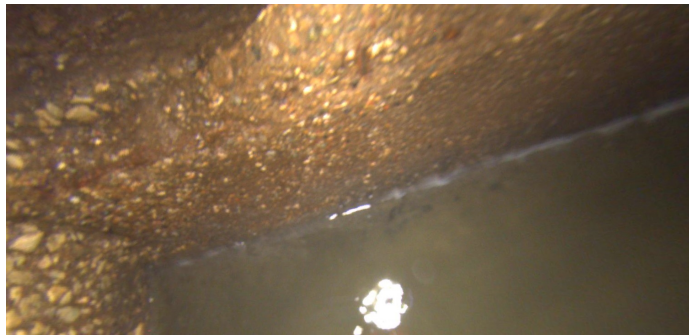
Code: **SAP**
Description: **Surface Aggregate Projecting**

Distance (ft): **12.7**
Structural Grade: **3**
O&M Grade: **0**
Clock Start/From: **8**
Clock To: **12**
1st Value:
2nd Value:
Value Percent:
Step: **NO**
Remarks:

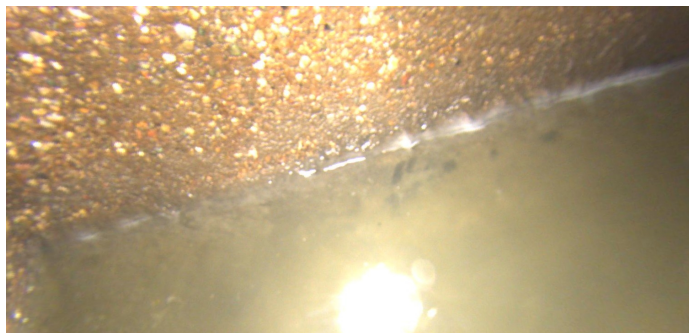
Code: **MGO**
Description: **General Observation**

Distance (ft): **13.2**
Structural Grade: **0**
O&M Grade: **0**
Clock Start/From:
Clock To:
1st Value:
2nd Value:
Value Percent:
Step: **NO**
Remarks: **END SURVEY**
