Manhole Inspection Report

Date:	05/01/2018	Weather:		Coding:	RZMACP
MH#:	M-505-035	Owner:	NA	Len. Surveyed:	6.1
P.O.#:		Surveyor:	Jen Costello	Rim to Invert:	6.2
Customer:		Cert. #:	U-907-5518	Wall Material:	Concrete (reinforced)

Street:	Intersection of 3rd St. and California	Project:	Hobart, IN
City:	Hobart, IN	GPS Northing:	41.53291702
Location:		GPS Easting:	-87.27053833
Drain Area:	West	GPS Accuracy:	Nearest Meter
Cover Shape:	Circular	Evidence of Surcharge:	No
Cover Size:	22.5	Potential for Runoff:	None
Comments:

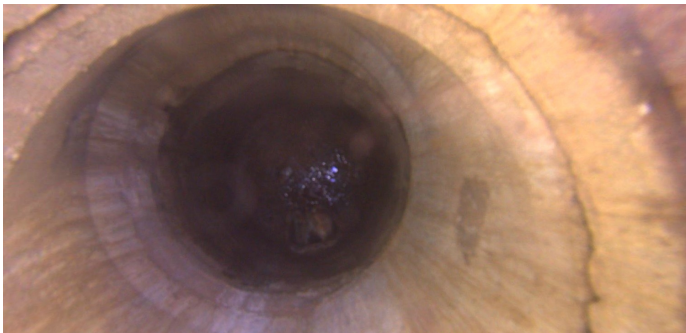
Code:	MGP
Description:	General Photo

Distance (ft):	.0
Structural Grade:	0
O&M Grade:	0
Clock Start/From:	
Clock To:	
1st Value:	
2nd Value:	
Value Percent:	
Step:	NO
Remarks:	AC

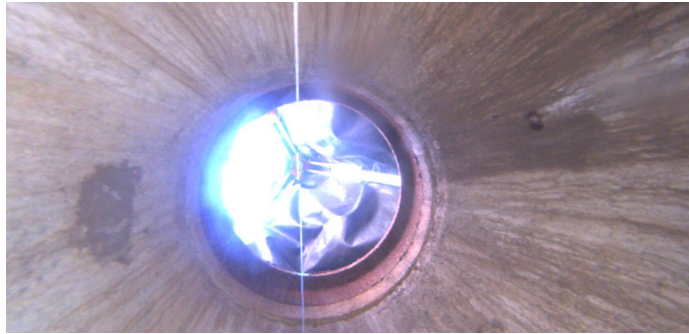
Code: **MGO**
Description: **General Observation**

Distance (ft): **3.4**
Structural Grade: **0**
O&M Grade: **0**
Clock Start/From:
Clock To:
1st Value:
2nd Value:
Value Percent:
Step: **NO**
Remarks: **UNDERSIDE OF FRAME**

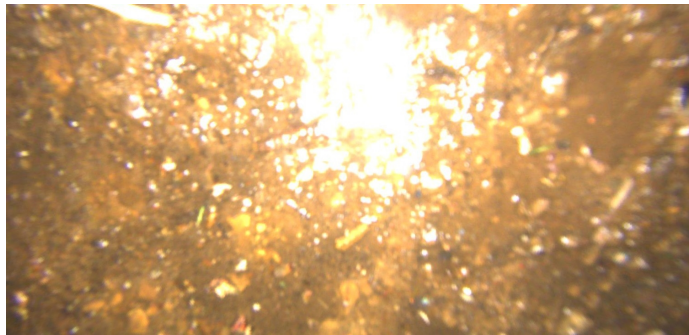
Code: **MGO**
Description: **General Observation**

Distance (ft): **6.1**
Structural Grade: **0**
O&M Grade: **0**
Clock Start/From:
Clock To:
1st Value:
2nd Value:
Value Percent:
Step: **NO**
Remarks: **END SURVEY**
