Manhole Inspection Report

Date:	04/30/2018	Weather:		Coding:	RZMACP
MH#:	M-505-036	Owner:	NA	Len. Surveyed:	8.7
P.O.#:		Surveyor:	Jen Costello	Rim to Invert:	9.8
Customer:		Cert. #:	U-907-5518	Wall Material:	Brick

Street:	California St. 286' South of 2nd St.	Project:	Hobart, IN
City:	Hobart, IN	GPS Northing:	2901507.474
Location:		GPS Easting:	2901507.474
Drain Area:	West	GPS Accuracy:	Sub-Meter
Cover Shape:	Circular	Evidence of Surcharge:	No
Cover Size:	22.5	Potential for Runoff:	None
Comments:

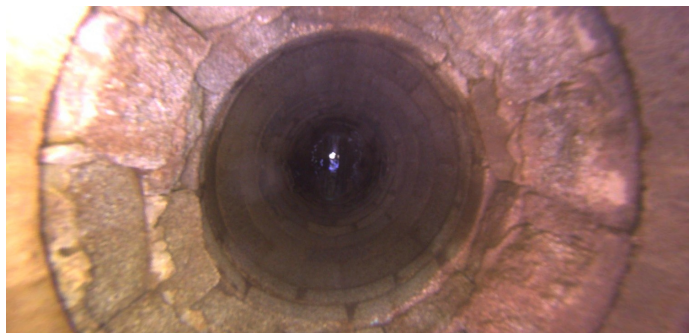
Code: **MGP**
Description: **General Photo**

Distance (ft): **.0**
Structural Grade: **0**
O&M Grade: **0**
Clock Start/From:
Clock To:
1st Value:
2nd Value:
Value Percent:
Step: **NO**
Remarks: **ACCESS MH**

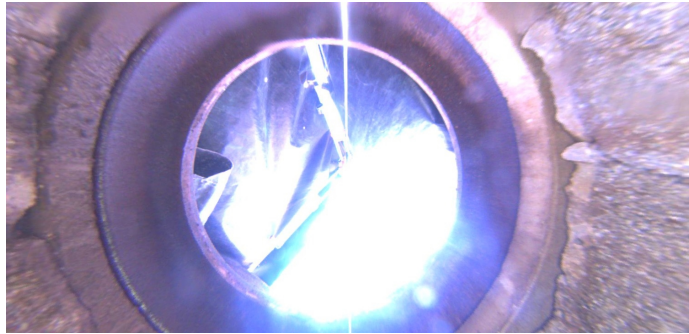
Code:	MGO
Description:	General Observation
Distance (ft):	1.6
Structural Grade:	0
O&M Grade:	0
Clock Start/From:	
Clock To:	
1st Value:	
2nd Value:	
Value Percent:	
Step:	NO
Remarks:	UNDERSIDE OF FRAME

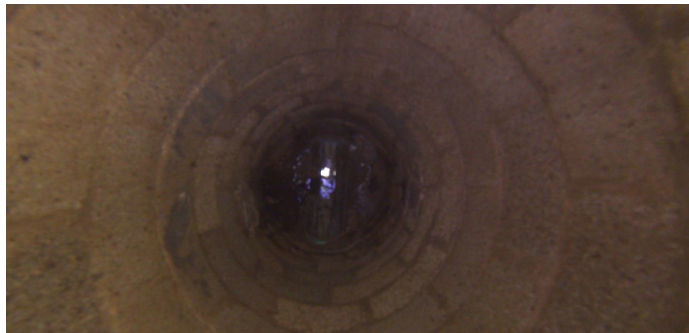
Code:	SAV
Description:	Surface Aggregate Visible
Distance (ft):	1.6
Structural Grade:	3
O&M Grade:	0
Clock Start/From:	12
Clock To:	12
1st Value:	
2nd Value:	
Value Percent:	
Step:	NO
Remarks:

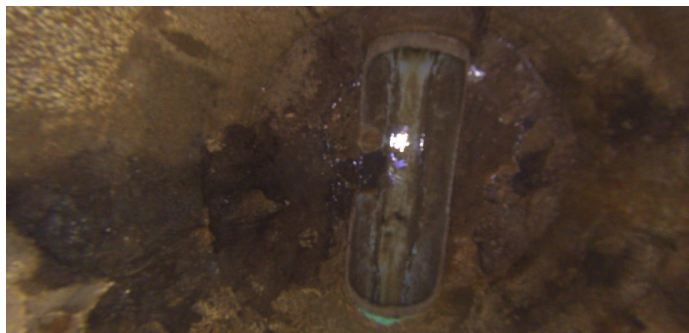
Code:	IW
Description:	Infil Weeper
Distance (ft):	6.1
Structural Grade:	0
O&M Grade:	2
Clock Start/From:	7
Clock To:	9
1st Value:	
2nd Value:	
Value Percent:	
Step:	NO
Remarks:

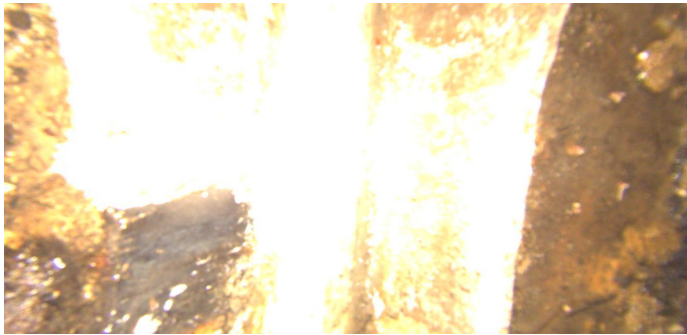
Code: **MGO**
Description: **General Observation**

Distance (ft): **8.7**

Structural Grade: **0**

O&M Grade: **0**

Remarks: **END SURVEY**
