Manhole Inspection Report

Date:	05/14/2018	Weather:		Coding:	RZMACP
MH#:	M-505-040	Owner:	NA	Len. Surveyed:	8.0
P.O.#:		Surveyor:	Jen Costello	Rim to Invert:	8.7
Customer:		Cert. #:	U-907-5518	Wall Material:	Concrete (reinforced)

Street:	2nd St. and Virginia St. to the East.	Project:	Hobart, IN
City:	Hobart, IN	GPS Northing:	41.53541565
Location:		GPS Easting:	-87.27172852
Drain Area:	West	GPS Accuracy:	Nearest Meter
Cover Shape:	Circular	Evidence of Surcharge:	No
Cover Size:	22.5	Potential for Runoff:	None
Comments:

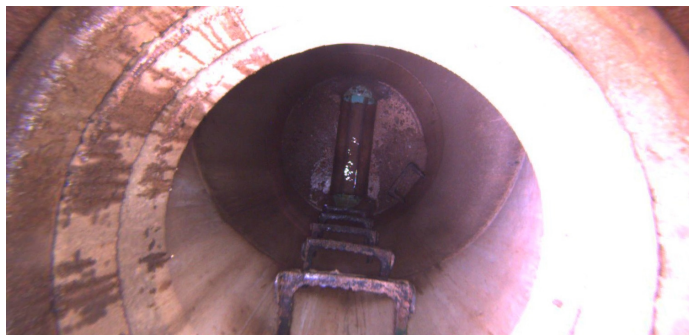
Code: **MGO**
Description: **General Observation**

Distance (ft): **.0**
Structural Grade: **0**
O&M Grade: **0**
Clock Start/From:
Clock To:
1st Value:
2nd Value:
Value Percent:
Step: **NO**
Remarks: **access mh**

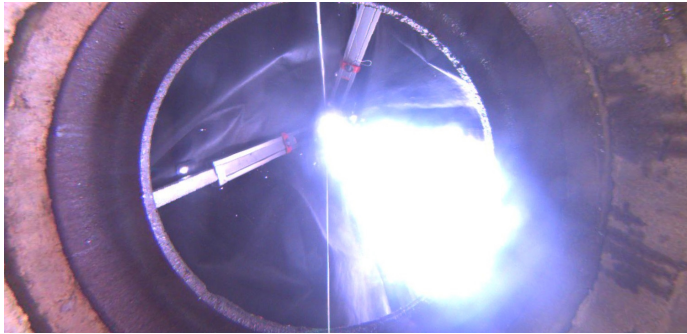
Code: **MGO**
Description: **General Observation**

Distance (ft): **2.0**
Structural Grade: **0**
O&M Grade: **0**
Clock Start/From:
Clock To:
1st Value:
2nd Value:
Value Percent:
Step: **NO**
Remarks: **underside of frame**

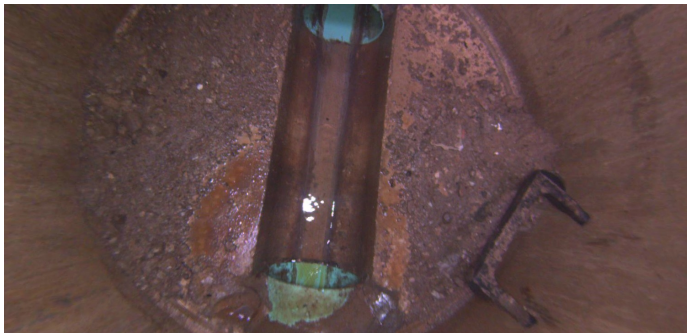
Code: **DSF**
Description: **Deposits Settled Fine**

Distance (ft): **5.6**
Structural Grade: **0**
O&M Grade: **2**
Clock Start/From: **12**
Clock To: **12**
1st Value:
2nd Value:
Value Percent: **5.000**
Step: **NO**
Remarks:

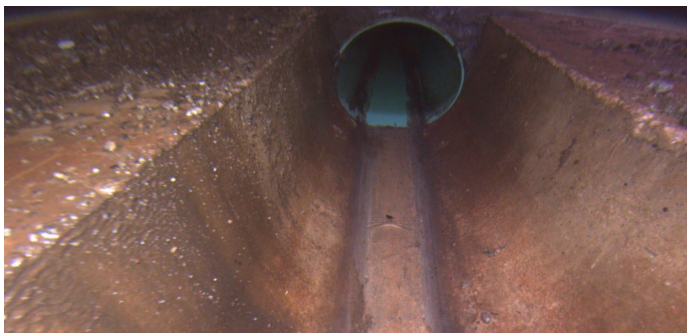
Code: **MGO**
Description: **General Observation**

Distance (ft): **8.0**
Structural Grade: **0**
O&M Grade: **0**
Clock Start/From:
Clock To:
1st Value:
2nd Value:
Value Percent:
Step: **NO**
Remarks: **end survey**
