Manhole Inspection Report

Date:	05/01/2018	Weather:		Coding:	RZMACP
MH#:	M-505-041	Owner:	NA	Len. Surveyed:	5.6
P.O.#:		Surveyor:	Jen Costello	Rim to Invert:	6.2
Customer:		Cert. #:	U-907-5518	Wall Material:	Concrete (reinforced)

Street:	Virginia St. 558' South of 2nd St.	Project:	Hobart, IN
City:	Hobart, IN	GPS Northing:	41.53302765
Location:		GPS Easting:	-87.27170563
Drain Area:	West	GPS Accuracy:	Nearest Meter
Cover Shape:	Circular	Evidence of Surcharge:	No
Cover Size:	22.5	Potential for Runoff:	None
Comments:

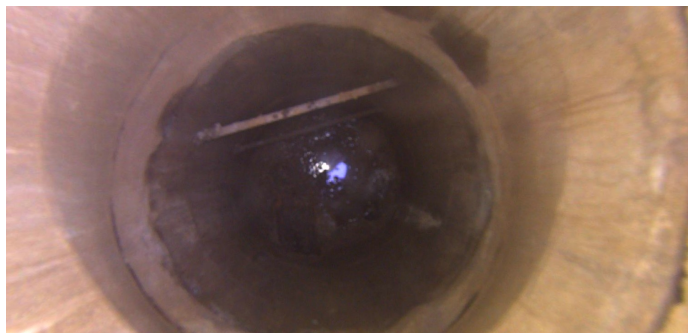
Code:	MGP
Description:	General Photo
Distance (ft):	.0
Structural Grade:	0
O&M Grade:	0
Clock Start/From:	
Clock To:	
1st Value:	
2nd Value:	
Value Percent:	
Step:	NO
Remarks:	ACCESS MH

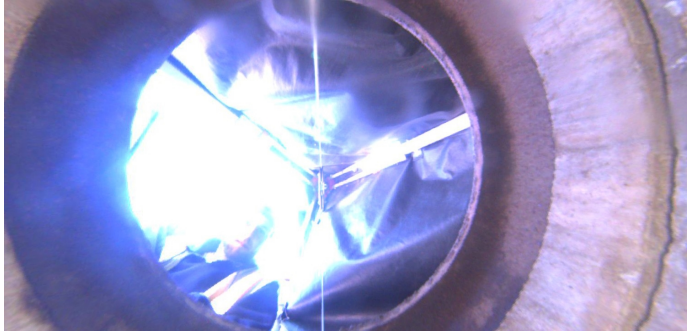
Code:	MGO
Description:	General Observation
Distance (ft):	1.6
Structural Grade:	0
O&M Grade:	0
Clock Start/From:	
Clock To:	
1st Value:	
2nd Value:	
Value Percent:	
Step:	NO
Remarks:	UNDERSIDE OF FRAME

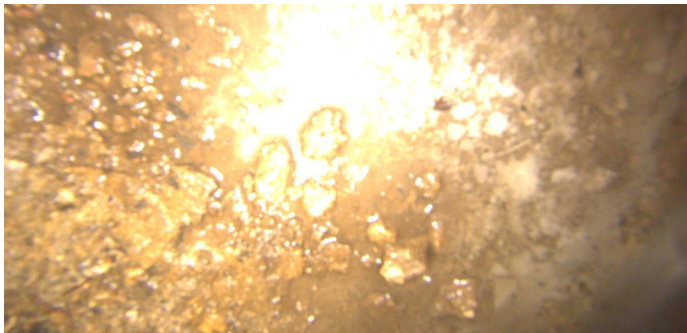
Code:	DSGV
Description:	Deposits Settled Gravel
Distance (ft):	5.6
Structural Grade:	0
O&M Grade:	2
Clock Start/From:	12
Clock To:	12
1st Value:	
2nd Value:	
Value Percent:	5.000
Step:	NO
Remarks:
