Manhole Inspection Report

Date:	05/14/2018	Weather:		Coding:	RZMACP
MH#:	M-505-043	Owner:	NA	Len. Surveyed:	12.2
P.O.#:		Surveyor:	Jen Costello	Rim to Invert:	13.8
Customer:		Cert. #:	U-907-5518	Wall Material:	Concrete (reinforced)

Street:	Intersection of Virginia St. and 2nd S	Project:	Hobart, IN
City:	Hobart, IN	GPS Northing:	41.53455734
Location:		GPS Easting:	-87.27170563
Drain Area:	West	GPS Accuracy:	Nearest Meter
Cover Shape:	Circular	Evidence of Surcharge:	No
Cover Size:	22.5	Potential for Runoff:	None
Comments:

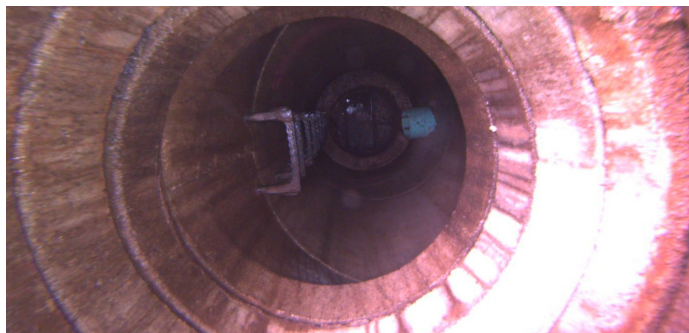
Code: **MGO**
 Description: **General Observation**

Distance (ft): **.0**
 Structural Grade: **0**
 O&M Grade: **0**
 Clock Start/From:
 Clock To:
 1st Value:
 2nd Value:
 Value Percent:
 Step: **NO**
 Remarks: **access mh**

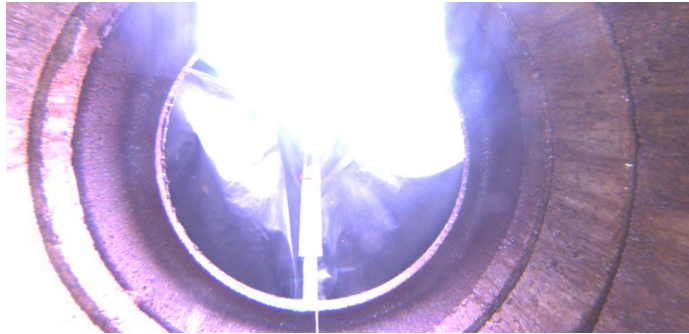
Code:	MGO
Description:	General Observation
Distance (ft):	2.2
Structural Grade:	0
O&M Grade:	0
Clock Start/From:	
Clock To:	
1st Value:	
2nd Value:	
Value Percent:	
Step:	NO
Remarks:	underside of frame

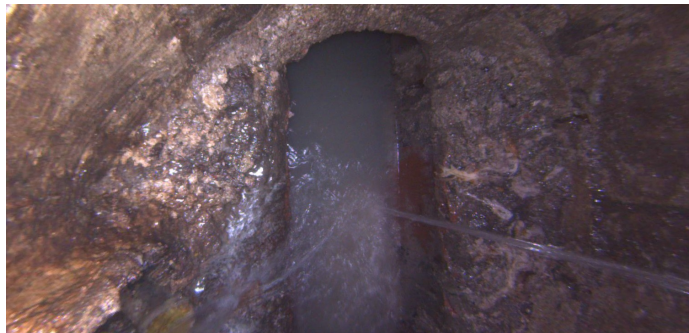
Code:	DAGS
Description:	Deposits Attached Grease
Distance (ft):	12.2
Structural Grade:	0
O&M Grade:	2
Clock Start/From:	12
Clock To:	12
1st Value:	
2nd Value:	
Value Percent:	5.000
Step:	NO
Remarks:

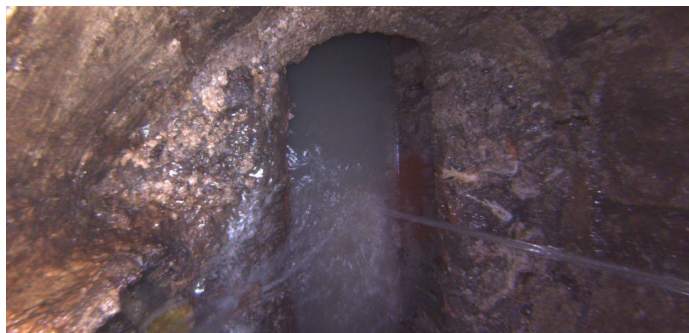
Code:	MGO
Description:	General Observation
Distance (ft):	12.2
Structural Grade:	0
O&M Grade:	0
Clock Start/From:	
Clock To:	
1st Value:	
2nd Value:	
Value Percent:	
Step:	NO
Remarks:	end survey
