Manhole Inspection Report

Date:	05/14/2018	Weather:		Coding:	RZMACP
MH#:	M-505-045	Owner:	NA	Len. Surveyed:	7.7
P.O.#:		Surveyor:	Jen Costello	Rim to Invert:	8.4
Customer:		Cert. #:	U-907-5518	Wall Material:	Concrete (reinforced)

Street:	Virginia St. 62' South of Cleveland A	Project:	Hobart, IN
City:	Hobart, IN	GPS Northing:	41.53620148
Location:		GPS Easting:	-87.27176666
Drain Area:	West	GPS Accuracy:	Nearest Meter
Cover Shape:	Circular	Evidence of Surcharge:	No
Cover Size:	22.5	Potential for Runoff:	None
Comments:

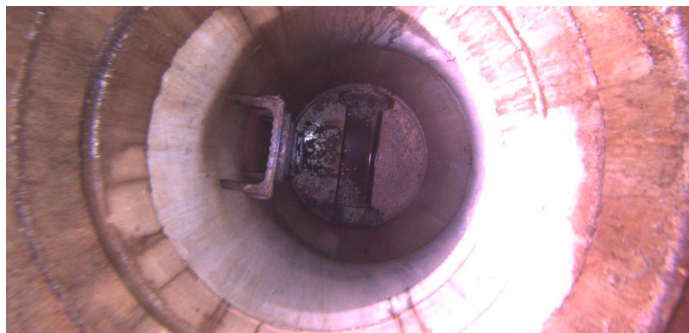
Code: **MGO**
Description: **General Observation**

Distance (ft): **.0**
Structural Grade: **0**
O&M Grade: **0**
Clock Start/From:
Clock To:
1st Value:
2nd Value:
Value Percent:
Step: **NO**
Remarks: **ACCESS MH**

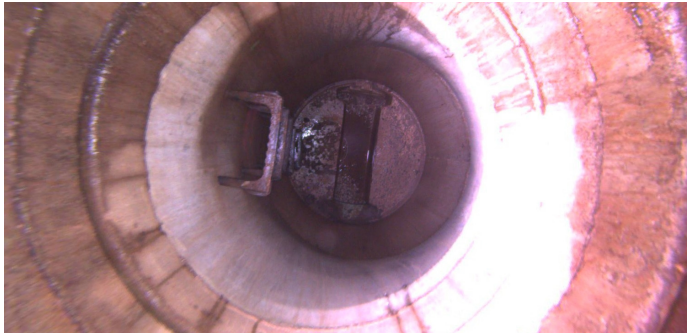
Code: **IS**
Description: **Infil Stain**

Distance (ft): **.0**
Structural Grade: **0**
O&M Grade: **0**
Clock Start/From: **12**
Clock To: **12**
1st Value:
2nd Value:
Value Percent:
Step: **NO**
Remarks:

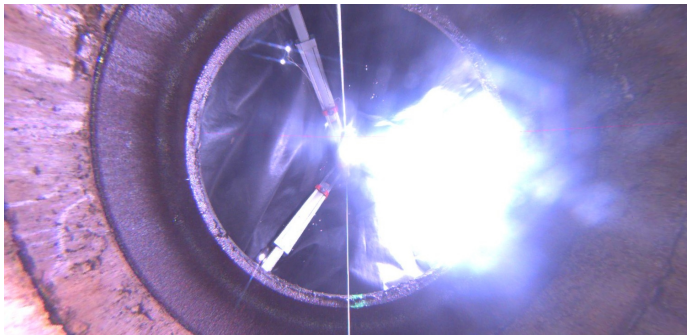
Code: **MGO**
Description: **General Observation**

Distance (ft): **1.7**
Structural Grade: **0**
O&M Grade: **0**
Clock Start/From:
Clock To:
1st Value:
2nd Value:
Value Percent:
Step: **NO**
Remarks: **UNDERSIDE OF FRAME**

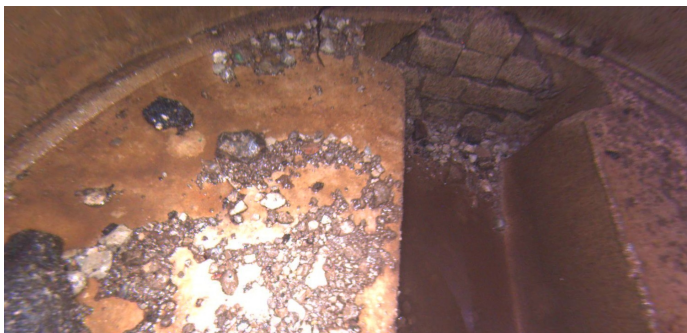
Code: **RPP**
Description: **Repair Patch**

Distance (ft): **7.2**
Structural Grade: **0**
O&M Grade: **0**
Clock Start/From: **11**
Clock To: **1**
1st Value:
2nd Value:
Value Percent:
Step: **NO**
Remarks: **BRICKS**

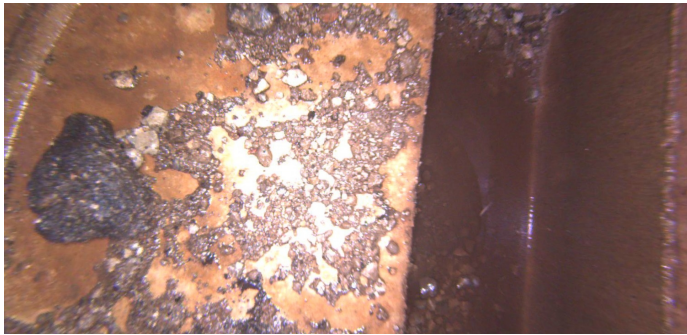
Code:	DSF
Description:	Deposits Settled Fine
Distance (ft):	7.2
Structural Grade:	0
O&M Grade:	2
Clock Start/From:	12
Clock To:	12
1st Value:	
2nd Value:	
Value Percent:	5.000
Step:	NO
Remarks:

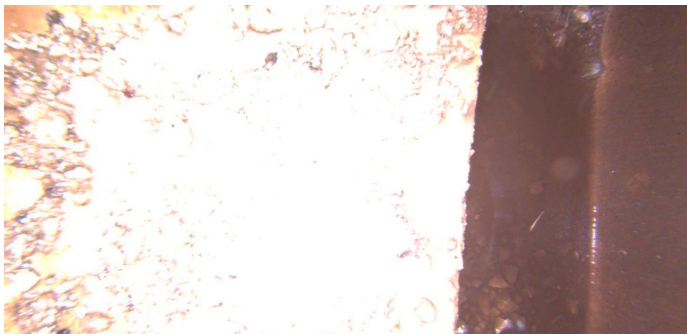
Code:	MGO
Description:	General Observation
Distance (ft):	7.7
Structural Grade:	0
O&M Grade:	0
Clock Start/From:	
Clock To:	
1st Value:	
2nd Value:	
Value Percent:	
Step:	NO
Remarks:	END SURVEY
