# Manhole Inspection Report

Date:	<b>05/14/2018</b>	Weather:		Coding:	<b>RZMACP</b>
MH#:	<b>M-505-049</b>	Owner:	<b>NA</b>	Len. Surveyed:	<b>7.4</b>
P.O.#:		Surveyor:	<b>Jen Costello</b>	Rim to Invert:	<b>13.5</b>
Customer:		Cert. #:	<b>U-907-5518</b>	Wall Material:	<b>Concrete (reinforced)</b>

Street:	<b>Intersection of Delaware St. and 2nd</b>	Project:	<b>Hobart, IN</b>
City:	<b>Hobart, IN</b>	GPS Northing:	<b>41.53464127</b>
Location:		GPS Easting:	<b>-87.27291107</b>
Drain Area:	<b>West</b>	GPS Accuracy:	<b>Nearest Meter</b>
Cover Shape:	<b>Circular</b>	Evidence of Surcharge:	<b>No</b>
Cover Size:	<b>22.5</b>	Potential for Runoff:	<b>None</b>
Comments:

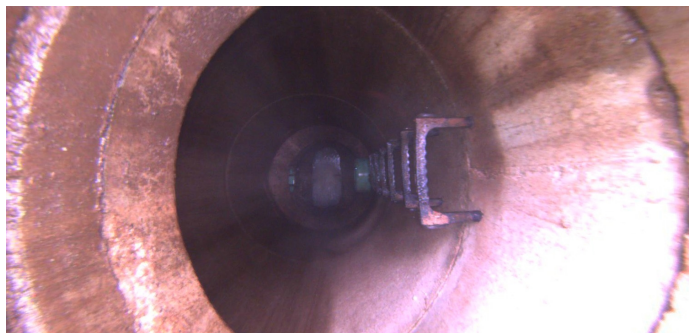
Code: **MGO**  
Description: **General Observation**

Distance (ft): **.0**  
Structural Grade: **0**  
O&M Grade: **0**  
Clock Start/From:  
Clock To:  
1st Value:  
2nd Value:  
Value Percent:  
Step: **NO**  
Remarks: **ACCESS MH**

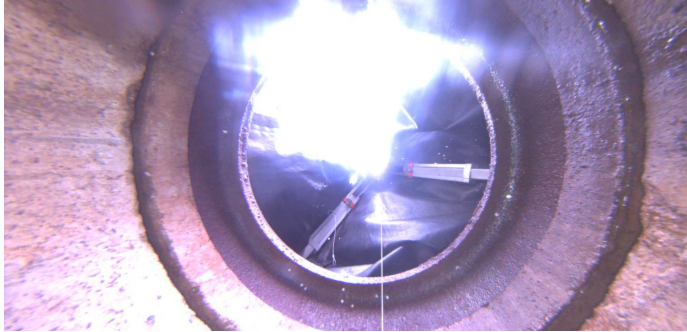
Code: **MGO**  
Description: **General Observation**

Distance (ft): **1.9**  
Structural Grade: **0**  
O&M Grade: **0**  
Clock Start/From:  
Clock To:  
1st Value:  
2nd Value:  
Value Percent:  
Step: **NO**  
Remarks: **END SURVEY**

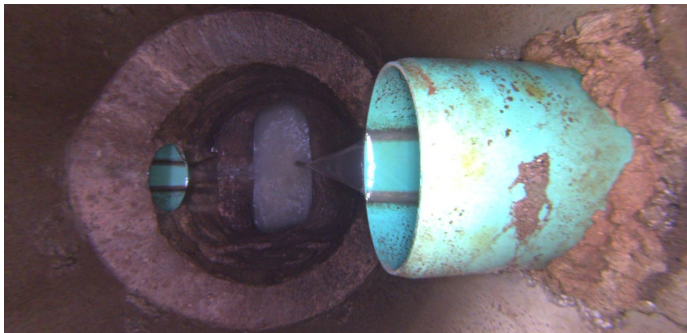
Code: **MGO**  
Description: **General Observation**

Distance (ft): **7.4**  
Structural Grade: **0**  
O&M Grade: **0**  
Clock Start/From:  
Clock To:  
1st Value:  
2nd Value:  
Value Percent:  
Step: **NO**  
Remarks: **END SURVEY**
