Manhole Inspection Report

Date:	05/14/2018	Weather:		Coding:	RZMACP
MH#:	M-505-050	Owner:	NA	Len. Surveyed:	7.3
P.O.#:		Surveyor:	Jen Costello	Rim to Invert:	8.7
Customer:		Cert. #:	U-907-5518	Wall Material:	Concrete (reinforced)

Street:	Delaware St. North of 2nd St.	Project:	Hobart, IN
City:	Hobart, IN	GPS Northing:	41.53547287
Location:		GPS Easting:	-87.2729187
Drain Area:	West	GPS Accuracy:	Nearest Meter
Cover Shape:	Circular	Evidence of Surcharge:	No
Cover Size:	22.5	Potential for Runoff:	None
Comments:

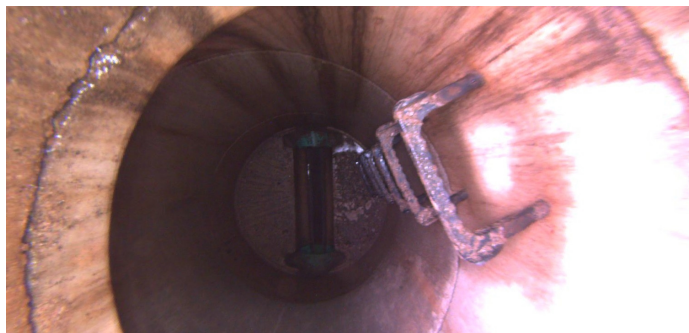
Code: **MGO**
Description: **General Observation**

Distance (ft): **.0**
Structural Grade: **0**
O&M Grade: **0**
Clock Start/From:
Clock To:
1st Value:
2nd Value:
Value Percent:
Step: **NO**
Remarks: **ACCESS MH**

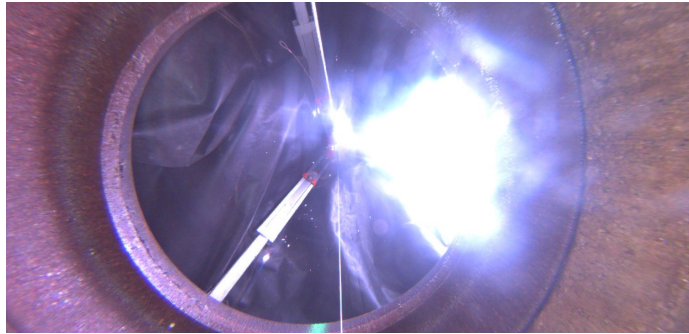
Code:	MGO
Description:	General Observation
Distance (ft):	1.3
Structural Grade:	0
O&M Grade:	0
Clock Start/From:	
Clock To:	
1st Value:	
2nd Value:	
Value Percent:	
Step:	NO
Remarks:	UNDERSIDE OF FRAME

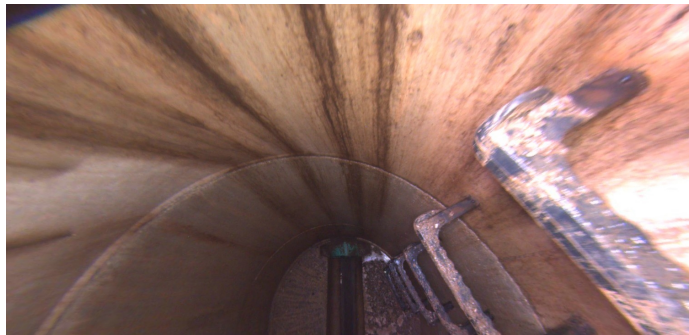
Code:	IS
Description:	Infil Stain
Distance (ft):	1.3
Structural Grade:	0
O&M Grade:	0
Clock Start/From:	10
Clock To:	3
1st Value:	
2nd Value:	
Value Percent:	
Step:	NO
Remarks:

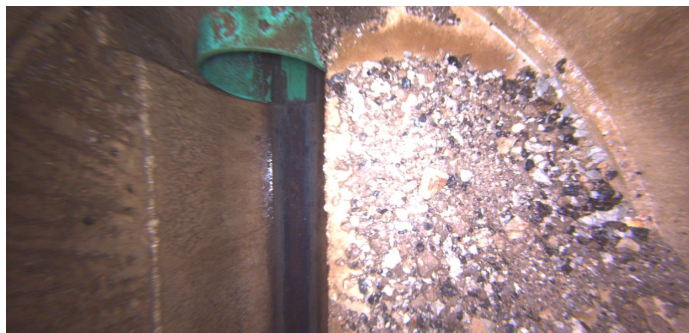
Code:	DSGV
Description:	Deposits Settled Gravel
Distance (ft):	6.8
Structural Grade:	0
O&M Grade:	2
Clock Start/From:	12
Clock To:	6
1st Value:	
2nd Value:	
Value Percent:	5.000
Step:	NO
Remarks:

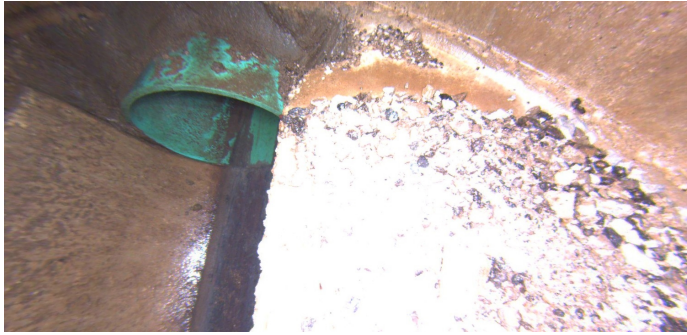
Code: **MGO**
Description: **General Observation**

Distance (ft): **7.3**
Structural Grade: **0**
O&M Grade: **0**
Clock Start/From:
Clock To:
1st Value:
2nd Value:
Value Percent:
Step: **NO**
Remarks: **END SURVEY**
