Manhole Inspection Report

Date:	05/14/2018	Weather:		Coding:	RZMACP
MH#:	M-505-051	Owner:	NA	Len. Surveyed:	8.1
P.O.#:		Surveyor:	Jen Costello	Rim to Invert:	8.6
Customer:		Cert. #:	U-907-5518	Wall Material:	Concrete (reinforced)

Street:	Delaware St. 60' South of Cleveland	Project:	Hobart, IN
City:	Hobart, IN	GPS Northing:	41.5363121
Location:		GPS Easting:	-87.27294922
Drain Area:	West	GPS Accuracy:	Nearest Meter
Cover Shape:	Circular	Evidence of Surcharge:	No
Cover Size:	22.5	Potential for Runoff:	None
Comments:

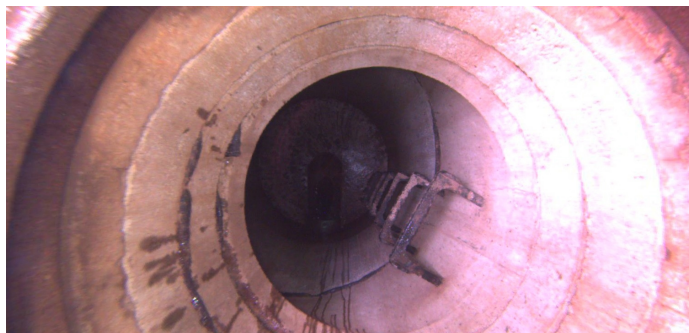
Code: **MGO**
Description: **General Observation**

Distance (ft): **.0**
Structural Grade: **0**
O&M Grade: **0**
Clock Start/From:
Clock To:
1st Value:
2nd Value:
Value Percent:
Step: **NO**
Remarks: **ACCESS MH**

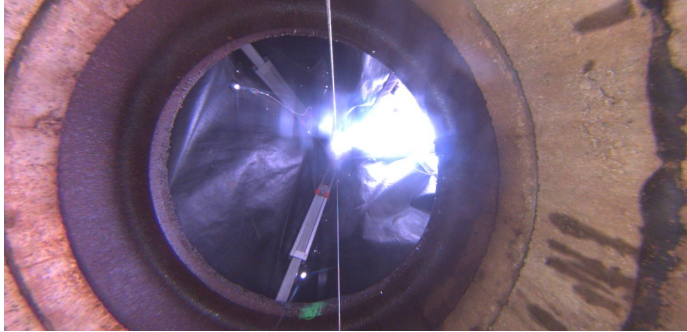
Code:	MGO
Description:	General Observation
Distance (ft):	2.0
Structural Grade:	0
O&M Grade:	0
Clock Start/From:	
Clock To:	
1st Value:	
2nd Value:	
Value Percent:	
Step:	NO
Remarks:	UNDERSIDE OF FRAME

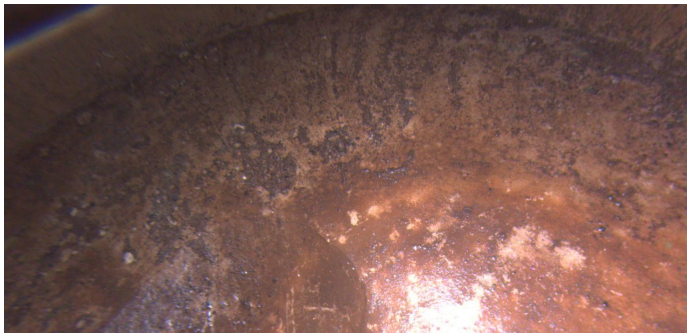
Code:	MGO
Description:	General Observation
Distance (ft):	8.1
Structural Grade:	0
O&M Grade:	0
Clock Start/From:	
Clock To:	
1st Value:	
2nd Value:	
Value Percent:	
Step:	NO
Remarks:	END SURVEY
