Manhole Inspection Report

Date:	05/01/2018	Weather:		Coding:	RZMACP
MH#:	M-505-053.1	Owner:	NA	Len. Surveyed:	3.4
P.O.#:		Surveyor:	Jen Costello	Rim to Invert:	3.4
Customer:		Cert. #:	U-907-5518	Wall Material:	Concrete (reinforced)

Street:	Colorado St. 397' South of 2nd St.	Project:	Hobart, IN
City:	Hobart, IN	GPS Northing:	41.53353119
Location:		GPS Easting:	-87.27409363
Drain Area:	West	GPS Accuracy:	Nearest Meter
Cover Shape:	Circular	Evidence of Surcharge:	No
Cover Size:	22.5	Potential for Runoff:	None
Comments:

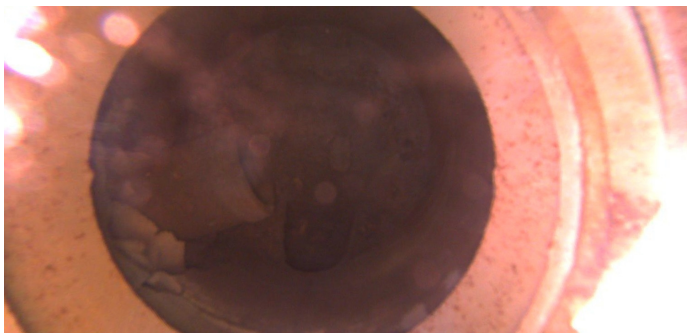
Code: **MGO**
Description: **General Observation**

Distance (ft): **.0**
Structural Grade: **0**
O&M Grade: **0**
Clock Start/From:
Clock To:
1st Value:
2nd Value:
Value Percent:
Step: **NO**
Remarks: **ACCESS MH**

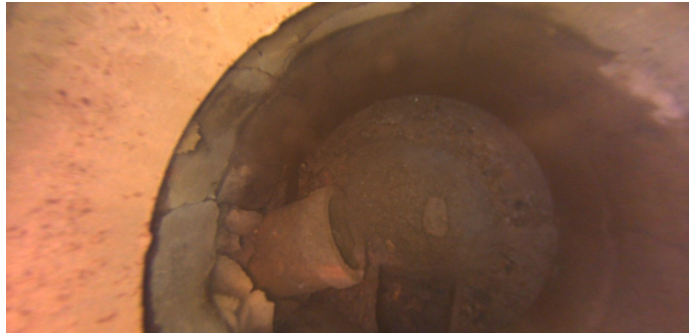
Code: **FM**
Description: **Fracture Multiple**

Distance (ft): **.9**
Structural Grade: **4**
O&M Grade: **0**
Clock Start/From: **8**
Clock To: **12**
1st Value:
2nd Value:
Value Percent:
Step: **NO**
Remarks:

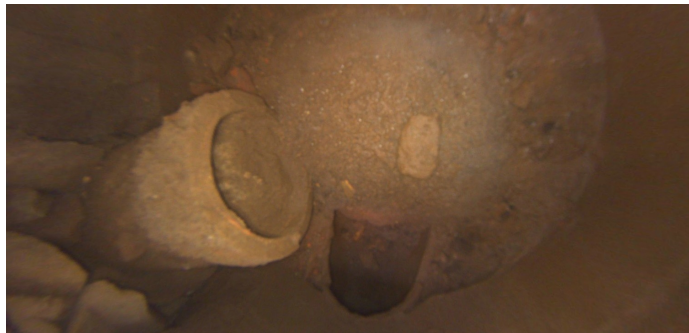
Code: **B**
Description: **Broken**

Distance (ft): **2.0**
Structural Grade: **4**
O&M Grade: **0**
Clock Start/From: **8**
Clock To: **9**
1st Value:
2nd Value:
Value Percent:
Step: **NO**
Remarks:

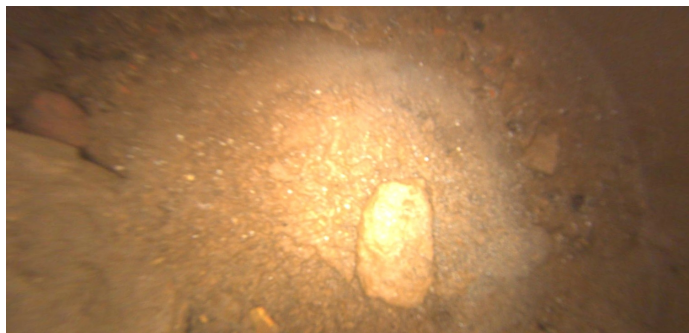
Code: **DSF**
Description: **Deposits Settled Fine**

Distance (ft): **2.8**
Structural Grade: **0**
O&M Grade: **2**
Clock Start/From: **12**
Clock To: **12**
1st Value:
2nd Value:
Value Percent: **5.000**
Step: **NO**
Remarks:

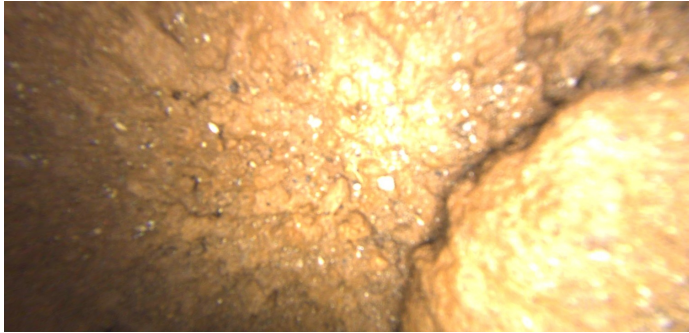
Code:	MGO
Description:	General Observation
Distance (ft):	3.4
Structural Grade:	0
O&M Grade:	0
Clock Start/From:	
Clock To:	
1st Value:	
2nd Value:	
Value Percent:	
Step:	NO
Remarks:	END SURVEY
