Manhole Inspection Report

Date:	05/13/2018	Weather:		Coding:	RZMACP
MH#:	M-505-063	Owner:	NA	Len. Surveyed:	8.7
P.O.#:		Surveyor:	Jen Costello	Rim to Invert:	8.7
Customer:		Cert. #:	U-907-5518	Wall Material:	Brick

Street:	1st Pl. 261' West of Colorado St.	Project:	Hobart, IN
City:	Hobart, IN	GPS Northing:	41.53551865
Location:		GPS Easting:	-87.27511597
Drain Area:	West	GPS Accuracy:	Nearest Meter
Cover Shape:	Circular	Evidence of Surcharge:	No
Cover Size:	22.5	Potential for Runoff:	None
Comments:

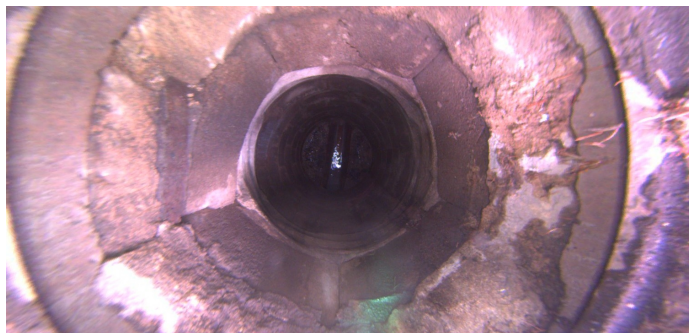
Code: **MGO**
Description: **General Observation**

Distance (ft): **.0**
Structural Grade: **0**
O&M Grade: **0**
Clock Start/From:
Clock To:
1st Value:
2nd Value:
Value Percent:
Step: **NO**
Remarks: **ACCESS MH**

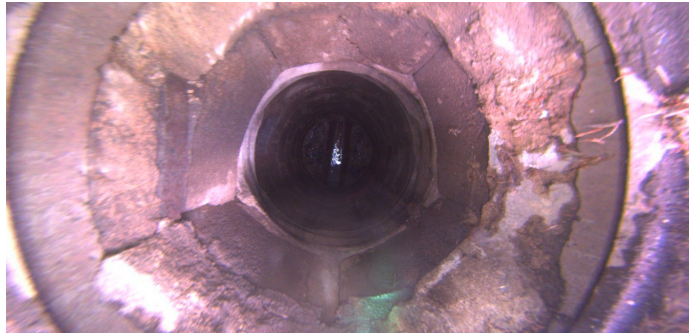
Code:	DAE
Description:	Deposits Attached Encrustation
Distance (ft):	.0
Structural Grade:	0
O&M Grade:	2
Clock Start/From:	12
Clock To:	12
1st Value:	
2nd Value:	
Value Percent:	10.000
Step:	NO
Remarks:

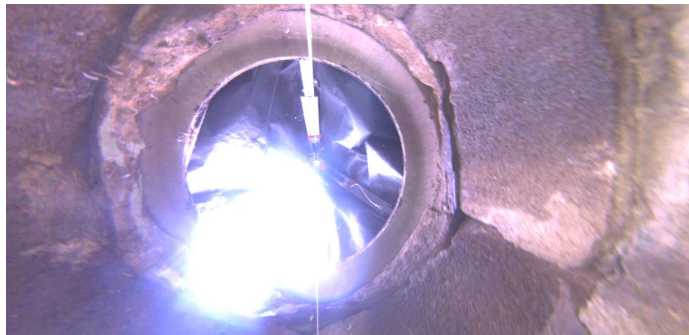
Code:	MGO
Description:	General Observation
Distance (ft):	2.2
Structural Grade:	0
O&M Grade:	0
Clock Start/From:	
Clock To:	
1st Value:	
2nd Value:	
Value Percent:	
Step:	NO
Remarks:	UNDERSIDE OF FRAME

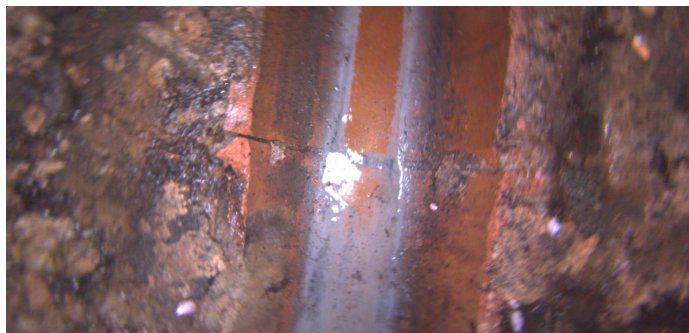
Code:	DSGV
Description:	Deposits Settled Gravel
Distance (ft):	7.7
Structural Grade:	0
O&M Grade:	2
Clock Start/From:	2
Clock To:	12
1st Value:	
2nd Value:	
Value Percent:	5.000
Step:	NO
Remarks:

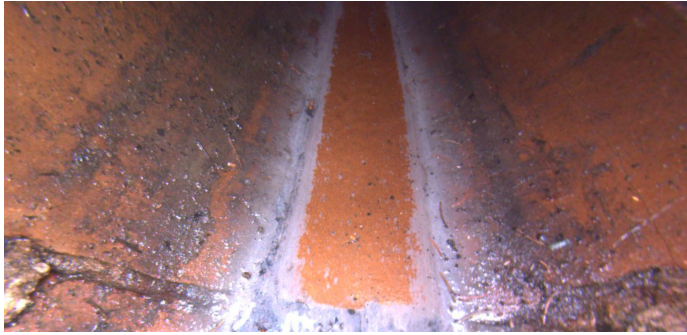
Code:	MGO
Description:	General Observation
Distance (ft):	8.7
Structural Grade:	0
O&M Grade:	0
Clock Start/From:	
Clock To:	
1st Value:	
2nd Value:	
Value Percent:	
Step:	NO
Remarks:	END SURVEY
