Manhole Inspection Report

Date:	05/13/2018	Weather:		Coding:	RZMACP
MH#:	M-505-064	Owner:	NA	Len. Surveyed:	8.1
P.O.#:		Surveyor:	Jen Costello	Rim to Invert:	8.2
Customer:		Cert. #:	U-907-5518	Wall Material:	Brick

Street:	1st Pl. 565' East of Wilson St.	Project:	Hobart, IN
City:	Hobart, IN	GPS Northing:	41.53557205
Location:		GPS Easting:	-87.27619934
Drain Area:	West	GPS Accuracy:	Nearest Meter
Cover Shape:	Circular	Evidence of Surcharge:	No
Cover Size:	22.5	Potential for Runoff:	None
Comments:

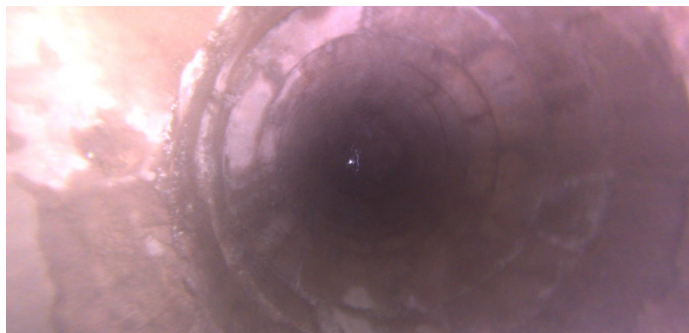
Code: **MGO**
Description: **General Observation**

Distance (ft): **.0**
Structural Grade: **0**
O&M Grade: **0**
Clock Start/From:
Clock To:
1st Value:
2nd Value:
Value Percent:
Step: **NO**
Remarks: **ACCESS MH**

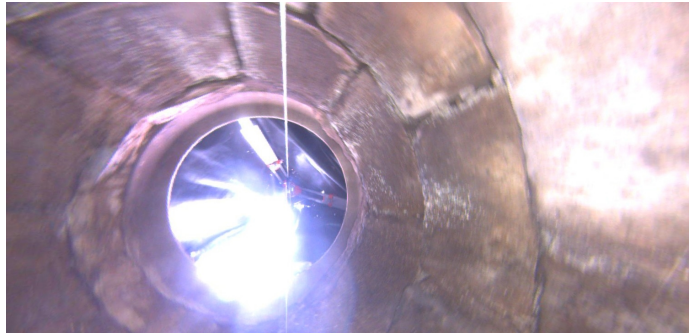
Code:	MGO
Description:	General Observation
Distance (ft):	3.0
Structural Grade:	0
O&M Grade:	0
Clock Start/From:	
Clock To:	
1st Value:	
2nd Value:	
Value Percent:	
Step:	NO
Remarks:	UNDERSIDE OF FRAME

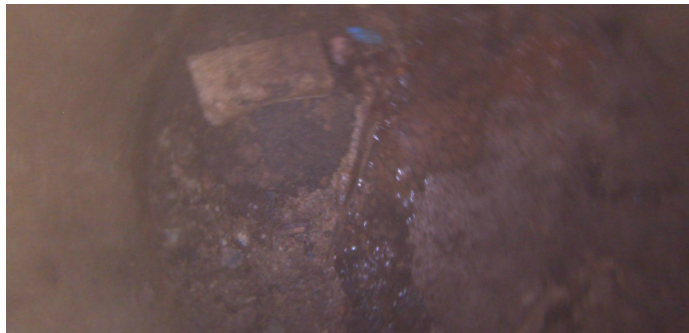
Code:	OBR
Description:	Obstacle Rocks
Distance (ft):	6.8
Structural Grade:	0
O&M Grade:	2
Clock Start/From:	10
Clock To:	
1st Value:	
2nd Value:	
Value Percent:	5.000
Step:	NO
Remarks:

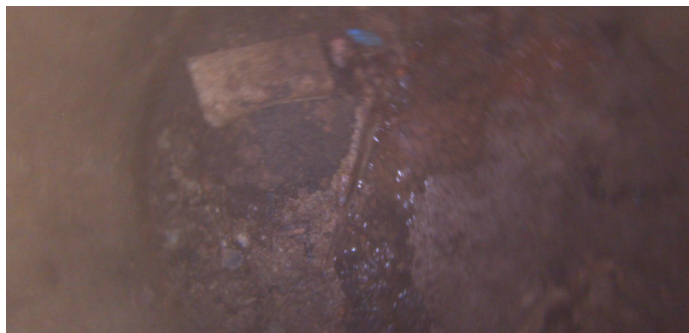
Code:	DSF
Description:	Deposits Settled Fine
Distance (ft):	6.8
Structural Grade:	0
O&M Grade:	2
Clock Start/From:	12
Clock To:	12
1st Value:	
2nd Value:	
Value Percent:	5.000
Step:	NO
Remarks:

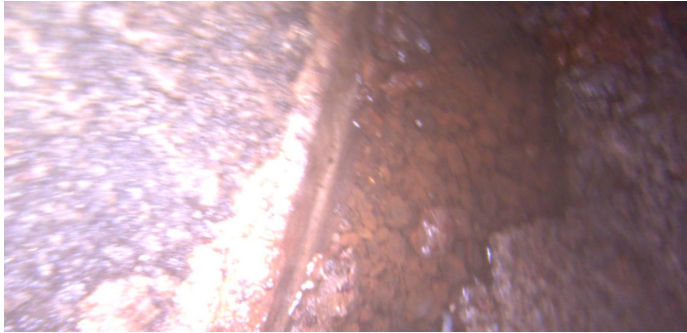
Code: **MGO**
Description: **General Observation**

Distance (ft): **8.1**

Remarks: **END SURVEY**
