# Manhole Inspection Report

Date:	<b>05/13/2018</b>	Weather:		Coding:	<b>RZMACP</b>
MH#:	<b>M-505-068</b>	Owner:	<b>NA</b>	Len. Surveyed:	<b>4.9</b>
P.O.#:		Surveyor:	<b>Jen Costello</b>	Rim to Invert:	<b>5.5</b>
Customer:		Cert. #:	<b>U-907-5518</b>	Wall Material:	<b>Brick</b>

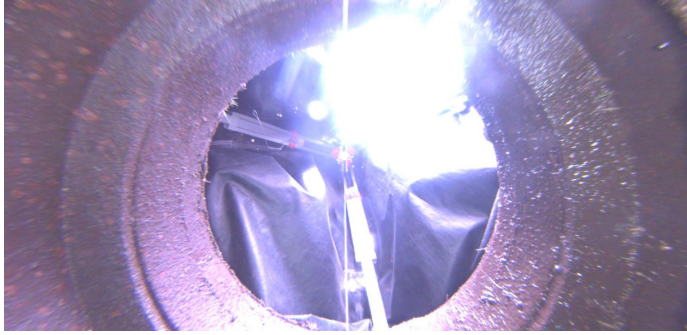
Code: **MGO**  
Description: **General Observation**

Distance (ft): **1.9**  
Structural Grade: **0**  
O&M Grade: **0**  
Clock Start/From:  
Clock To:  
1st Value:  
2nd Value:  
Value Percent:  
Step: **NO**  
Remarks: **UNDERSIDE OF FRAME**

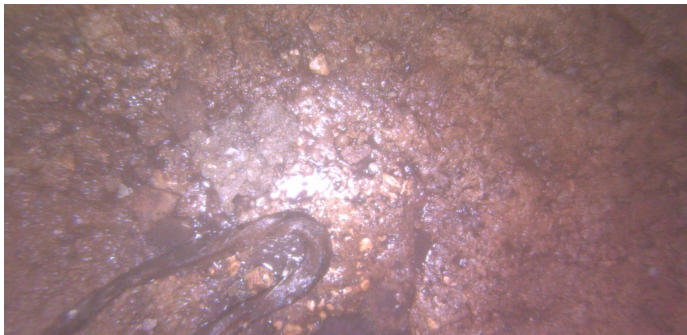
Code: **MGO**  
Description: **General Observation**

Distance (ft): **4.9**  
Structural Grade: **0**  
O&M Grade: **0**  
Clock Start/From:  
Clock To:  
1st Value:  
2nd Value:  
Value Percent:  
Step: **NO**  
Remarks: **END SURVEY**
