Manhole Inspection Report

Date:	05/13/2018	Weather:		Coding:	RZMACP
MH#:	M-505-070	Owner:	NA	Len. Surveyed:	9.1
P.O.#:		Surveyor:	Jen Costello	Rim to Invert:	9.4
Customer:		Cert. #:	U-907-5518	Wall Material:	Brick

Street:	Wilson St. 169' South of Cleveland A	Project:	Hobart, IN
City:	Hobart, IN	GPS Northing:	41.53598022
Location:		GPS Easting:	-87.27824402
Drain Area:	West	GPS Accuracy:	Nearest Meter
Cover Shape:	Circular	Evidence of Surcharge:	No
Cover Size:	22.5	Potential for Runoff:	None
Comments:

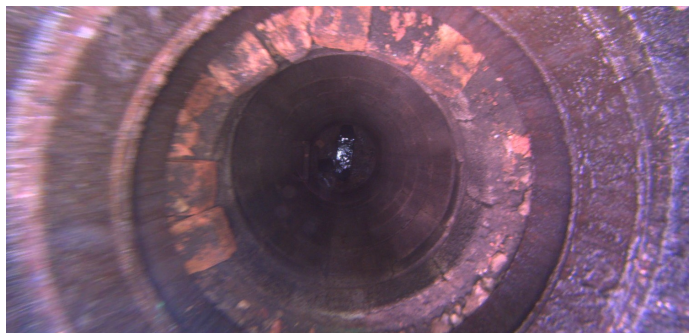
Code: **MGO**
Description: **General Observation**

Distance (ft): **.0**
Structural Grade: **0**
O&M Grade: **0**
Clock Start/From:
Clock To:
1st Value:
2nd Value:
Value Percent:
Step: **NO**
Remarks: **ACCESS MH**

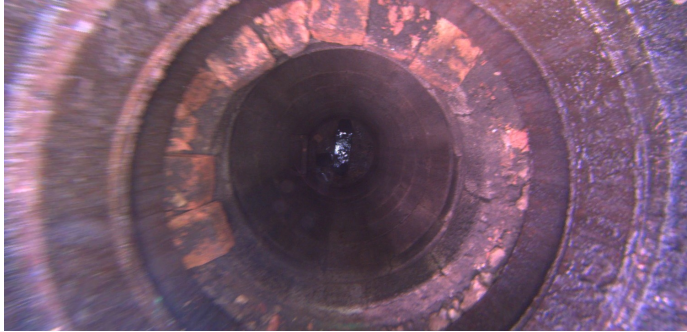
Code: **DB**
Description: **Displaced Brick**

Distance (ft): **.0**
Structural Grade: **3**
O&M Grade: **0**
Clock Start/From: **8**
Clock To: **9**
1st Value:
2nd Value:
Value Percent:
Step: **NO**
Remarks:

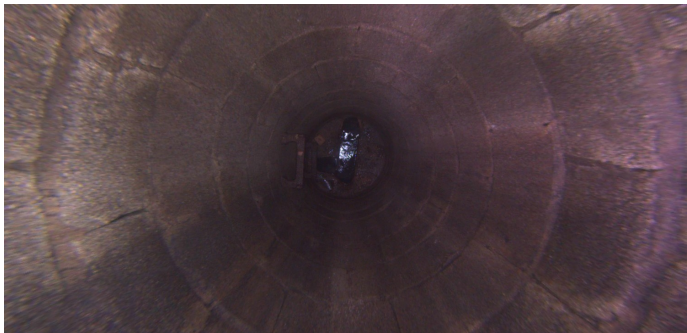
Code: **SAV**
Description: **Surface Aggregate Visible**

Distance (ft): **1.3**
Structural Grade: **3**
O&M Grade: **0**
Clock Start/From: **12**
Clock To: **12**
1st Value:
2nd Value:
Value Percent:
Step: **NO**
Remarks:

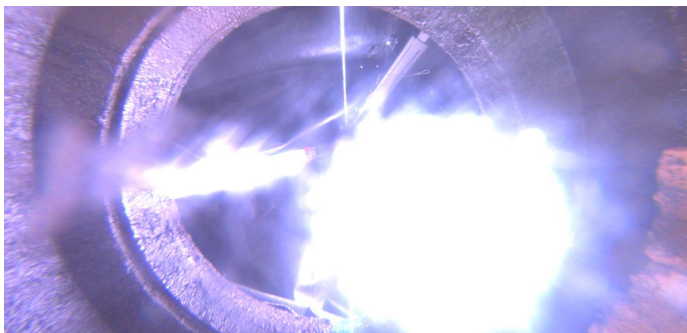
Code: **MGO**
Description: **General Observation**

Distance (ft): **1.7**
Structural Grade: **0**
O&M Grade: **0**
Clock Start/From:
Clock To:
1st Value:
2nd Value:
Value Percent:
Step: **NO**
Remarks: **UNDERSIDE OF FRAME**

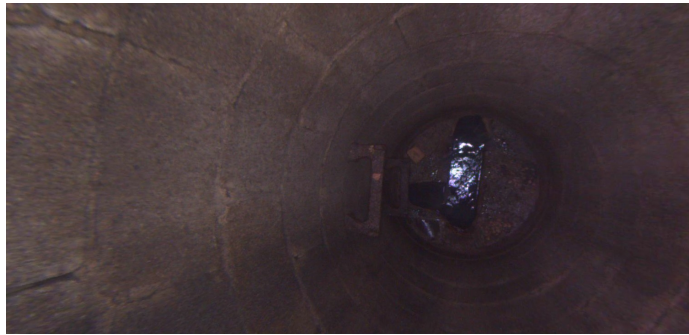
Code: **MGO**
Description: **General Observation**

Distance (ft): **2.1**
Structural Grade: **0**
O&M Grade: **0**
Clock Start/From:
Clock To:
1st Value:
2nd Value:
Value Percent:
Step: **NO**
Remarks: **MISSING AND BROKEN STEPS**

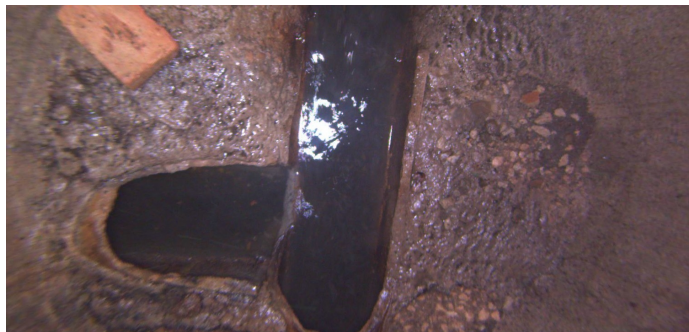
Code: **DSGV**
Description: **Deposits Settled Gravel**

Distance (ft): **7.6**
Structural Grade: **0**
O&M Grade: **2**
Clock Start/From: **12**
Clock To: **12**
1st Value:
2nd Value:
Value Percent: **5.000**
Step: **NO**
Remarks:

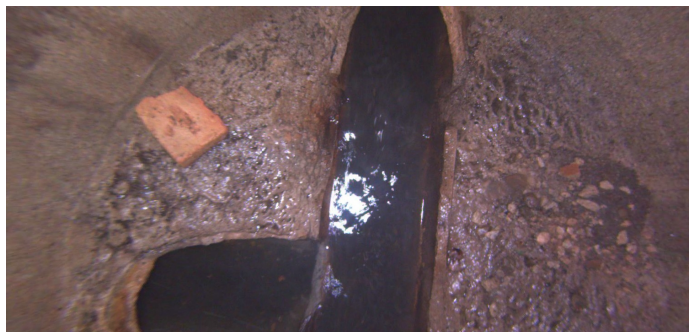
Code: **OBR**
Description: **Obstacle Rocks**

Distance (ft): **7.6**
Structural Grade: **0**
O&M Grade: **2**
Clock Start/From: **10**
Clock To:
1st Value:
2nd Value:
Value Percent: **5.000**
Step: **NO**
Remarks:

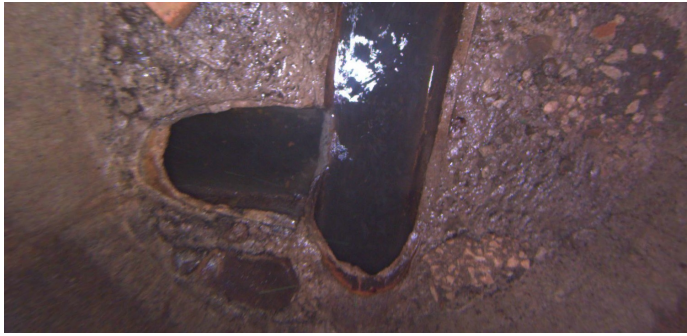
Code: **OBM**
Description: **Obstacle Pipe Material**

Distance (ft): **7.6**
Structural Grade: **0**
O&M Grade: **2**
Clock Start/From: **6**
Clock To: **7**
1st Value:
2nd Value:
Value Percent: **5.000**
Step: **NO**
Remarks:

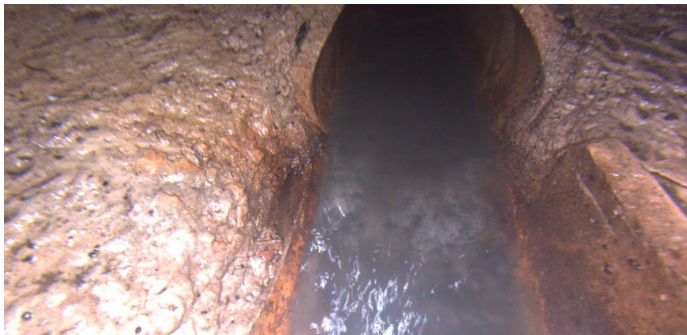
Code: **MGO**
Description: **General Observation**

Distance (ft): **8.9**
Structural Grade: **0**
O&M Grade: **0**
Clock Start/From:
Clock To:
1st Value:
2nd Value:
Value Percent:
Step: **NO**
Remarks: **END SURVEY**

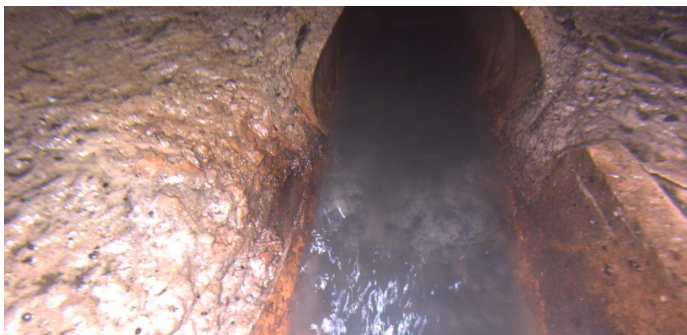
Code: **SAV**
Description: **Surface Aggregate Visible**

Distance (ft): **8.9**
Structural Grade: **3**
O&M Grade: **0**
Clock Start/From: **12**
Clock To: **12**
1st Value:
2nd Value:
Value Percent:
Step: **NO**
Remarks:
