# Manhole Inspection Report

Date:	<b>04/28/2018</b>	Weather:		Coding:	<b>RZMACP</b>
MH#:	<b>M-505-078</b>	Owner:	<b>NA</b>	Len. Surveyed:	<b>4.6</b>
P.O.#:		Surveyor:	<b>Jen Costello</b>	Rim to Invert:	<b>5.1</b>
Customer:		Cert. #:	<b>U-907-5518</b>	Wall Material:	<b>Concrete (reinforced)</b>

Street:	<b>4th Pl. and 4th St. to the Middle We</b>	Project:	<b>Hobart, IN</b>
City:	<b>Hobart, IN</b>	GPS Northing:	<b>2900478.058</b>
Location:		GPS Easting:	<b>2900478.058</b>
Drain Area:	<b>West</b>	GPS Accuracy:	<b>Sub-Meter</b>
Cover Shape:	<b>Circular</b>	Evidence of Surcharge:	<b>No</b>
Cover Size:	<b>22.5</b>	Potential for Runoff:	<b>None</b>
Comments:

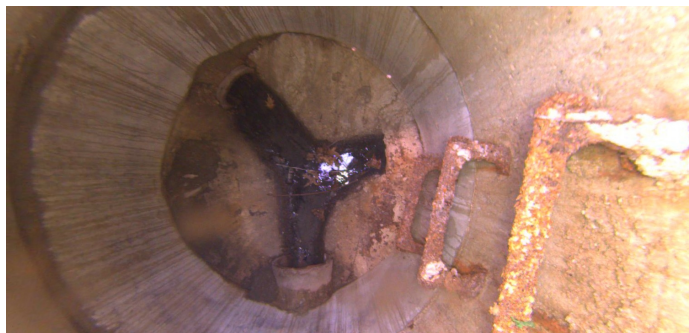
Code: **MGO**  
Description: **General Observation**

Distance (ft): **.0**  
Structural Grade: **0**  
O&M Grade: **0**  
Clock Start/From:  
Clock To:  
1st Value:  
2nd Value:  
Value Percent:  
Step: **NO**  
Remarks: **ACCESS MH**

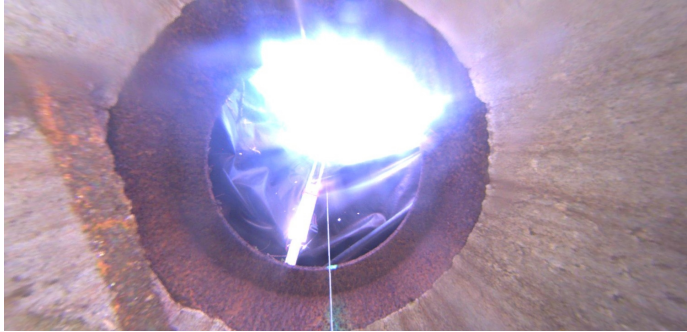
Code:	<b>MGP</b>
Description:	<b>General Photo</b>
Distance (ft):	<b>1.8</b>
Structural Grade:	<b>0</b>
O&M Grade:	<b>0</b>
Clock Start/From:	
Clock To:	
1st Value:	
2nd Value:	
Value Percent:	
Step:	<b>NO</b>
Remarks:	<b>UNDERSIDE OF FRAME</b>

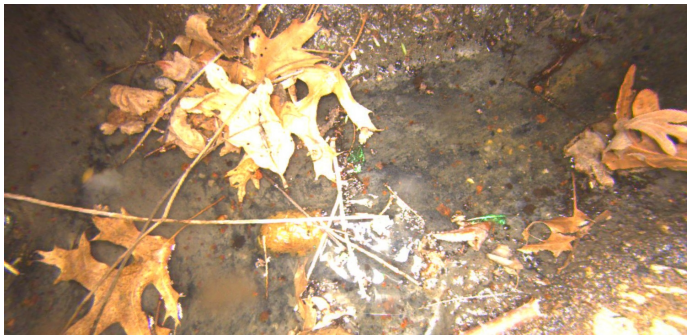
Code:	<b>MGO</b>
Description:	<b>General Observation</b>
Distance (ft):	<b>4.6</b>
Structural Grade:	<b>0</b>
O&M Grade:	<b>0</b>
Clock Start/From:	
Clock To:	
1st Value:	
2nd Value:	
Value Percent:	
Step:	<b>NO</b>
Remarks:	<b>END SURVEY</b>
