Manhole Inspection Report

Date:	04/28/2018	Weather:		Coding:	RZMACP
MH#:	M-505-081	Owner:	NA	Len. Surveyed:	6.3
P.O.#:		Surveyor:	Jen Costello	Rim to Invert:	7.2
Customer:		Cert. #:	U-907-5518	Wall Material:	Concrete (reinforced)

Street:	4th St. 715' East of Wabash St.	Project:	Hobart, IN
City:	Hobart, IN	GPS Northing:	2899794.847
Location:		GPS Easting:	2899794.847
Drain Area:	West	GPS Accuracy:	Sub-Meter
Cover Shape:	Circular	Evidence of Surcharge:	No
Cover Size:	22.5	Potential for Runoff:	None
Comments:

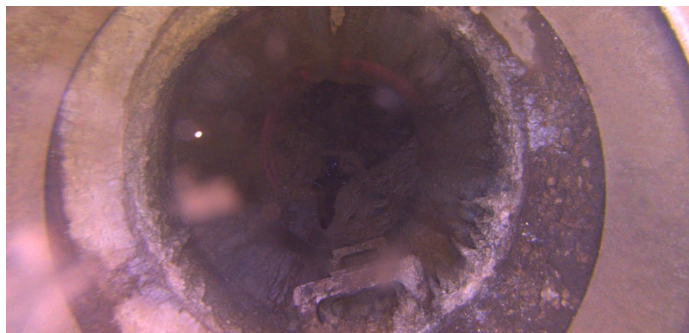
Code: **MGO**
Description: **General Observation**

Distance (ft): **.0**
Structural Grade: **0**
O&M Grade: **0**
Clock Start/From:
Clock To:
1st Value:
2nd Value:
Value Percent:
Step: **NO**
Remarks: **ACCESS MH**

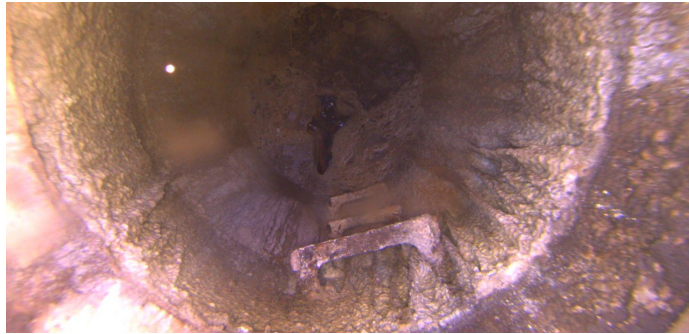
Code:	DAE
Description:	Deposits Attached Encrustation
Distance (ft):	.5
Structural Grade:	0
O&M Grade:	2
Clock Start/From:	12
Clock To:	12
1st Value:	
2nd Value:	
Value Percent:	5.000
Step:	NO
Remarks:

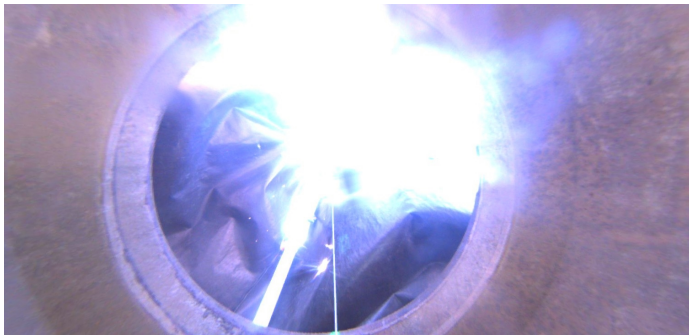
Code:	MGP
Description:	General Photo
Distance (ft):	1.3
Structural Grade:	0
O&M Grade:	0
Clock Start/From:	
Clock To:	
1st Value:	
2nd Value:	
Value Percent:	
Step:	NO
Remarks:	UNDERSIDE OF FRAME

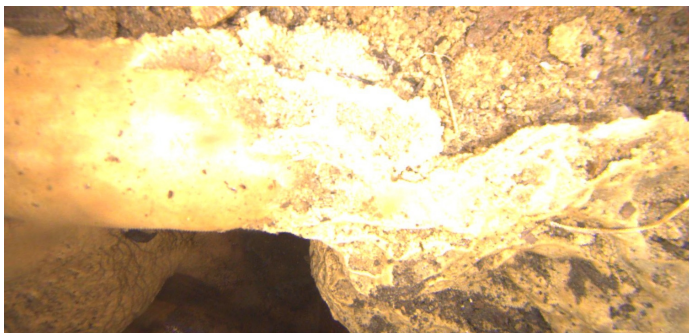
Code:	MGO
Description:	General Observation
Distance (ft):	6.3
Structural Grade:	0
O&M Grade:	0
Clock Start/From:	
Clock To:	
1st Value:	
2nd Value:	
Value Percent:	
Step:	NO
Remarks:	END SURVEY
