Manhole Inspection Report

Date:	09/27/2022	Weather:		Coding:	RZMACP
MH#:	M-505-084	Owner:	NA	Len. Surveyed:	7.7
P.O.#:		Surveyor:	Jen Costello	Rim to Invert:	8.4
Customer:		Cert. #:	U-907-5518	Wall Material:	Concrete (cast in place)

Street:	4th Pl. 6 Manholes East of Liftstatio	Project:	Hobart, IN
City:	Hobart, IN	GPS Northing:	2287959.199
Location:	Local Rural Streets	GPS Easting:	2900517.943
Drain Area:	West	GPS Accuracy:	Sub-Meter
Cover Shape:	Circular	Evidence of Surcharge:	No
Cover Size:	24.0	Potential for Runoff:	None
Comments:

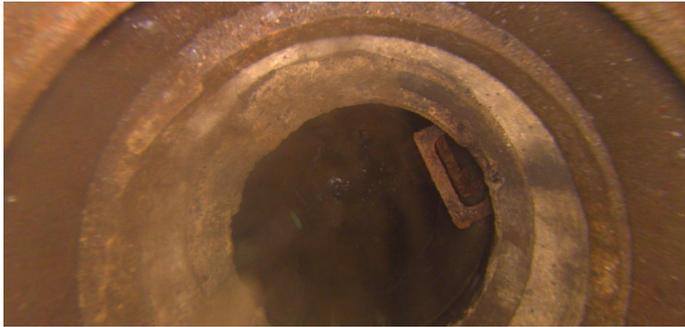
Code: **SRI**
Description: **Surface Roughness Increased**

Distance (ft): **.0**
Structural Grade: **1**
O&M Grade: **0**
Clock Start/From: **12**
Clock To: **12**
1st Value:
2nd Value:
Value Percent:
Step: **NO**
Remarks:

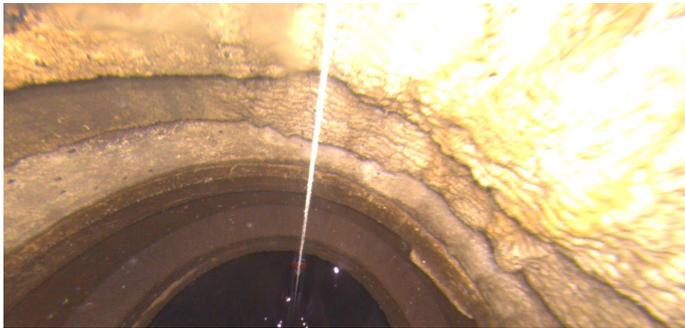
Code: **ISGT**
Description: **Intruding Sealing Grout**

Distance (ft): **2.5**
Structural Grade: **0**
O&M Grade: **2**
Clock Start/From: **12**
Clock To: **12**
1st Value:
2nd Value:
Value Percent: **5.000**
Step: **NO**
Remarks:

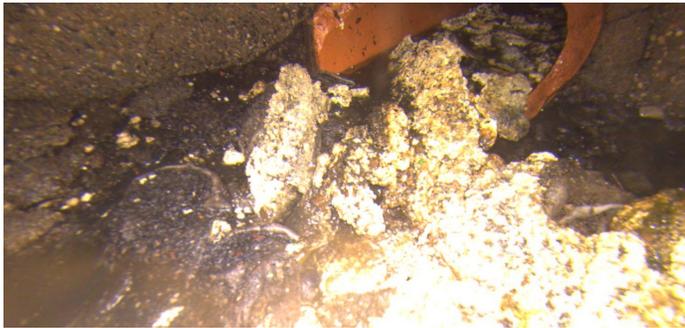
Code: **OBR**
Description: **Obstacle Rocks**

Distance (ft): **7.7**
Structural Grade: **0**
O&M Grade: **2**
Clock Start/From: **12**
Clock To: **12**
1st Value:
2nd Value:
Value Percent: **10.000**
Step: **NO**
Remarks:

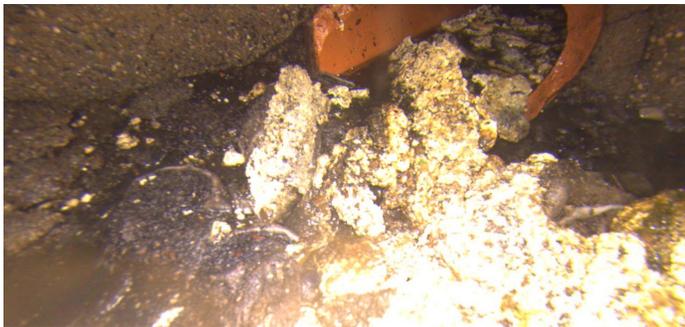
Code: **SRI**
Description: **Surface Roughness Increased**

Distance (ft): **7.7**
Structural Grade: **1**
O&M Grade: **0**
Clock Start/From: **12**
Clock To: **12**
1st Value:
2nd Value:
Value Percent:
Step: **NO**
Remarks:

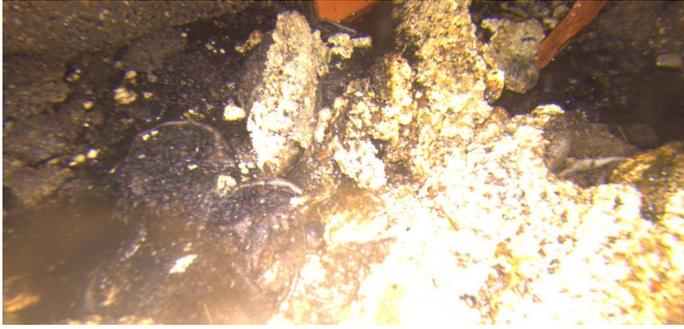
Code: **SAV**
Description: **Surface Aggregate Visible**

Distance (ft): **7.7**
Structural Grade: **3**
O&M Grade: **0**
Clock Start/From: **12**
Clock To: **12**
1st Value:
2nd Value:
Value Percent:
Step: **NO**
Remarks:
