Manhole Inspection Report

Date:	04/28/2018	Weather:		Coding:	RZMACP
MH#:	M-505-086	Owner:	NA	Len. Surveyed:	10.7
P.O.#:		Surveyor:	Jen Costello	Rim to Invert:	11.2
Customer:		Cert. #:	U-907-5518	Wall Material:	Concrete (reinforced)

Street:	4th Pl. 4 Manholes East of Liftstatio	Project:	Hobart, IN
City:	Hobart, IN	GPS Northing:	2900073.066
Location:		GPS Easting:	2900073.066
Drain Area:	West	GPS Accuracy:	Sub-Meter
Cover Shape:	Circular	Evidence of Surcharge:	No
Cover Size:	22.5	Potential for Runoff:	None
Comments:

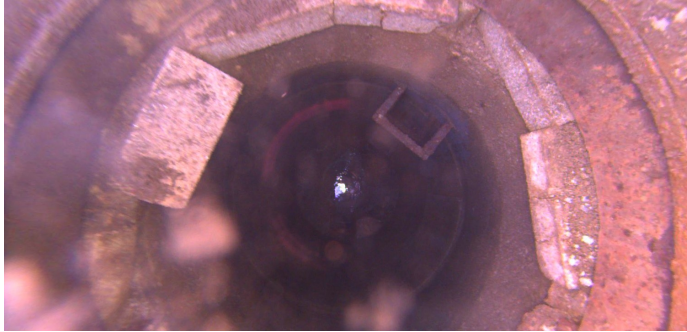
Code: **DB**
Description: **Displaced Brick**

Distance (ft): **.0**
Structural Grade: **3**
O&M Grade: **0**
Clock Start/From: **9**
Clock To: **3**
1st Value:
2nd Value:
Value Percent:
Step: **NO**
Remarks:

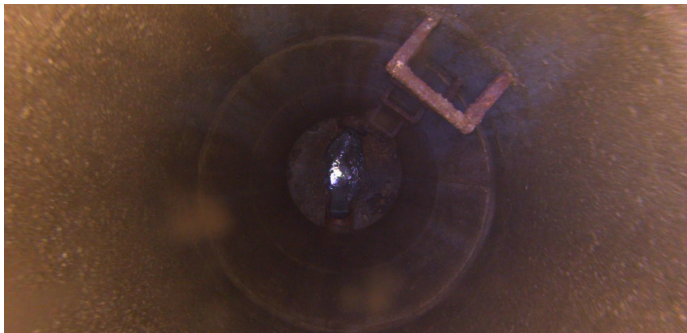
Code: **SAV**
Description: **Surface Aggregate Visible**

Distance (ft): **1.3**
Structural Grade: **3**
O&M Grade: **0**
Clock Start/From: **12**
Clock To: **12**
1st Value:
2nd Value:
Value Percent:
Step: **NO**
Remarks:

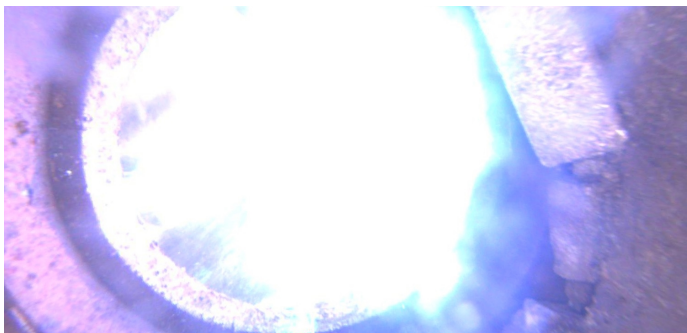
Code: **MGO**
Description: **General Observation**

Distance (ft): **2.4**
Structural Grade: **0**
O&M Grade: **0**
Clock Start/From:
Clock To:
1st Value:
2nd Value:
Value Percent:
Step: **NO**
Remarks: **UNDERSIDE OF FRAME**

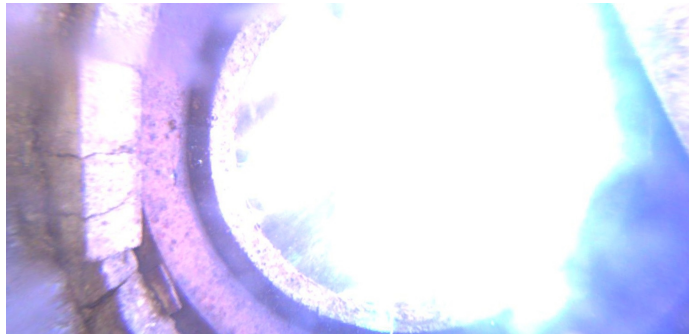
Code: **FM**
Description: **Fracture Multiple**

Distance (ft): **2.4**
Structural Grade: **4**
O&M Grade: **0**
Clock Start/From: **3**
Clock To: **4**
1st Value:
2nd Value:
Value Percent:
Step: **NO**
Remarks:

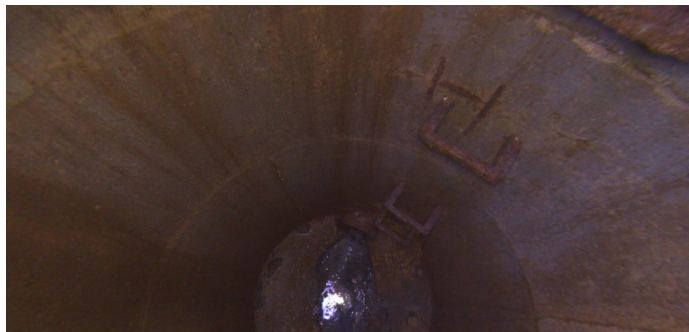
Code: **SRV**
Description: **Surface Reinforcement Visible**

Distance (ft): **4.0**
Structural Grade: **5**
O&M Grade: **0**
Clock Start/From: **1**
Clock To: **2**
1st Value:
2nd Value:
Value Percent:
Step: **NO**
Remarks:

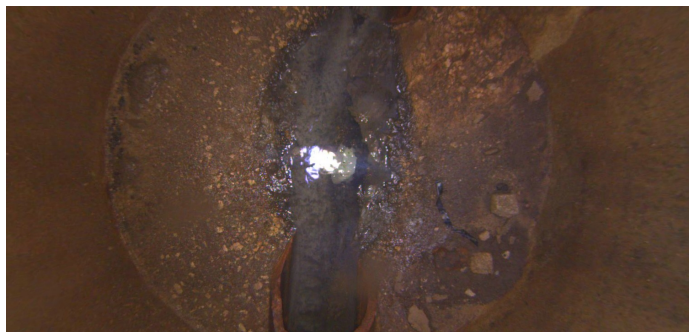
Code: **SAV**
Description: **Surface Aggregate Visible**

Distance (ft): **8.7**
Structural Grade: **3**
O&M Grade: **0**
Clock Start/From: **12**
Clock To: **12**
1st Value:
2nd Value:
Value Percent:
Step: **NO**
Remarks:

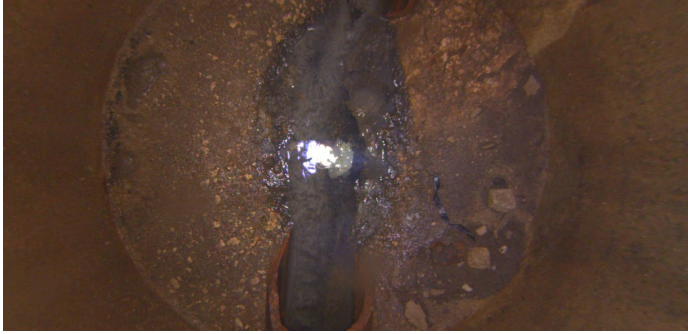
Code: **DSGV**
Description: **Deposits Settled Gravel**

Distance (ft): **8.7**
Structural Grade: **0**
O&M Grade: **2**
Clock Start/From: **12**
Clock To: **12**
1st Value:
2nd Value:
Value Percent: **5.000**
Step: **NO**
Remarks:
