Manhole Inspection Report

Date:	04/24/2018	Weather:		Coding:	RZMACP
MH#:	M-505-087	Owner:	NA	Len. Surveyed:	12.7
P.O.#:		Surveyor:	John Kuglmaier	Rim to Invert:	12.1
Customer:		Cert. #:	U-1215-07002349	Wall Material:	Concrete (reinforced)

Street:	4th Pl. 3 Manholes East of Liftstatio	Project:	Hobart, IN
City:	Hobart, IN	GPS Northing:	2899827.711
Location:		GPS Easting:	2899827.711
Drain Area:	West	GPS Accuracy:	Sub-Meter
Cover Shape:	Circular	Evidence of Surcharge:	Yes
Cover Size:	22.5	Potential for Runoff:	None
Comments:

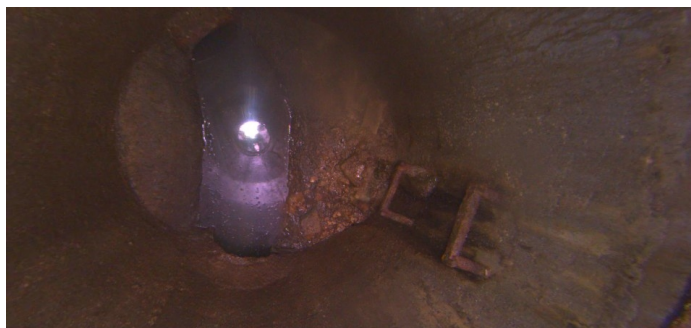
Code: **IS**
Description: **Infil Stain**

Distance (ft): **8.7**
Structural Grade: **0**
O&M Grade: **0**
Clock Start/From: **4**
Clock To:
1st Value:
2nd Value:
Value Percent:
Step: **NO**
Remarks:

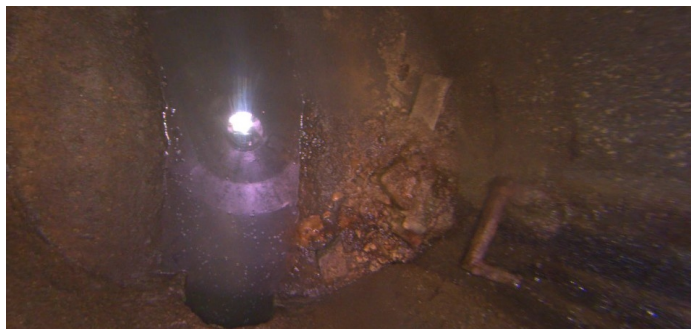
Code: **DAZ**
Description: **Deposits Attached Other**

Distance (ft): **10.3**
Structural Grade: **0**
O&M Grade: **2**
Clock Start/From: **3**
Clock To: **5**
1st Value:
2nd Value:
Value Percent: **10.000**
Step: **NO**
Remarks: **Mixed materials**

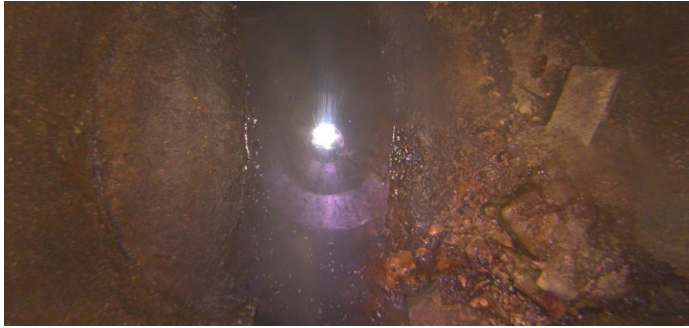
Code:	MGO
Description:	General Observation
Distance (ft):	11.1
Structural Grade:	0
O&M Grade:	0
Clock Start/From:	
Clock To:	
1st Value:	
2nd Value:	
Value Percent:	
Step:	NO
Remarks:	Ins. Comp.
