Manhole Inspection Report

Date:	04/24/2018	Weather:		Coding:	RZMACP
MH#:	M-505-089	Owner:	NA	Len. Surveyed:	7.3
P.O.#:		Surveyor:	John Kuglmaier	Rim to Invert:	7.0
Customer:		Cert. #:	U-1215-07002349	Wall Material:	Concrete (reinforced)

Street:	South of 4th Pl. 1 Manhole From Lift	Project:	Hobart, IN
City:	Hobart, IN	GPS Northing:	2899591.574
Location:		GPS Easting:	2899591.574
Drain Area:	West	GPS Accuracy:	Sub-Meter
Cover Shape:	Circular	Evidence of Surcharge:	Yes
Cover Size:	22.5	Potential for Runoff:	None
Comments:

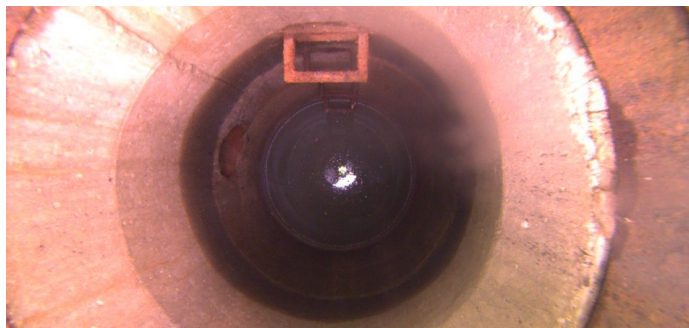
Code: **MGP**
Description: **General Photo**

Distance (ft): **.0**
Structural Grade: **0**
O&M Grade: **0**
Clock Start/From:
Clock To:
1st Value:
2nd Value:
Value Percent:
Step: **NO**
Remarks:

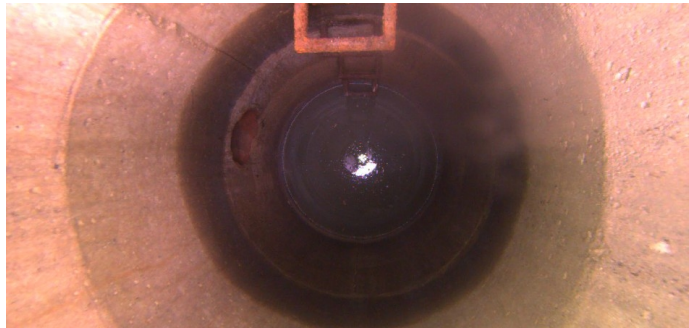
Code: **IS**
Description: **Infil Stain**

Distance (ft): **.4**
Structural Grade: **0**
O&M Grade: **0**
Clock Start/From: **12**
Clock To: **12**
1st Value:
2nd Value:
Value Percent:
Step: **NO**
Remarks:

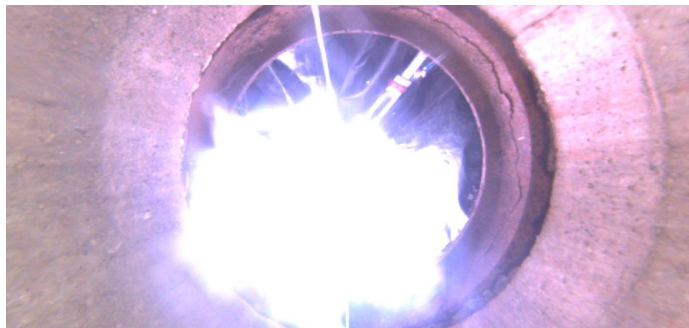
Code: **MGP**
Description: **General Photo**

Distance (ft): **2.5**
Structural Grade: **0**
O&M Grade: **0**
Clock Start/From:
Clock To:
1st Value:
2nd Value:
Value Percent:
Step: **NO**
Remarks:

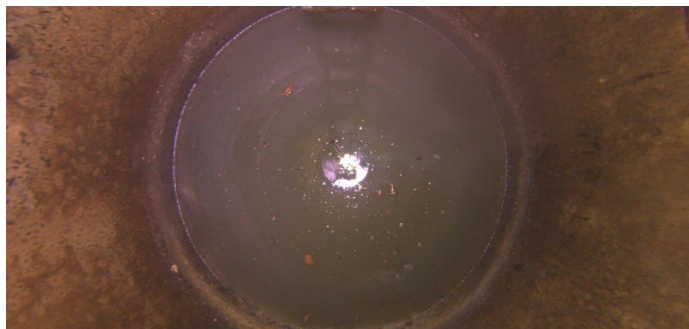
Code: **MGO**
Description: **General Observation**

Distance (ft): **4.4**
Structural Grade: **0**
O&M Grade: **0**
Clock Start/From:
Clock To:
1st Value:
2nd Value:
Value Percent:
Step: **NO**
Remarks: **Surcharge**

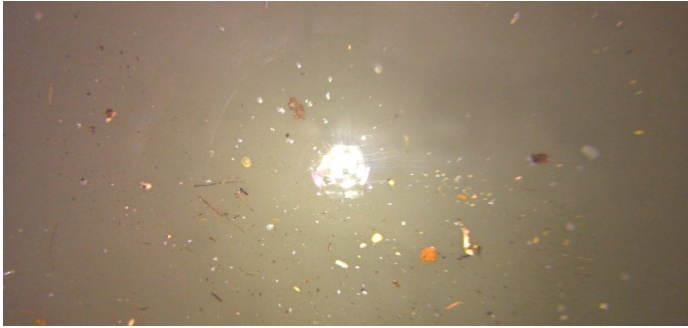
Code:	MSA
Description:	Abandoned Survey
Distance (ft):	6.4
Structural Grade:	0
O&M Grade:	0
Clock Start/From:	
Clock To:	
1st Value:	
2nd Value:	
Value Percent:	
Step:	NO
Remarks:	Surcharge
