Manhole Inspection Report

O&M Index:	0.00	O&M Quick:	0000	O&M Rating:	0.00
Structural Index:	5.00	Structural Quick:	5100	Structural Rating:	5.00
Overall Index:	5.00	Overall Quick:	5100	Overall Rating:	5.00

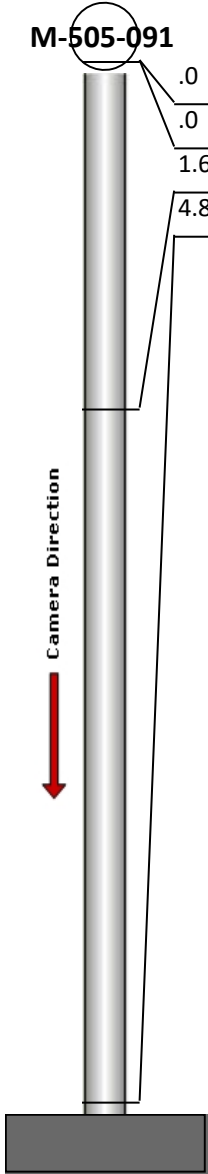
.0	MGO	General Observation	10	NA
	.0	B	Broken	20	S 5
	1.6	MGP	General Photo	36	NA
	4.8	MGO	General Observation	55	NA

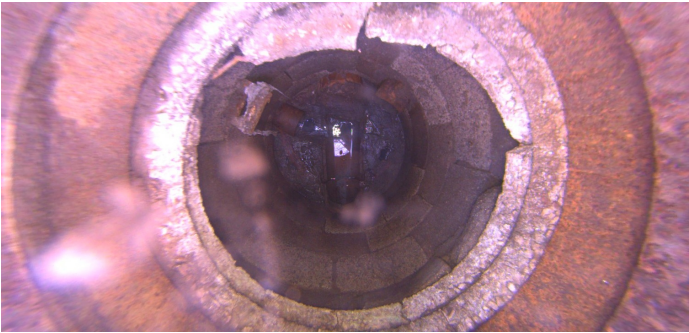
Code: **MGO**
 Description: **General Observation**

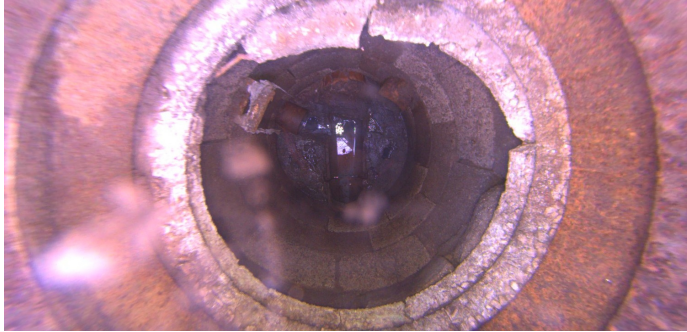
Code: **B**
Description: **Broken**

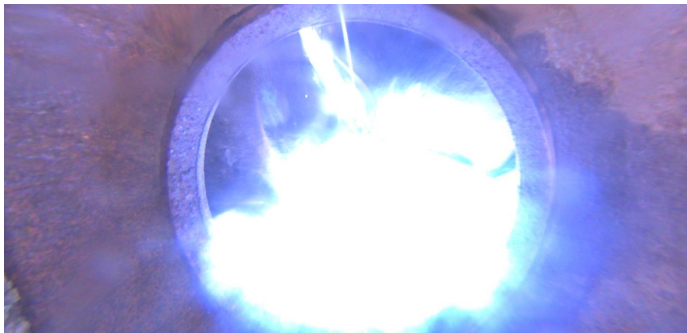
Code: **MGP**
Description: **General Photo**
