Manhole Inspection Report

Date:	04/28/2018	Weather:		Coding:	RZMACP
MH#:	M-505-097	Owner:	NA	Len. Surveyed:	7.5
P.O.#:		Surveyor:	Jen Costello	Rim to Invert:	7.7
Customer:		Cert. #:	U-907-5518	Wall Material:	Concrete (reinforced)

Street:	4th St. 1145' East of Wabash St.	Project:	Hobart, IN
City:	Hobart, IN	GPS Northing:	2900223.007
Location:		GPS Easting:	2900223.007
Drain Area:	West	GPS Accuracy:	Sub-Meter
Cover Shape:	Circular	Evidence of Surcharge:	No
Cover Size:	22.5	Potential for Runoff:	None
Comments:

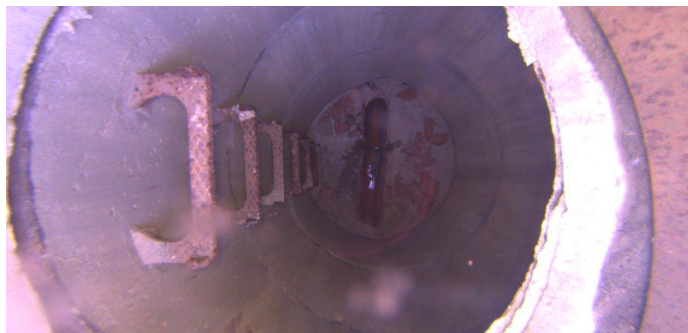
Code: **MGO**
Description: **General Observation**

Distance (ft): **.0**
Structural Grade: **0**
O&M Grade: **0**
Clock Start/From:
Clock To:
1st Value:
2nd Value:
Value Percent:
Step: **NO**
Remarks: **access MH**

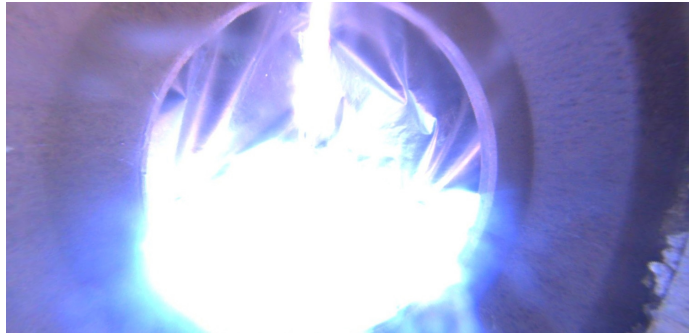
Code:	MGP
Description:	General Photo
Distance (ft):	1.3
Structural Grade:	0
O&M Grade:	0
Clock Start/From:	
Clock To:	
1st Value:	
2nd Value:	
Value Percent:	
Step:	NO
Remarks:	UNDERSIDE OF FRAME

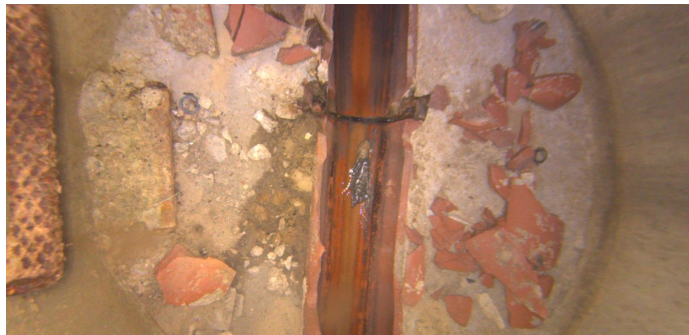
Code:	OBM
Description:	Obstacle Pipe Material
Distance (ft):	5.4
Structural Grade:	0
O&M Grade:	2
Clock Start/From:	12
Clock To:	12
1st Value:	
2nd Value:	
Value Percent:	10.000
Step:	NO
Remarks:

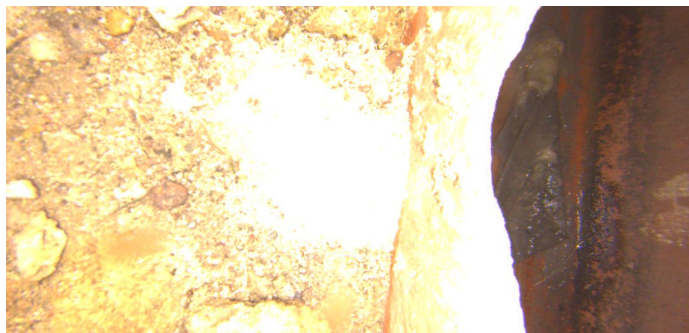
Code:	MGO
Description:	General Observation
Distance (ft):	7.5
Structural Grade:	0
O&M Grade:	0
Clock Start/From:	
Clock To:	
1st Value:	
2nd Value:	
Value Percent:	
Step:	NO
Remarks:	END SURVEY
