Manhole Inspection Report

Date:	09/28/2022	Weather:		Coding:	RZMACP
MH#:	M-506-002	Owner:	NA	Len. Surveyed:	16.6
P.O.#:		Surveyor:	Jen Costello	Rim to Invert:	18.2
Customer:		Cert. #:	U-907-5518	Wall Material:	Concrete (cast in place)

Street:	8th St. 302' West of Wisconsin St.	Project:	Hobart, IN
City:	Hobart, IN	GPS Northing:	2286504.501
Location:	Yard	GPS Easting:	2901566.423
Drain Area:	Southwest	GPS Accuracy:	Sub-Meter
Cover Shape:	Circular	Evidence of Surcharge:	Yes
Cover Size:	24.0	Potential for Runoff:	None
Comments:

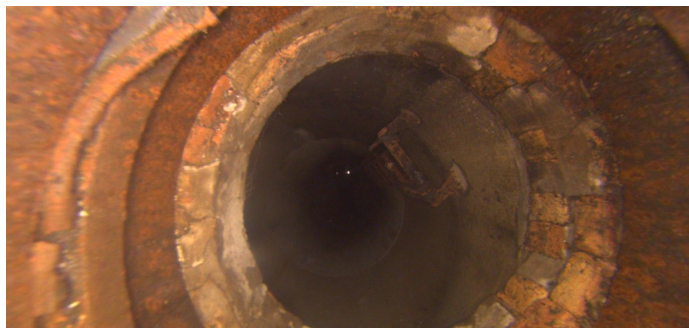
Code: **MGO**
Description: **General Observation**

Distance (ft): **.0**
Structural Grade: **0**
O&M Grade: **0**
Clock Start/From:
Clock To:
1st Value:
2nd Value:
Value Percent:
Step: **NO**
Remarks: **access mh**

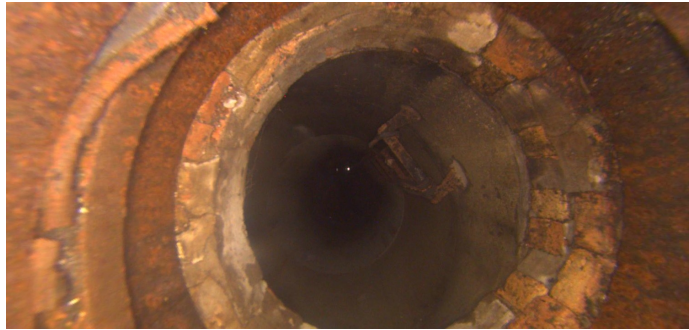
Code: **ISGT**
Description: **Intruding Sealing Grout**

Distance (ft): **.0**
Structural Grade: **0**
O&M Grade: **2**
Clock Start/From: **9**
Clock To: **12**
1st Value:
2nd Value:
Value Percent: **5.000**
Step: **NO**
Remarks:

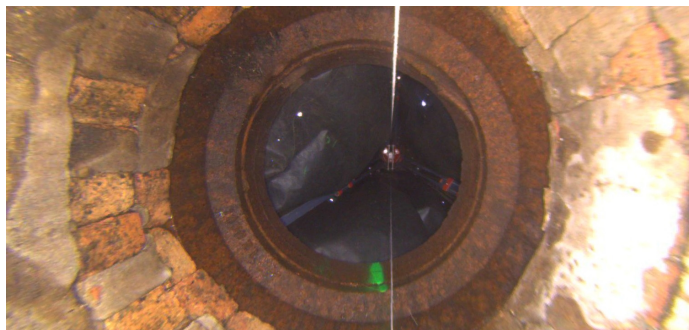
Code: **MGO**
Description: **General Observation**

Distance (ft): **2.9**
Structural Grade: **0**
O&M Grade: **0**
Clock Start/From:
Clock To:
1st Value:
2nd Value:
Value Percent:
Step: **NO**
Remarks: **underside of frame**

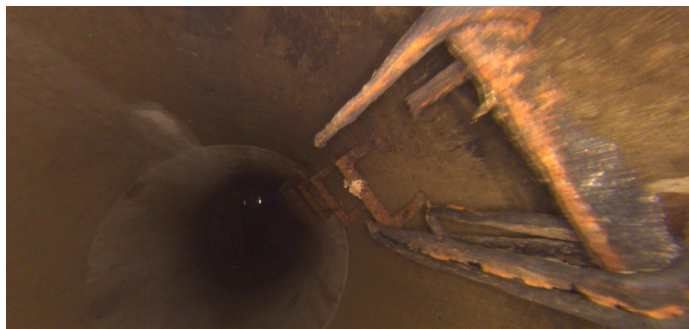
Code: **DAR**
Description: **Deposits Attached Ragging**

Distance (ft): **2.9**
Structural Grade: **0**
O&M Grade: **2**
Clock Start/From: **2**
Clock To: **3**
1st Value:
2nd Value:
Value Percent: **10.000**
Step: **YES**
Remarks:

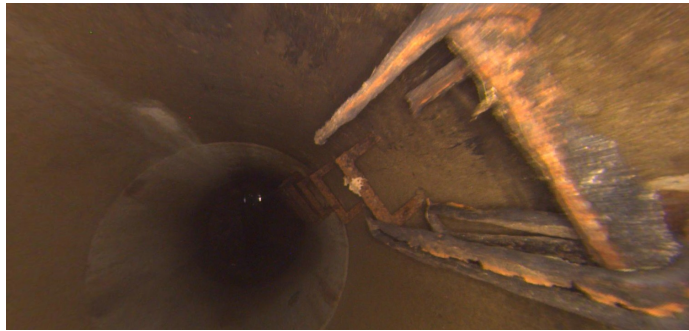
Code: **SRI**
Description: **Surface Roughness Increased**

Distance (ft): **2.9**
Structural Grade: **1**
O&M Grade: **0**
Clock Start/From: **12**
Clock To: **12**
1st Value:
2nd Value:
Value Percent:
Step: **NO**
Remarks:

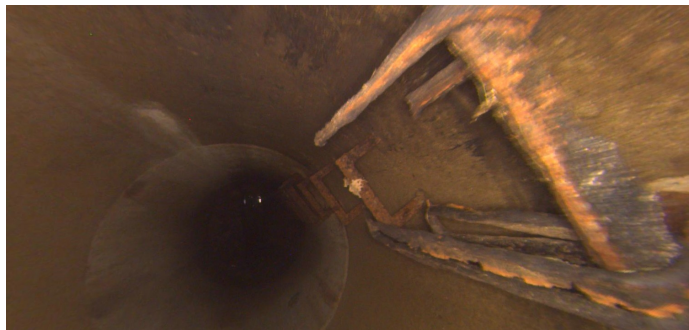
Code: **MMC**
Description: **Material Change**

Distance (ft): **2.9**
Structural Grade: **0**
O&M Grade: **0**
Clock Start/From:
Clock To:
1st Value:
2nd Value:
Value Percent:
Step: **NO**
Remarks: **concrete**

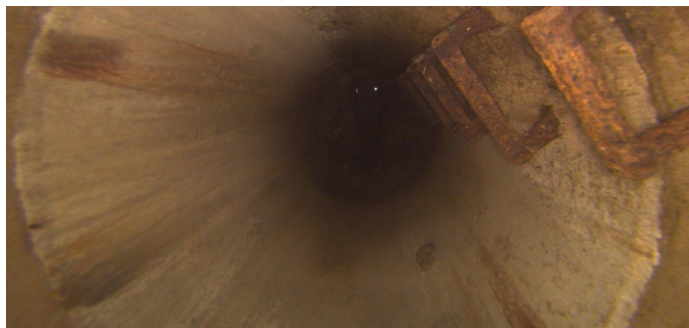
Code: **IW**
Description: **Infil Weeper**

Distance (ft): **6.4**
Structural Grade: **0**
O&M Grade: **2**
Clock Start/From: **4**
Clock To: **9**
1st Value:
2nd Value:
Value Percent:
Step: **NO**
Remarks:

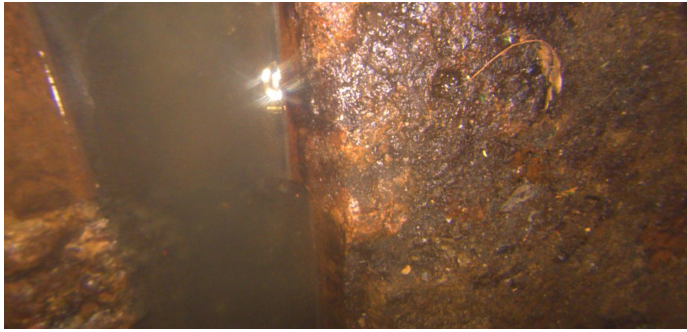
Code: **DSF**
Description: **Deposits Settled Fine**

Distance (ft): **16.6**
Structural Grade: **0**
O&M Grade: **2**
Clock Start/From: **12**
Clock To: **12**
1st Value:
2nd Value:
Value Percent: **5.000**
Step: **NO**
Remarks:

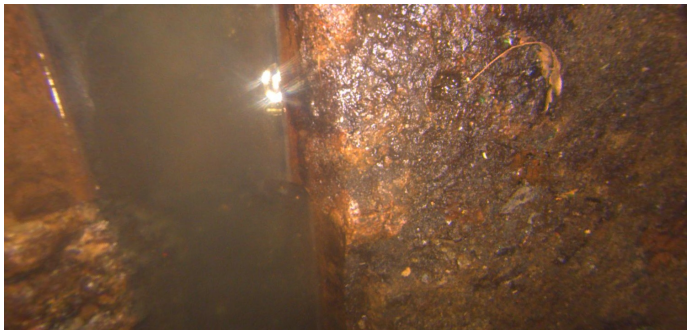
Code: **SRI**
Description: **Surface Roughness Increased**

Distance (ft): **16.6**
Structural Grade: **1**
O&M Grade: **0**
Clock Start/From: **12**
Clock To: **12**
1st Value:
2nd Value:
Value Percent:
Step: **NO**
Remarks:

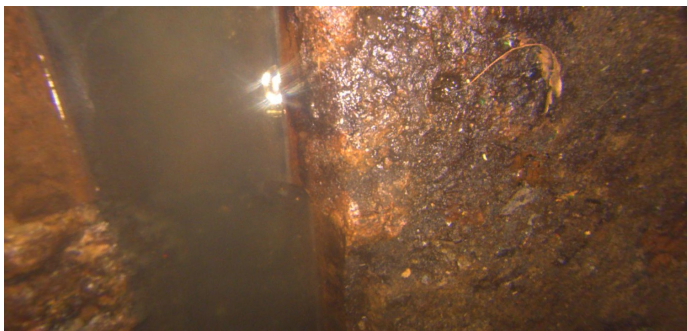
Code: **MGO**
Description: **General Observation**

Distance (ft): **16.6**
Structural Grade: **0**
O&M Grade: **0**
Clock Start/From:
Clock To:
1st Value:
2nd Value:
Value Percent:
Step: **NO**
Remarks: **end of survey**
