# Manhole Inspection Report

Date:	<b>04/24/2018</b>	Weather:		Coding:	<b>RZMACP</b>
MH#:	<b>M-506-003</b>	Owner:	<b>NA</b>	Len. Surveyed:	<b>14.4</b>
P.O.#:		Surveyor:	<b>Jen Costello</b>	Rim to Invert:	<b>16.5</b>
Customer:		Cert. #:	<b>U-907-5518</b>	Wall Material:	<b>Concrete (reinforced)</b>

Street:	<b>8th St. 601' West of Wisconsin St.</b>	Project:	<b>Hobart, IN</b>
City:	<b>Hobart, IN</b>	GPS Northing:	<b>41.5254631</b>
Location:		GPS Easting:	<b>-87.27134705</b>
Drain Area:	<b>Southwest</b>	GPS Accuracy:	<b>Nearest Meter</b>
Cover Shape:	<b>Circular</b>	Evidence of Surcharge:	<b>No</b>
Cover Size:	<b>22.5</b>	Potential for Runoff:	<b>None</b>
Comments:

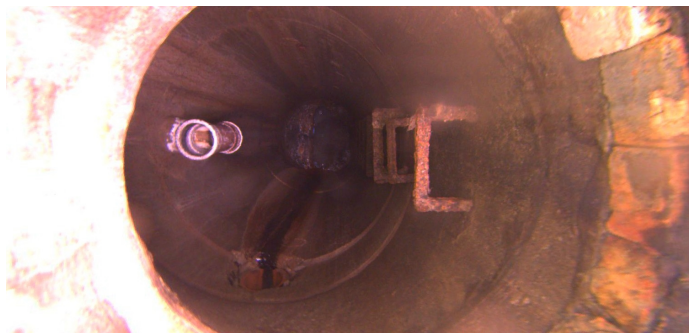
Code: **MGO**  
Description: **General Observation**

Distance (ft): **.0**  
Structural Grade: **0**  
O&M Grade: **0**  
Clock Start/From:  
Clock To:  
1st Value:  
2nd Value:  
Value Percent:  
Step: **NO**  
Remarks: **ACCESS MH**

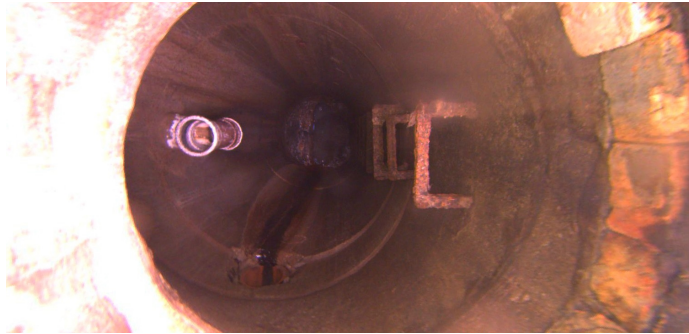
Code: **DB**  
Description: **Displaced Brick**

Distance (ft): **.0**  
Structural Grade: **3**  
O&M Grade: **0**  
Clock Start/From: **2**  
Clock To: **4**  
1st Value:  
2nd Value:  
Value Percent:  
Step: **NO**  
Remarks:

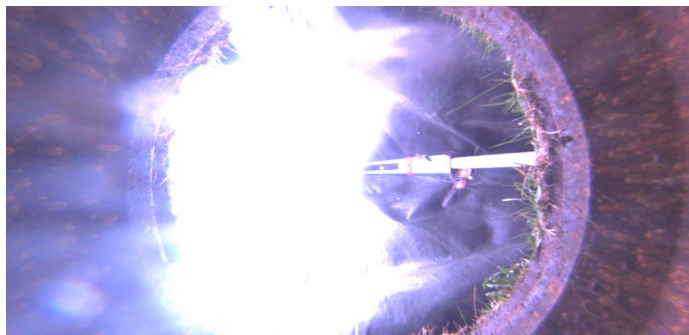
Code: **MGO**  
Description: **General Observation**

Distance (ft): **1.2**  
Structural Grade: **0**  
O&M Grade: **0**  
Clock Start/From:  
Clock To:  
1st Value:  
2nd Value:  
Value Percent:  
Step: **NO**  
Remarks: **UNDERSIDE OF FRAME**

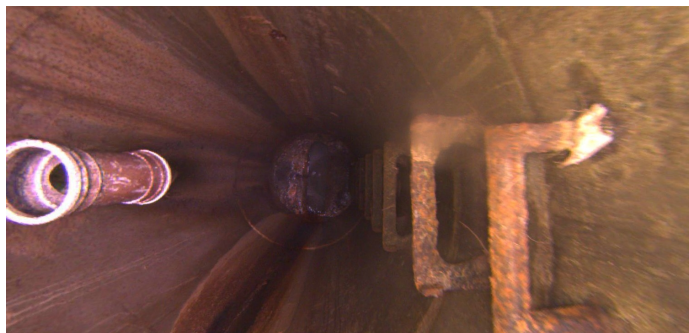
Code: **OBP**  
Description: **Obstacle External Pipe or Cable**

Distance (ft): **2.6**  
Structural Grade: **0**  
O&M Grade: **2**  
Clock Start/From: **9**  
Clock To:  
1st Value:  
2nd Value:  
Value Percent: **5.000**  
Step: **NO**  
Remarks:

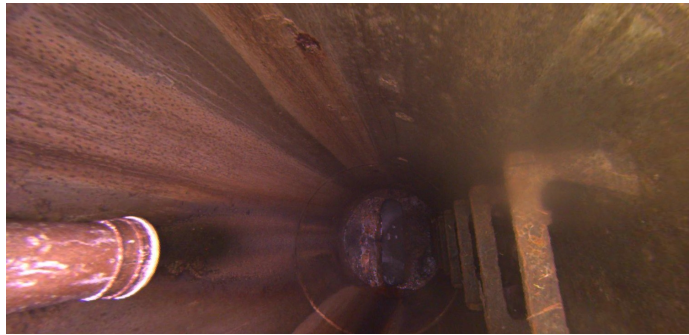
Code: **IS**  
Description: **Infil Stain**

Distance (ft): **4.2**  
Structural Grade: **0**  
O&M Grade: **0**  
Clock Start/From: **12**  
Clock To: **12**  
1st Value:  
2nd Value:  
Value Percent:  
Step: **NO**  
Remarks:

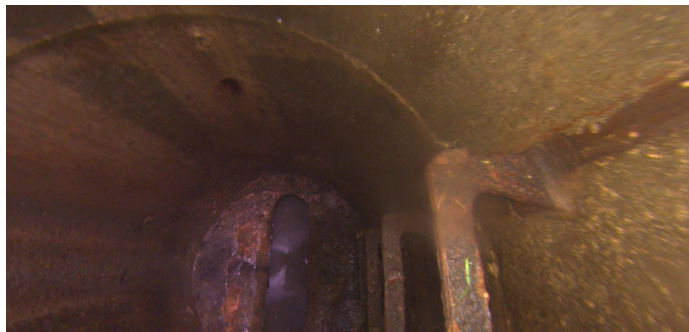
Code: **SAV**  
Description: **Surface Aggregate Visible**

Distance (ft): **9.2**  
Structural Grade: **3**  
O&M Grade: **0**  
Clock Start/From: **12**  
Clock To: **12**  
1st Value:  
2nd Value:  
Value Percent:  
Step: **NO**  
Remarks:

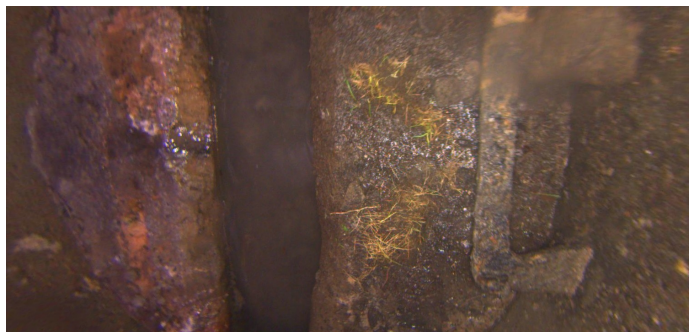
Code: **DSF**  
Description: **Deposits Settled Fine**

Distance (ft): **14.3**  
Structural Grade: **0**  
O&M Grade: **2**  
Clock Start/From: **12**  
Clock To: **12**  
1st Value:  
2nd Value:  
Value Percent: **5.000**  
Step: **NO**  
Remarks:

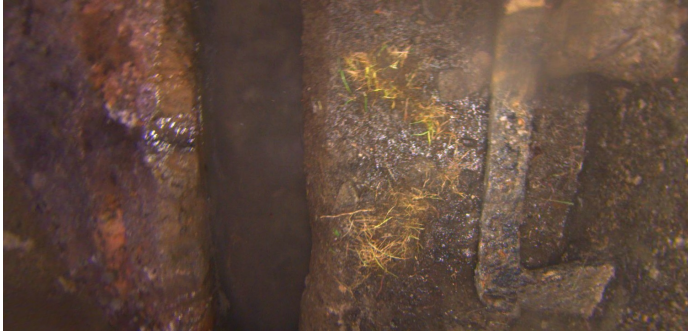
Code:	MGO
Description:	General Observation
Distance (ft):	14.4
Structural Grade:	0
O&M Grade:	0
Clock Start/From:	
Clock To:	
1st Value:	
2nd Value:	
Value Percent:	
Step:	NO
Remarks:	end survey
